Hazardous Building Materials Assessment (Pre-construction)

Regional Rehabilitation Centre
300 Wellington Street North,
Hamilton, Ontario

July 5, 2022

Pinchin File: 303980.020

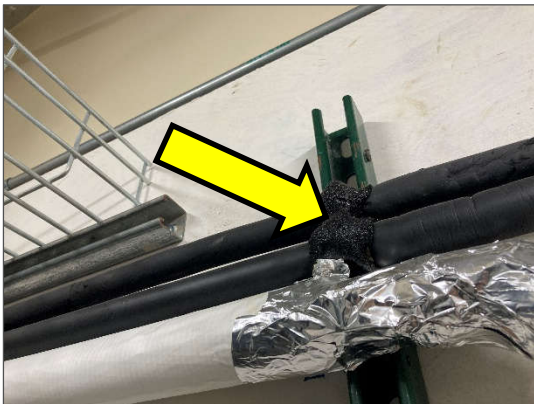
Photo 1

Tar wrapping over Armaflex insulation (Photo 1) present on refrigerant piping throughout the building does not contain asbestos (samples S0010A-C).

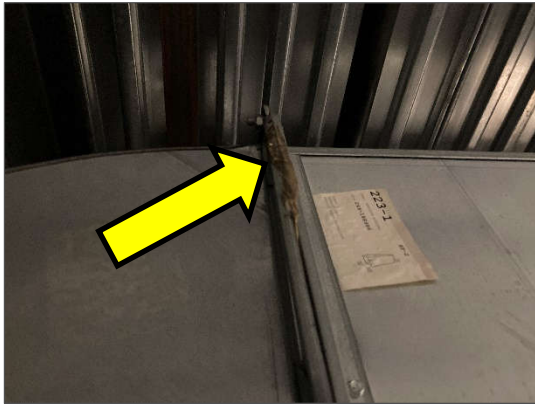
Colour	Sample Number	Asbestos Type
Beige putty, Photo 1	S0005A-C	None Detected

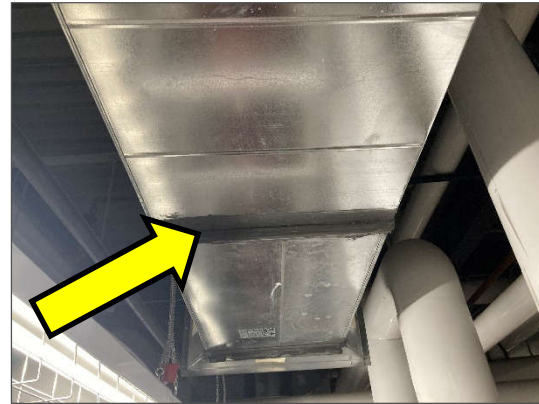
Colour	Sample Number	Asbestos Type
Grey mastic, Photo 2	S0007A-C	None Detected

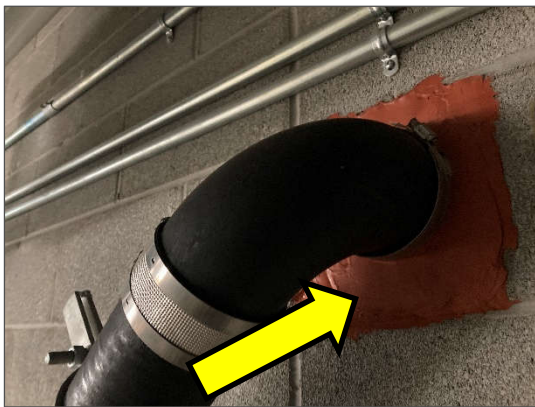
Colour, Photo #	Application	Sample Number	Asbestos Type
Red, Photo 1	Pipe penetrations through walls	S0004A-C	None Detected
Pink, Photo 2	Conduit penetrations through walls	S0008A-C	None Detected
Grey, Photo 3	Conduit penetrations through floors	S0009A-C	None Detected
Bright pink, Photo 4	Pipe penetrations through walls and floors	S0011A-C	None Detected
Brown, Photo 5	Sprinkler line penetrations through walls	S0013A-C	None Detected
White, Photo 6	Pipe and conduit penetrations	N/A	None (drywall tape and joint compound)

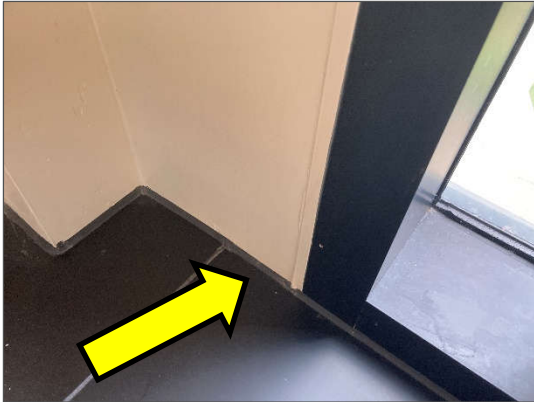
Material, Colour, Photo #	Application	Sample Number	Asbestos Type
Caulking, black, Photo 1	Around window frames	S0001A-C	None Detected
Caulking, white, Photo 2	Around door frames	S0002A-C	None Detected
Caulking, grey, Photo 3	Around door frames	S0003A-C	None Detected
Putty, black, Photo 4	Between the windows and frames of doors	S0006A-C	None Detected
Caulking, clear, Photo 5	Around window frames	S0012A-C	None Detected
Caulking, grey, Photo 6	Around courtyard exterior window frames	S0014A-C	None Detected
Caulking, grey, Photo 7	Expansion joint on courtyard exterior windowsills	S0015A-C	None Detected
Caulking, brown, Photo 8	Expansion joint on concrete floors	S0016A-C	None Detected
Putty, black, Photo 9	Between windows and frames, exterior (inaccessible during assessment due to elevated heights)	N/A	Presumed

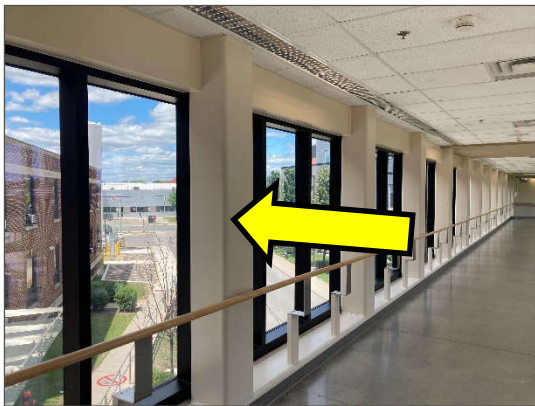
Sample Number, Photo #	Colour, Substrate Description	Lead (%)
L0001, Photo 1	Beige, drywall wall	<0.0040
L0002, Photo 2	Orange, poured concrete wall	<0.0066
L0003, Photo 3	Green, poured concrete wall	<0.0051
L0004, Photo 4	Olive, drywall wall	<0.0058
L0005, Photo 5	Lime green, drywall ceiling	<0.0075
L0006, Photo 6	Blue, drywall wall	<0.0071
L0007, Photo 7	White, drywall ceiling	<0.0059
L0008, Photo 8	Lavender, drywall wall	<0.0069
