Hazardous Building Materials Assessment (Pre-construction)

Ron Joyce Centre
325 Wellington Street North,
Hamilton, Ontario

November 2, 2022

Pinchin File: 303980.041

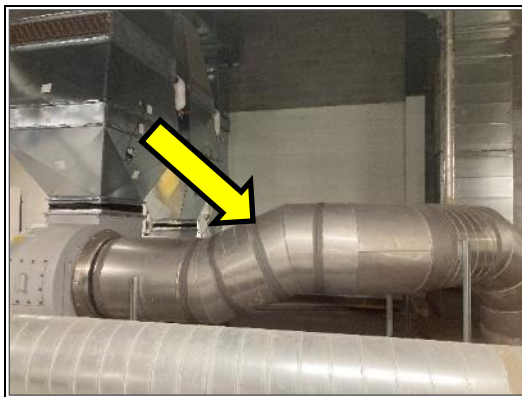
Photo 1

Grey duct mastic present at seams / joints on ducts throughout the assessed area does not contain asbestos (samples S0003A-C, Photo 1).

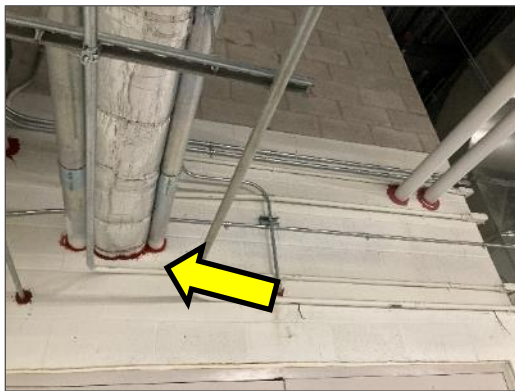
Colour, Photo #	Application	Sample Number	Asbestos Type
Red, Photo 1	Conduit penetrations through walls	S0004A-C	None Detected
Pink, Photo 2	Pipe penetrations through walls	S0008A-C	None Detected
Grey, Photo 3	Pipe penetrations through floors	S0007A-C	None Detected
Brown, Photo 4	Conduit penetrations through walls	S0009A-C	None Detected
White, Photo 5	Duct penetrations through walls	S0010A-C	None Detected
