Asbestos Reassessment

Hamilton General Hospital
237 Barton Street East,
Hamilton, Ontario

January 13, 2025

Pinchin File: 336568.061

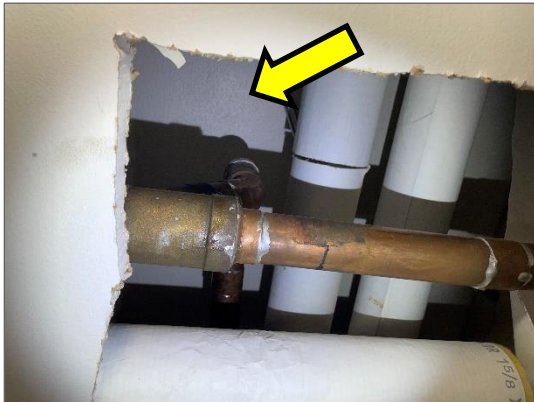
Photo 1

Acoustic sprayed texture finish (photo 1), containing chrysotile asbestos (sample S043a, lab reference no. b55013), is present as a ceiling finish on the plaster ceiling above the drywall ceiling in the Housekeeping Closet (Location 1007), the Women's Washroom (Location 1027), and the Men's Washroom (Location 1028), and is suspected to be present above solid ceilings in other areas of the East Wing.

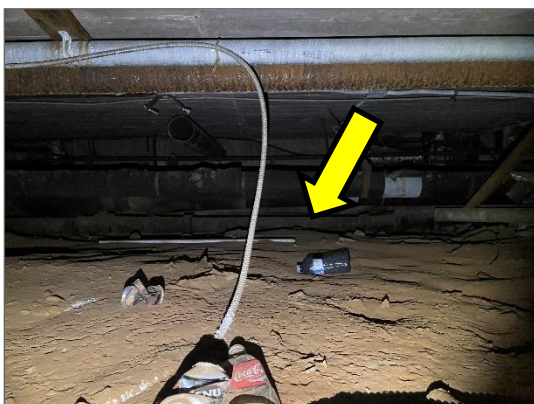
Photo 1

Transite pipe (photo 1), presumed to contain asbestos based on visual observation, is present as a sanitary drain in the Crawlspace (Location 1).

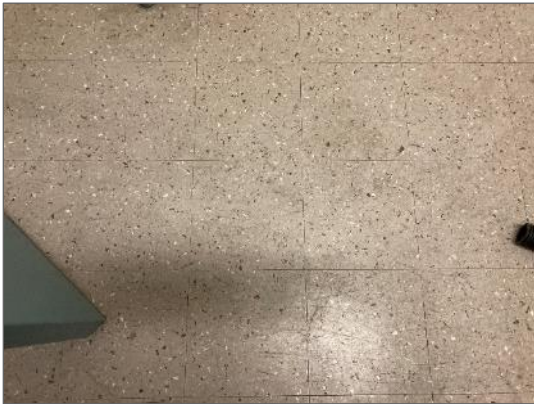
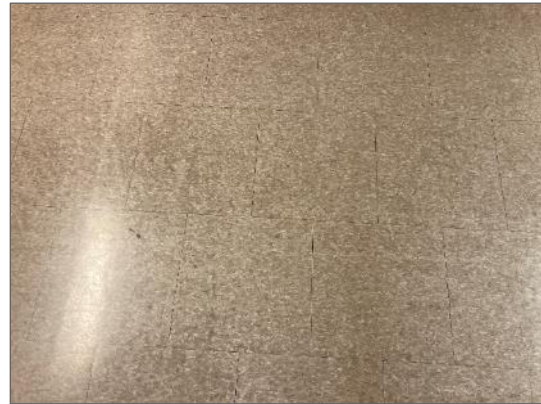
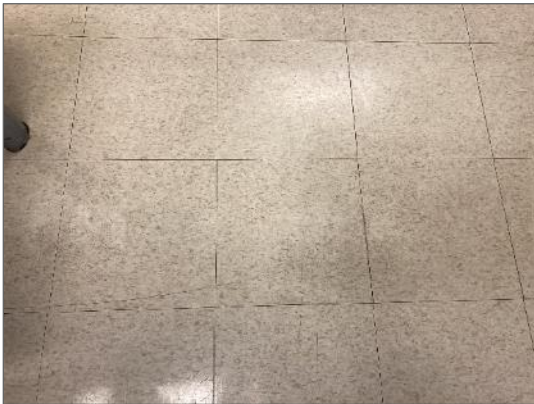
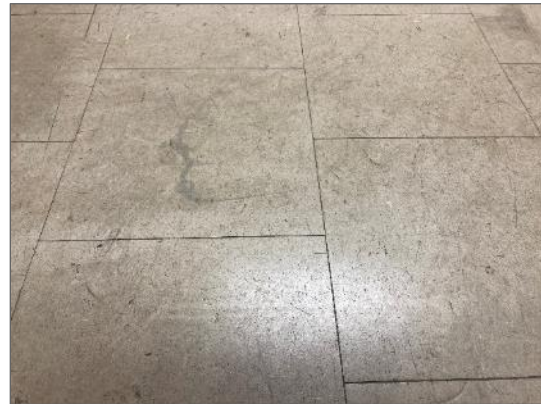
Size, Pattern, Colour, Photo #	Sample Number, lab ref no.	Asbestos Type (tile)	Asbestos Type (mastic)
9" x 9", grey with white and black flecks, photo 1	S0001A-C, 71961912	None detected	None detected
12" x 12", beige dense fleck	S0002A-C, 71961912	None detected	None detected
12" x 12", pink dense fleck, photo 2	S0003A-C, 71961912	None detected	None detected
12" x 12", beige with brown fleck, photo 3	S0004A-C, 71961912	None detected	None detected
12" x 12", beige with brown and white streaks, photo 4	S0005A-C, 71961912	None detected	None detected
12" x 12", grey dense fleck	S0009A-C, 71961912	None detected	None detected

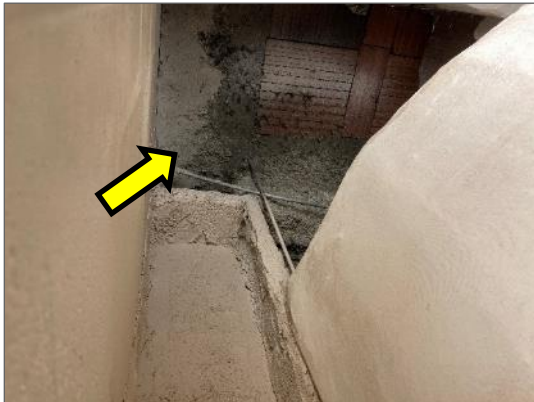
Photo 1

Fibrous sprayed fireproofing (photo 1) present on structural steel throughout the main floor of the North Wing does not contain asbestos (samples S034A-C, lab reference no. b54880).

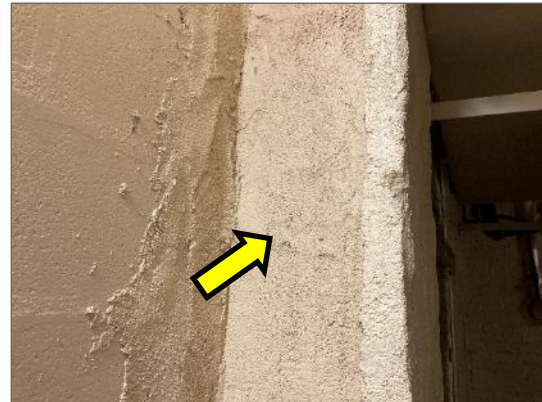
Photo 2

Cementitious sprayed fireproofing (photo 2) present on structural steel throughout the North Wing does not contain asbestos (samples S0007A-E, lab reference no. b229350 and samples S0002A-C, lab reference no. 71961910).

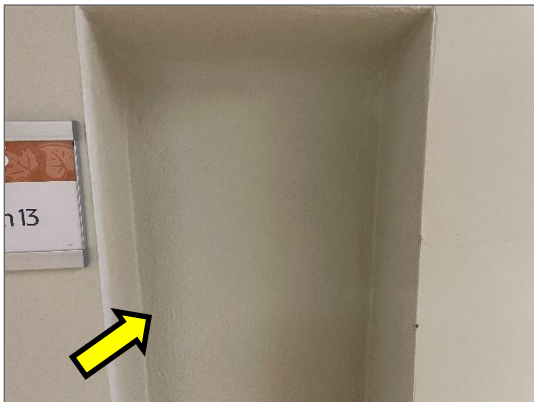
Photo 1

Texture coat (photo 1), containing chrysotile asbestos, is present on plaster walls in select areas of the North Wing (samples S0001A-C, lab reference no. 71961910).

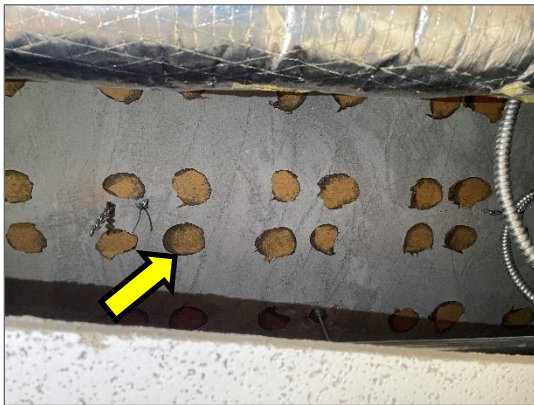
Photo 1

Brown puck mastic from former glue-on ceiling tiles (photo 1) does not contain asbestos (samples S0015A-C, lab ref no. R8153497).

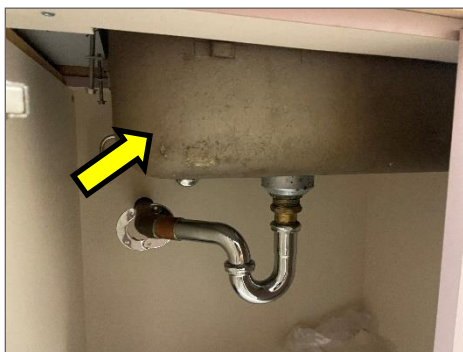
Photo 1

Gold mastic (photo 1), containing chrysotile asbestos, is present as an undercoating on sinks throughout the North Wing (sample S0003A, lab reference no. 71961910).

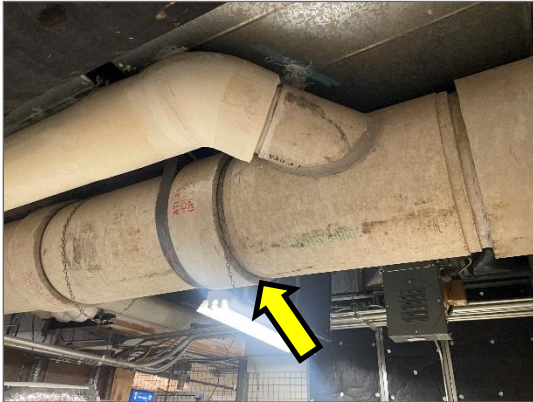
Photo 1

Transite pipe (photo 1), presumed to contain asbestos based on visual observation, is present as a sanitary drain in the Maintenance Shops (Location 14).

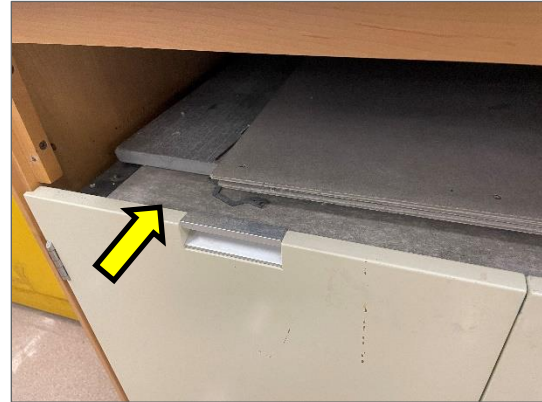
Photo 2

Transite board (photo 2), presumed to contain asbestos based on visual observation, is present in fume hoods and associated shelving throughout the Main Building.

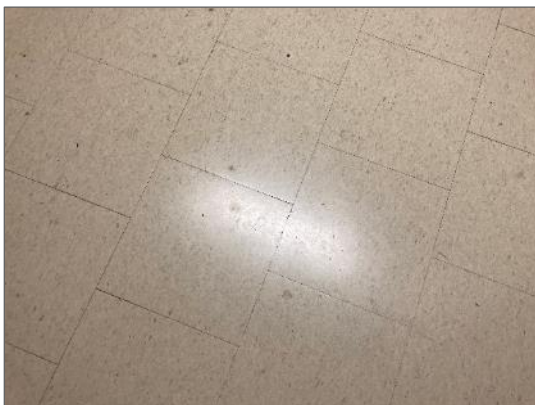
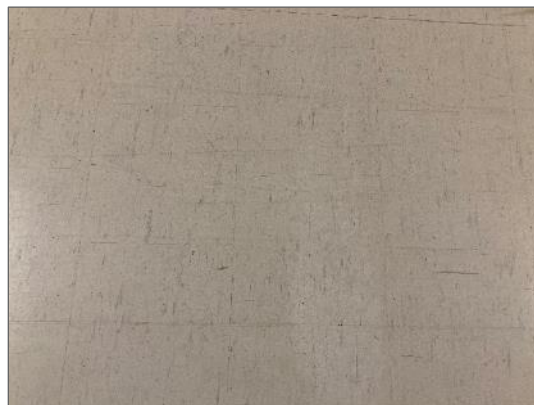
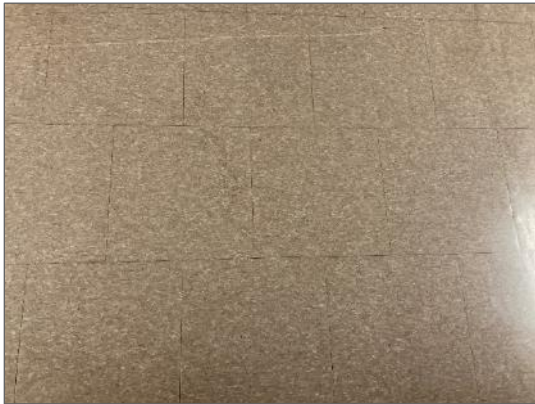
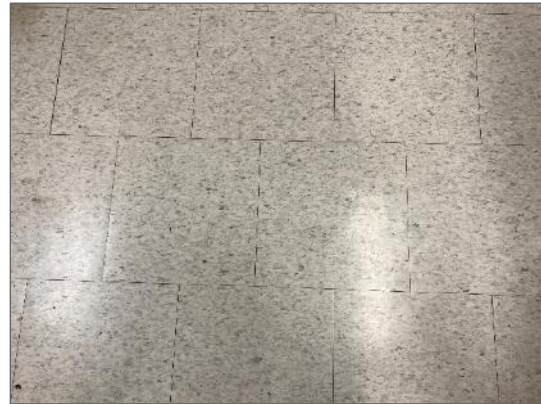
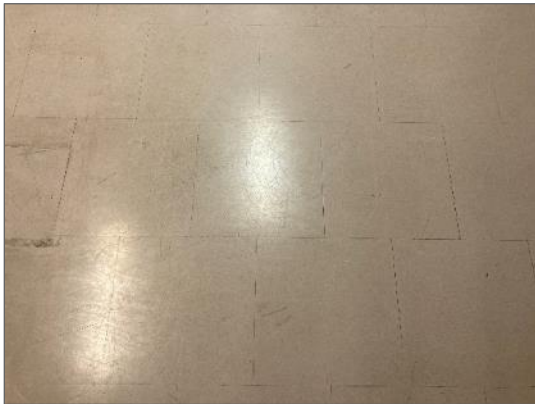
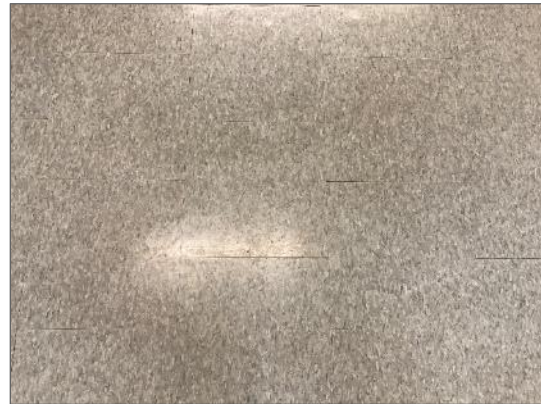
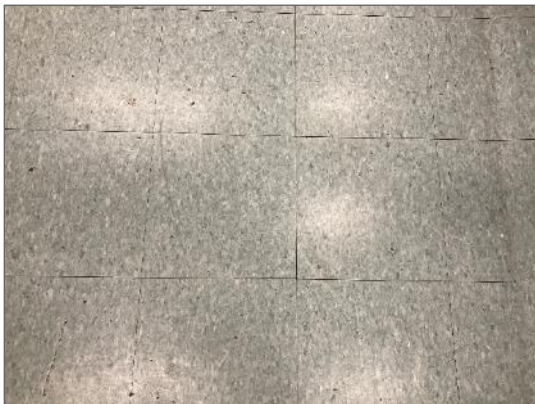
Size, Pattern, Colour, Photo #	Sample Number, lab ref no.	Asbestos Type (tile)	Asbestos Type (mastic)
12" x 12", beige with brown fleck, photo 1	S0001A-C, 71962359	None detected	None detected
12" x 12", white with black streaks, photo 2	S0002A-C, 71962359	None detected	None detected
12" x 12", pink with dense fleck, photo 3	S0005A-C, 71962359	None detected	None detected
12" x 12", light grey with dense fleck, photo 4	S0006A-C, 71962359	None detected	None detected
12" x 12", pink, photo 5	S0007A-C, 71962359	None detected	None detected
12" x 12", grey with dense fleck, photo 6	S0008A-C, 71962359	None detected	None detected
12" x 12", blue with dense fleck, photo 7	S0009A-C, 71962359	None detected	None detected

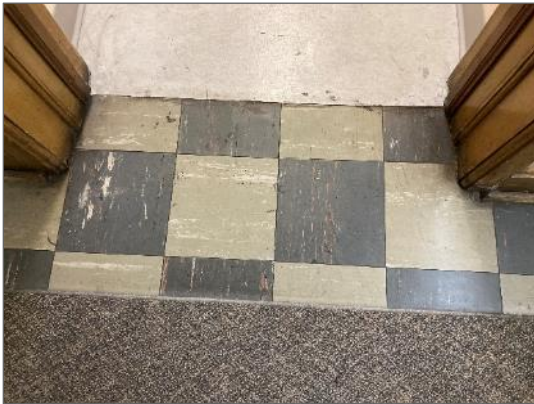
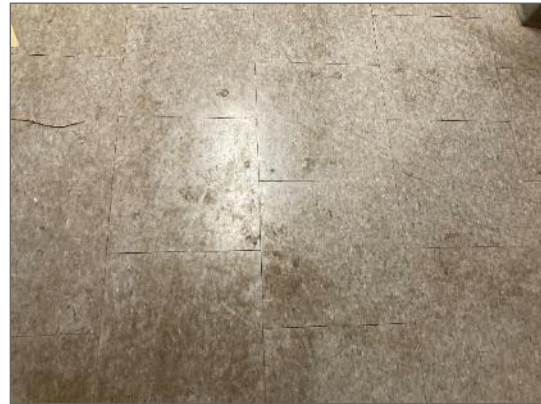
Size, Pattern, Colour, Photo #	Sample Number, lab ref no.	Asbestos Type (tile)	Asbestos Type (mastic)
9" x 9", green/grey checker pattern, photo 1	2018-0004A, 51821456	Chrysotile	Chrysotile
12" x 12", grey with dense fleck, photo 2	S0001A-C, b247688	None detected	None detected

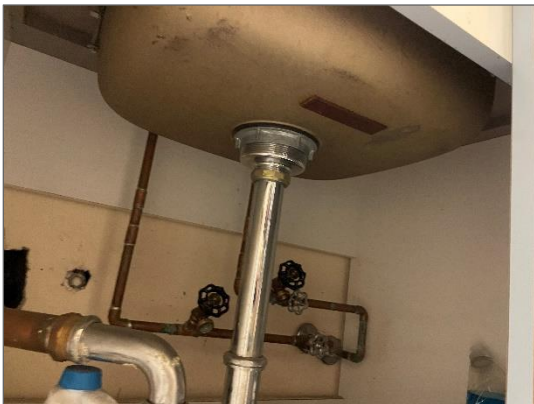
Photo 1

Gold mastic (photo 1), containing chrysotile asbestos (sample S0002A, lab reference no. b247688), is present as an undercoating on a sink in the Kitchen (Location 1003).

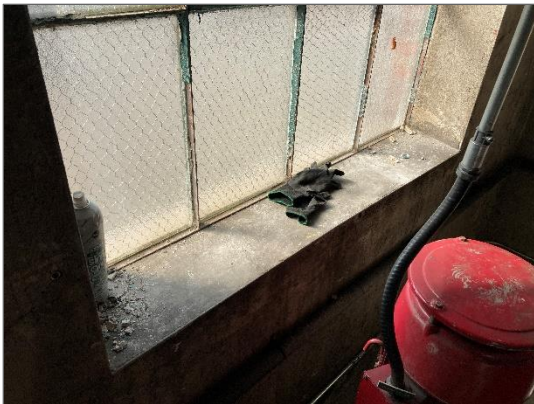
Photo 1 (photo taken during previous assessment)

Caulking (Photo 1), containing chrysotile asbestos (sample S0013A, lab reference no. 10036723), is present around the interior window frame of the Rooftop Mechanical Penthouse (Location 8001).

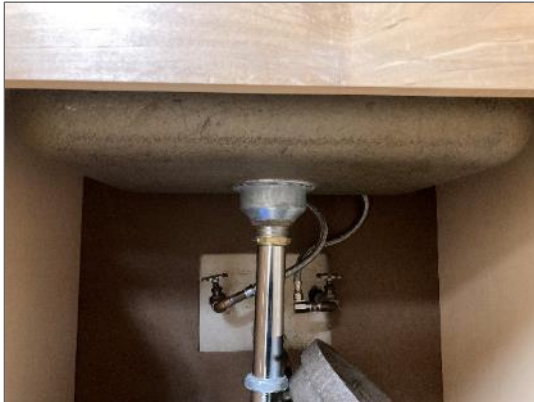
Photo 1

Gold mastic (photo 1), containing chrysotile asbestos (sample S0001A, lab reference no. 71962345), is present as an undercoating on a sink in the Corridor (Location 15).

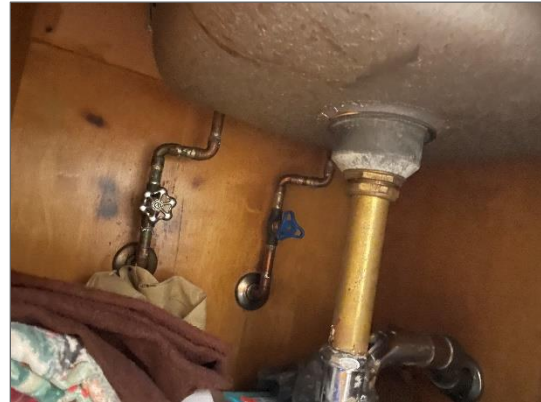
Photo 2

Silver mastic (photo 2), containing chrysotile asbestos (sample S0005A, lab reference no. 71962345), is present as an undercoating on sinks in the Margaret Charter's Auditorium (Location 1001) and the kitchen in the Corridor (Location 4001).
