# Asbestos Reassessment

Juravinski Hospital  
711 Concession Street,  
Hamilton, Ontario

January 8, 2025

Pinchin File: 336568.061

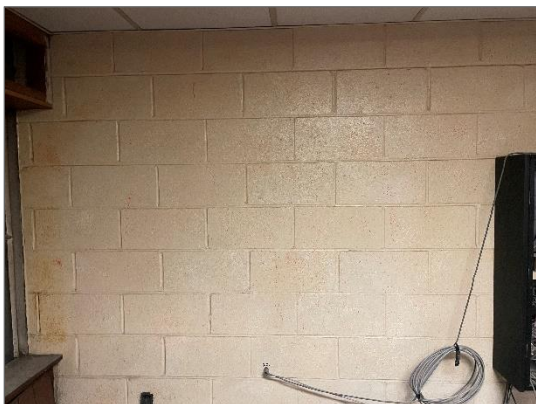
Photo 1

Textured paint (photo 1), containing chrysotile asbestos (sample S0001A, lab reference no. b250758), is present on concrete block walls in the Electrical Room Office (Location 5).

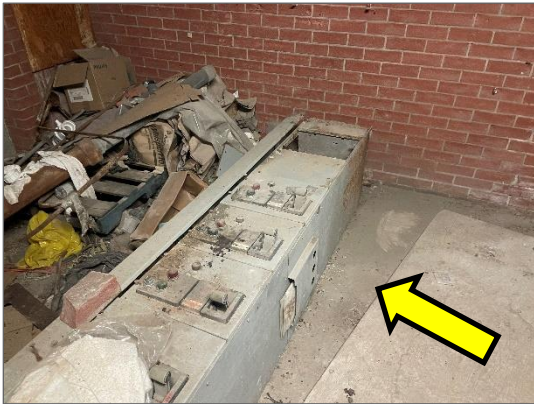
Photo 1

| Size, Pattern, Colour, Photo # | Location (Location #) | Sample Number, lab reference no. | Asbestos Type (tile) | Asbestos Type (mastic) |
|---|---|--|---|---|
| 12" x 12", beige flecks, photo 1 | Basement Level Two (Location 1) | ECOH sample 16262-JH-01A<br>Pinchin sample 2018-0013A-C, b195703 | Chrysotile | None detected |

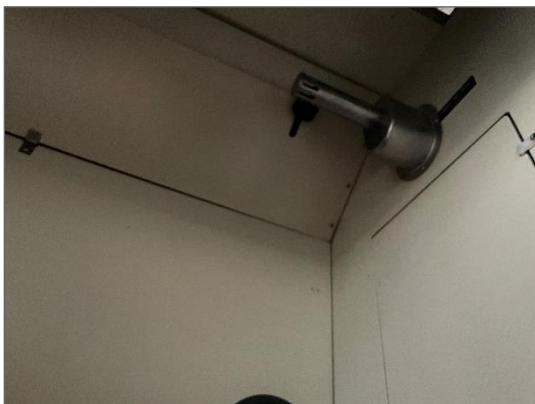
Photo 1

Transite board (photo 1), presumed to contain asbestos based on visual observation, is present in fume hoods throughout J Wing.

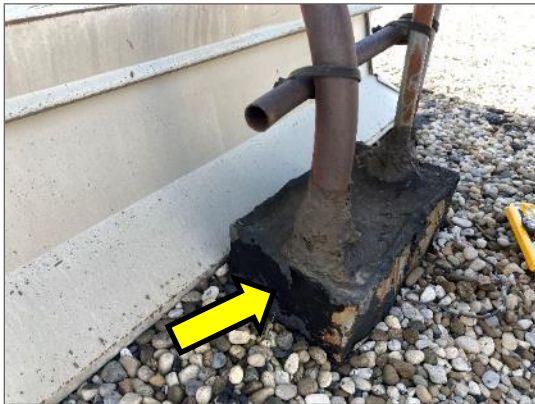
Photo 1 (photo taken during previous assessment)

Tar (photo 1), containing chrysotile asbestos (sample S0006B, lab reference no. R6604935), is present on a pipe penetration on the Roof (Location 6001) above the mechanical penthouse. The tar is assumed to be present on the deck below the built-up roofing and therefore the roofing materials should be presumed to contain asbestos.

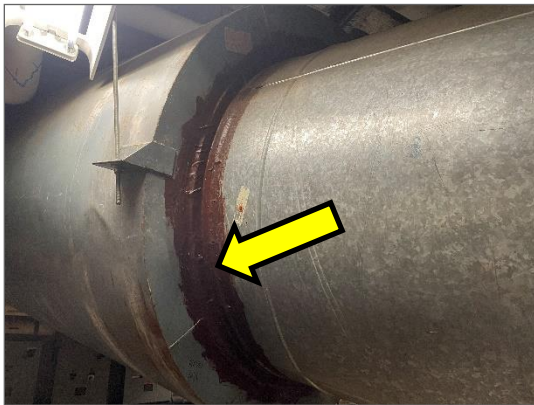
Photo 1

Red duct mastic (photo 1), presumed to contain asbestos, is present in the Mechanical Room (Location 7).

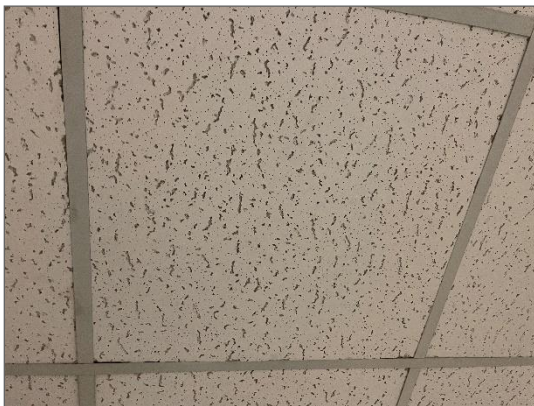
Photo 1

Acoustic lay-in ceiling tiles (24" x 24" large fissures and pinholes pattern, photo 1), containing chrysotile asbestos and a trace amount of amosite asbestos (<0.5%), are present throughout Level 1 (sample 053a, lab reference no. b54898).

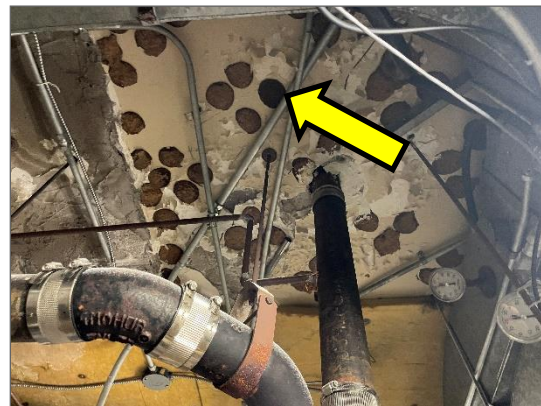
Photo 2

Brown ceiling tile mastic (photo 2), containing chrysotile asbestos, is present above lay-in ceiling tiles throughout the M Wing (sampled by HHS in March 2013).

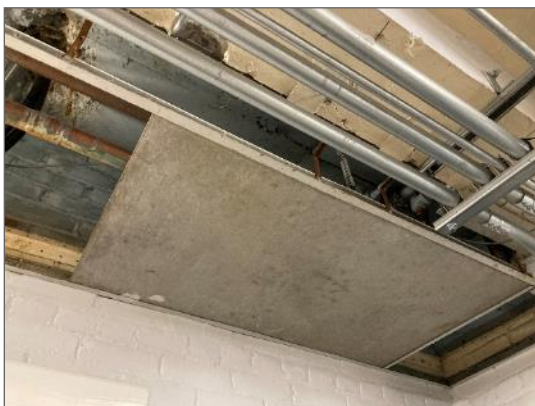
Photo 1 (photo taken during previous assessment)

Transite board (photo 1), presumed to contain asbestos based on visual observation, is present as a ceiling panel in the Elevator Mechanical Room (Location 4).

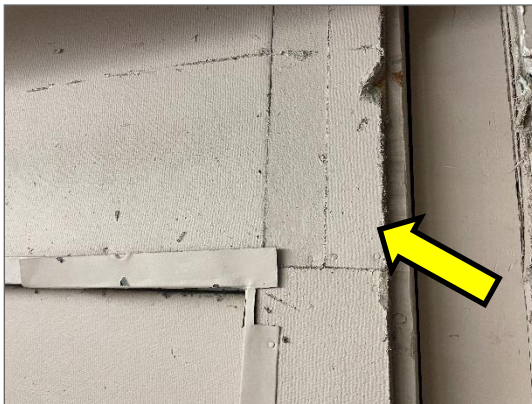
Photo 1

Fibrous board (photo 1), containing chrysotile asbestos (sample S0007A, lab reference no. b250890), is present within the Basement Storage Area (Location 5).

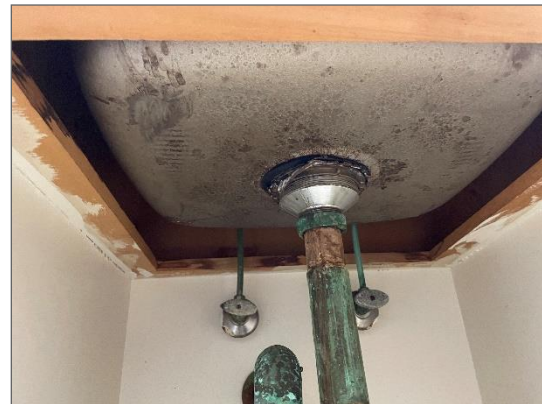
Photo 2

Gold mastic (photo 2), containing chrysotile asbestos (sample S0005A, lab reference no. b250890), is present as a sink undercoating throughout the M Wing.

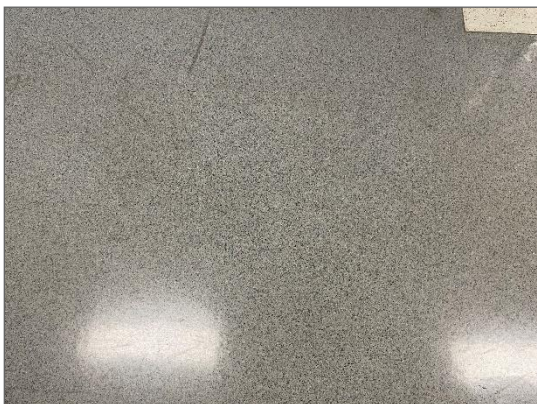
Photo 1

Vinyl sheet flooring (grey noise pattern, photo 1), presumed to contain asbestos, is present in the Level 0 Corridor (Location 4).

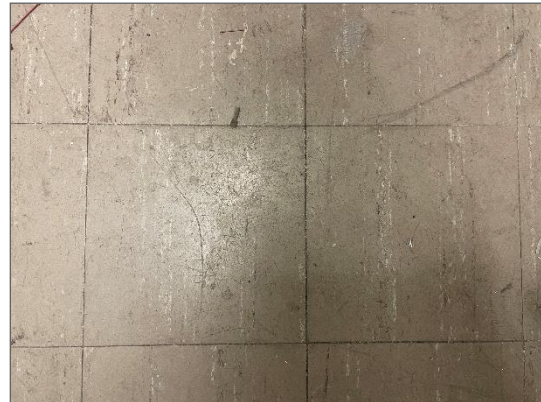
Photo 4

| Size, Colour/Pattern, Photo # | Sample Number, Lab ref no. | Asbestos Type (tile) | Asbestos Type (mastic) |
|--|---|---|---|
| 9" x 9", brown with brown and white lines, photo 4 | 011a, b54892<br>2018-0004A, b195703 | Chrysotile | Chrysotile |

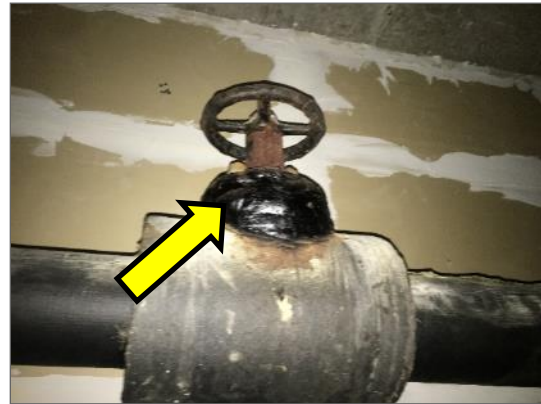
Photo 2

Tar (photo 2), containing chrysotile asbestos (sample S0004A, b250891-B), is present over horsehair on pipe fittings (elbows, valves, tees, hangers etc.) throughout the 90 Wing Core.

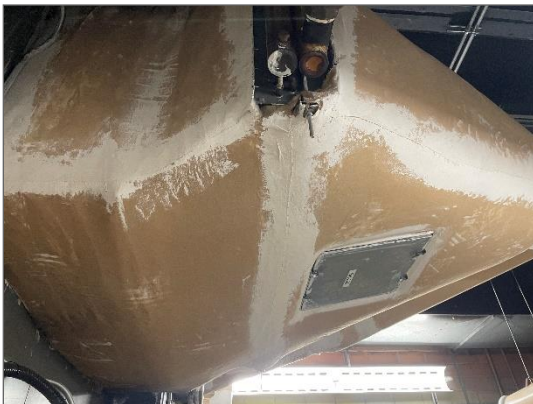
Photo 1

Parging cement (photo 1), containing chrysotile asbestos (sample 034a, lab reference no. b54895), is present over the fittings, edges, seams, and pins of fibreglass insulation on ducts in the Basement Mechanical Room (Location 1) and the Mechanical Penthouse (Location 6001).

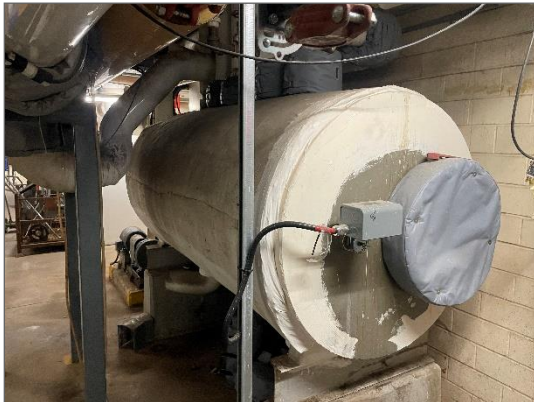
Photo 1

Parging cement (photo 1), containing chrysotile asbestos (previously sampled), is present over fibreglass insulation on the condensate tank present within the Basement Mechanical Room (Location 1).

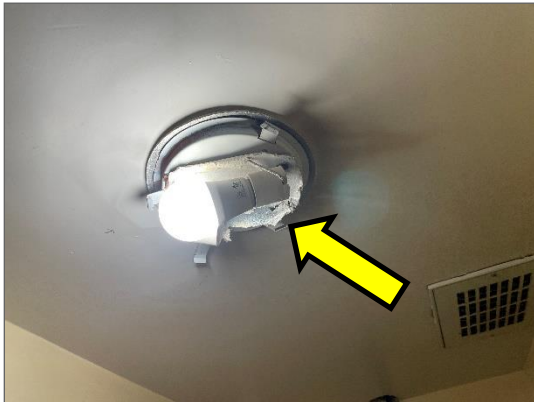
Photo 1

Paper heat shields (photo 1), containing chrysotile asbestos (sample S0003A, lab reference no. b250891-B), are present in light fixtures throughout the 90 Wing Core.

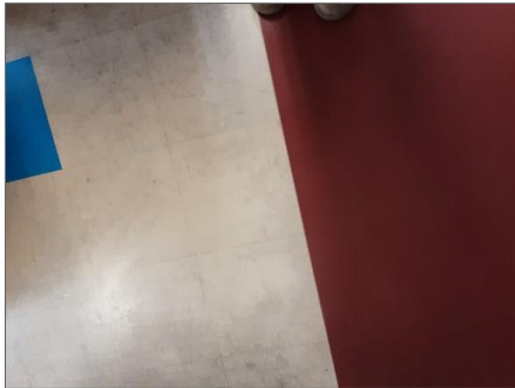
Photo 5

| Size, Colour/Pattern, Photo # | Sample Number, Lab ref no. | Asbestos Type (tile) | Asbestos Type (mastic) |
|--|---|---|---|
| 12" x 12", brown/beige/blue/red with flecks, photo 5 | 2018-0008A-C, b195703 | None detected | None detected |

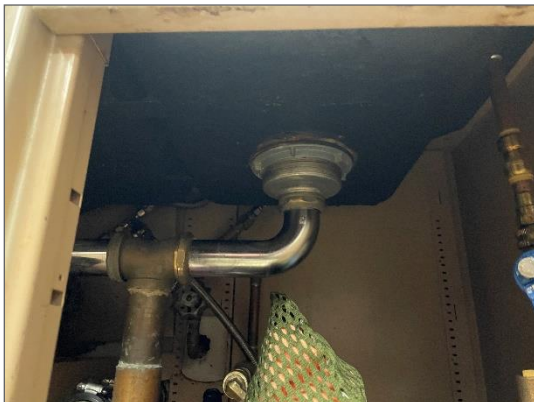
Photo 1

Black mastic (photo 1), containing chrysotile asbestos (samples S0010A, lab reference no. 100232307), is present as a sink undercoating in the Level 3 Utility Room (Location 3008).

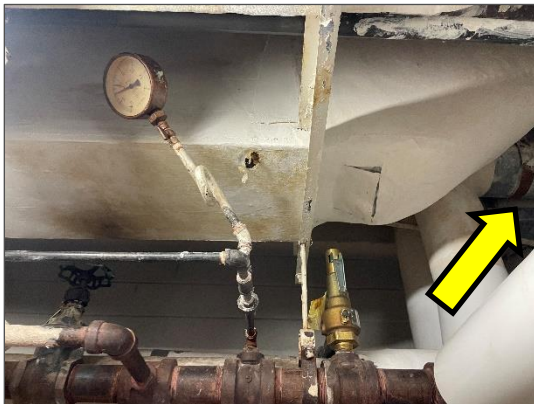
Photo 1

Red mastic (Photo 1), containing chrysotile asbestos, is present on ducts throughout the F Wing (sample S0004A, lab reference no. 71993019).

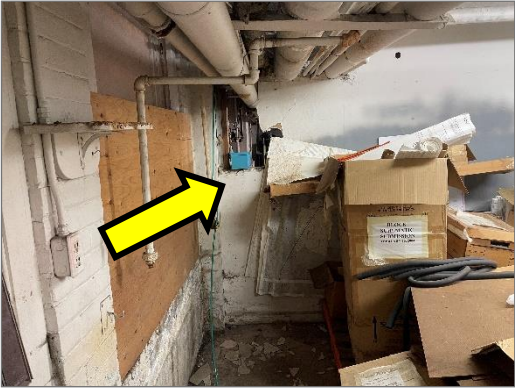
| ASBESTOS | | | | | | | | | | | |
|---|---|---|---|---|---|---|---|---|---|---|---|
| Wall | | Drywall and joint compound | NF | | | B | Y | () | 1 (3) | % | Type 1/ Removal/Repair |

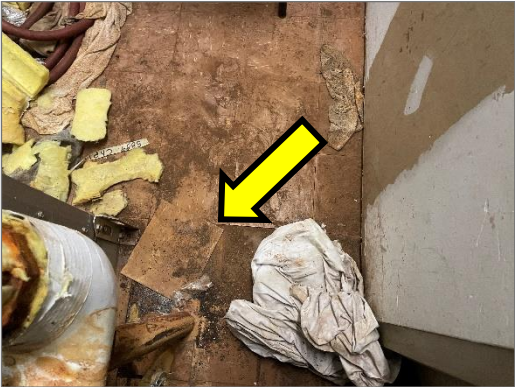
| ASBESTOS | | | | | | | | | | | |
|---|---|--|---|---|---|---|---|---|---|---|---|
| Floor | | Vinyl Floor Tile and Mastic, 9 X 9<br>BROWN FLECKS | NF | | | B | Y | () | 1 (3) | SF | Type 1 Removal |

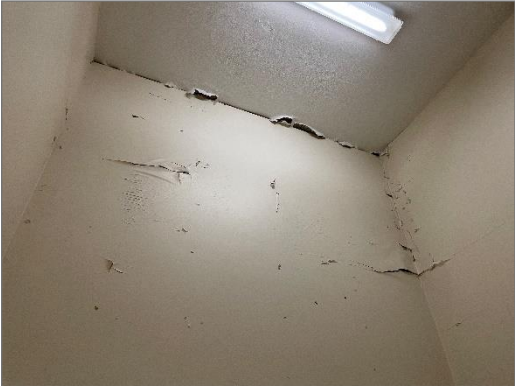
| ASBESTOS | | | | | | | | | | | |
|---|---|---|---|---|---|---|---|---|---|---|---|
| Ceiling | | Plaster, ROUGH | PF | | | C | Y | () | 3 (4) | SF | Type 2 |
