# Asbestos Reassessment

McMaster University Medical  
Centre (MUMC)  
1200 Main Street West,  
Hamilton, Ontario

January 23, 2025

Pinchin File: 336568.061

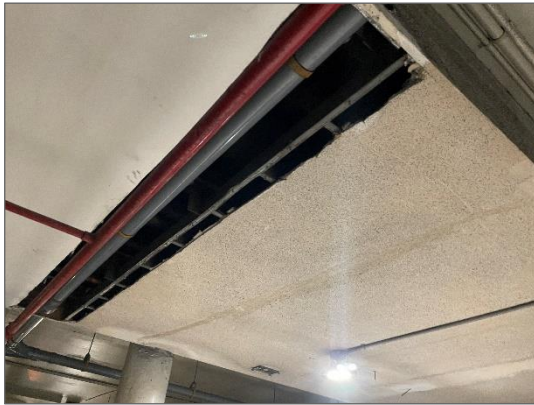
Photo 1

Spray-applied texture finish, containing chrysotile asbestos (sample 2018-0017B-C, lab reference no. 51825828), is present on the drywall ceiling of the corridor in the Blue Parking Garage (Blue quad, Location 8).

Overspray from the asbestos-containing texture coat is assumed present above the ceiling at light fixture openings, on the deck, ducts and within junction boxes.

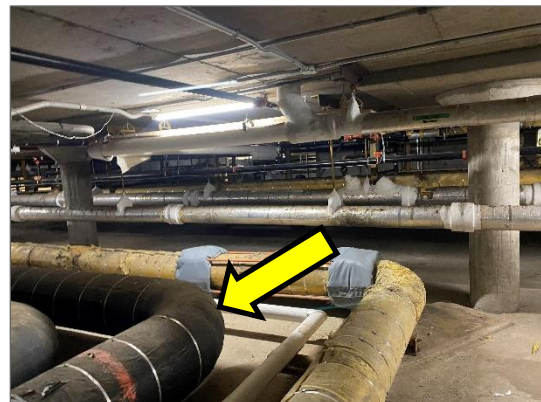
Photo 2

Tar (photo 2), containing asbestos (sample 004A, lab reference no. b54378), is present on pipe fittings (elbows, valves, tees, etc.) on the chilled water and domestic water systems within the MM levels and interstitial spaces of all quads.

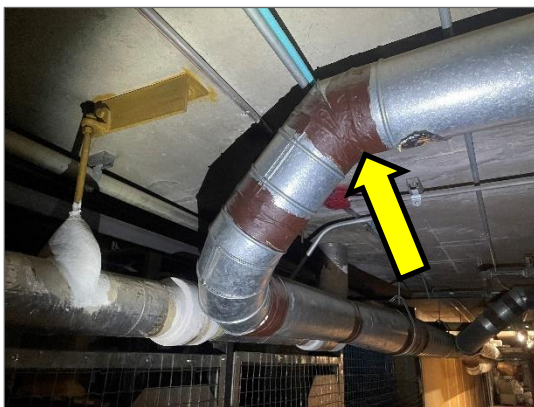
Photo 1

Brown/red duct mastic (photo 1), containing asbestos (ECOH samples 16262-MUMC-ASB-05A, lab reference no. 551600473), is present throughout the building.

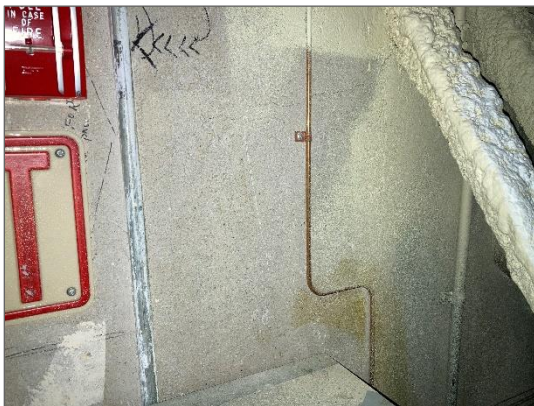
Photo 1

Rough plaster (photo 1) is present sporadically on perimeter shaft walls in the interstitial spaces (all quads, Locations 9001-9004). Seven samples of rough plaster were collected (samples S001A-C, lab reference no. b182855, S0014A-C, lab reference no. b247200, and sample S0031A, lab reference no. 10016154) and it was found that four samples contained actinolite/tremolite asbestos, with two samples containing more than 0.5% asbestos which is the definition of an asbestos-containing material under O. Reg. 278/05. The variable asbestos content is a result of vermiculite mixed into the plaster during

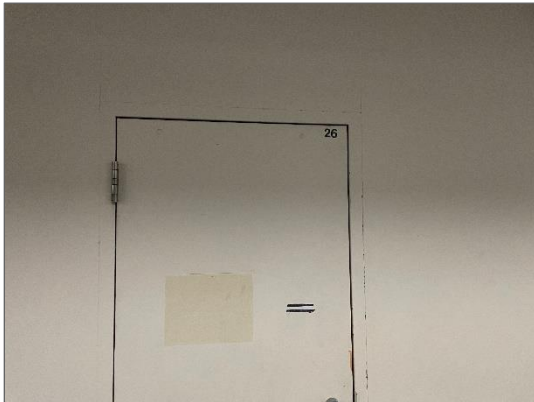
Photo 1

Drywall joint compound (photo 1), containing asbestos, is present on wall and ceiling finishes throughout the building (previously sampled under various projects). Assume all original joint compound to contain asbestos unless specific sampling proves otherwise.

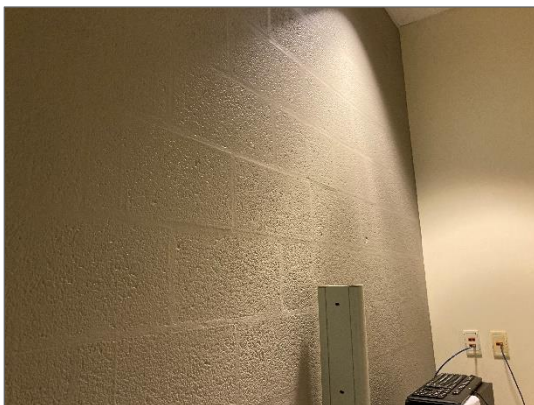
Photo 1

Asbestos and non-asbestos paint/coating material is present on concrete block walls throughout the building (photo 1). Refer to “Paint Bulk Sample Results Letter – McMaster University Medical Centre” (Pinchin File No. 303980.008) on the HMIS 2.0 online database for details. All paint/coating material should be presumed to be asbestos-containing unless sampling has indicated otherwise.

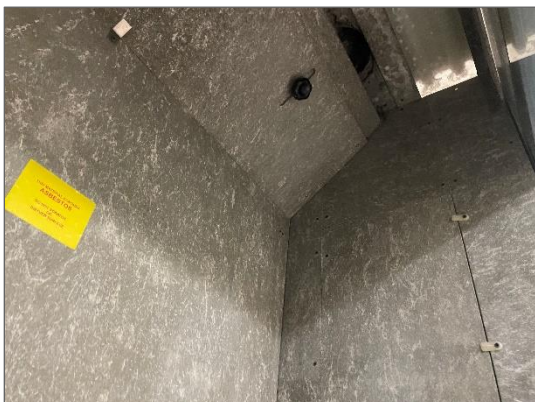
Photo 1

Transite board (photo 1), presumed to contain asbestos based on visual observation, is present within fume hoods throughout the building, the majority of which are present within the third and fourth floor laboratories. It is also present under lab counters and as cabinet liners in lab areas.

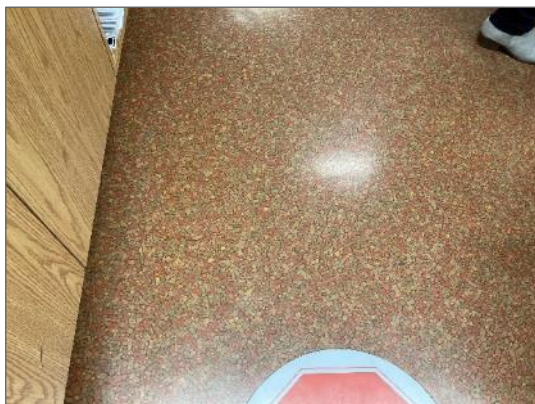
Photo 3

| Pattern, Colour, Photo # | Sample Number, Lab Ref No. | Asbestos |
|---|---|---|
| Red with green squares, photo 3 | 047A, b54507 | Yes |

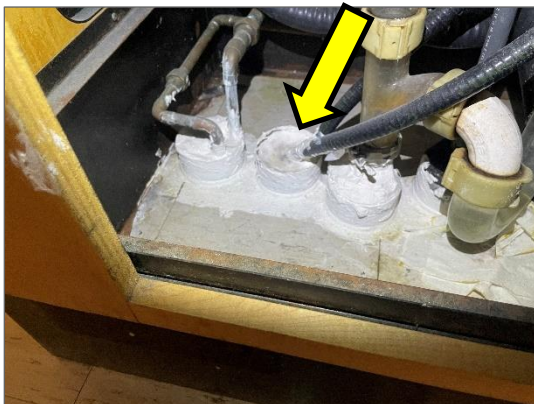
Photo 1

Parging cement firestopping (photo 1), presumed to contain asbestos (previously sampled), is present around pipe penetrations throughout the building, particularly beneath sinks and fume hoods within the third and fourth floor laboratories.

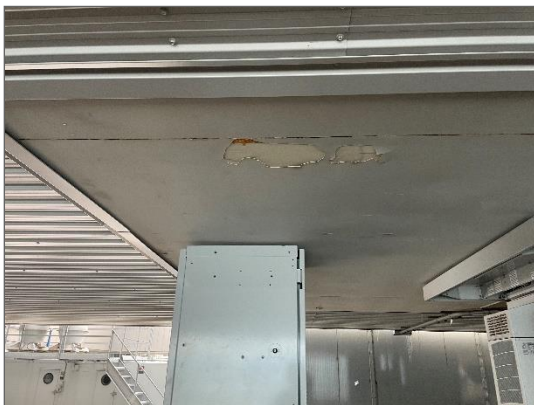
Photo 1

Drywall joint compound (photo 1), containing asbestos (previously sampled), is present as a finish on drywall soffits on the Roof (Locations 5001-5004). Ongoing abatement of soffits has been occurring since July 2022, and HMIS has been updated accordingly.

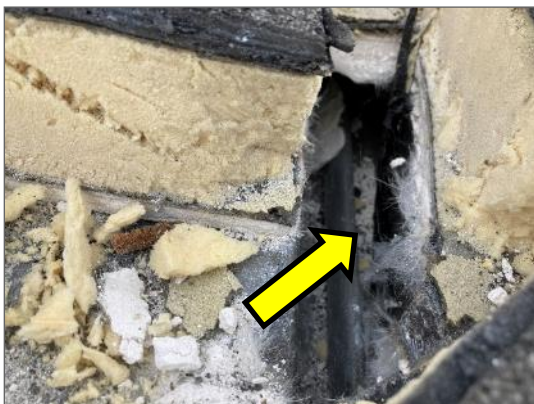
Photo 1 (photo taken during sampling)

Residual tar roofing material (photo 1), containing asbestos (sample S0006B-C, lab reference no. b290700), is present in the channels of the steel decking below the non-asbestos roofing on the Level 6 Mechanical Penthouse Roof (Location 6001).

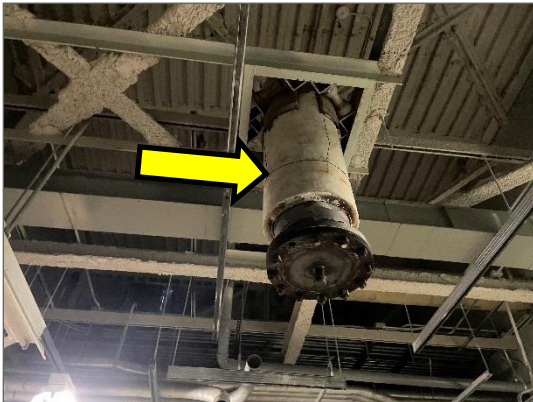
Photo 1

Breeching on redundant diesel generator exhausts (photo 1) throughout the Level 6 Mechanical Penthouse is insulated with preformed block insulation containing asbestos (mag block) covered with parging cement containing asbestos (previously sampled).

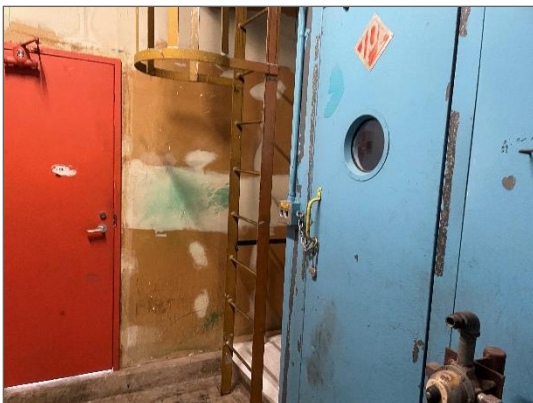
Photo 1

Drywall joint compound (photo 1), containing asbestos (previously sampled), is present as a wall and ceiling finish throughout the Level 6 Mechanical Penthouse. Assume all original joint compound to contain asbestos unless specific sampling proves otherwise.

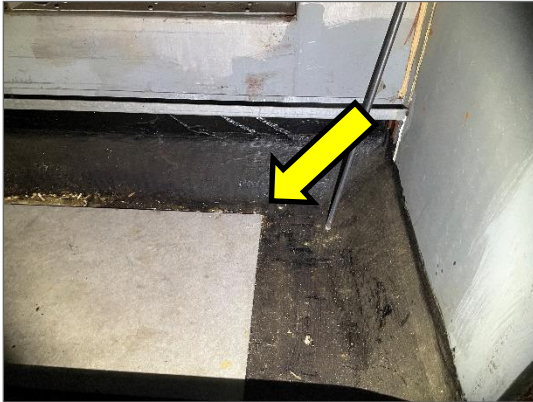
Photo 1

Transite board (photo 1), presumed to contain asbestos based on visual observation, is present within air handling units 44 (Location 13) and 47 (Location 26).

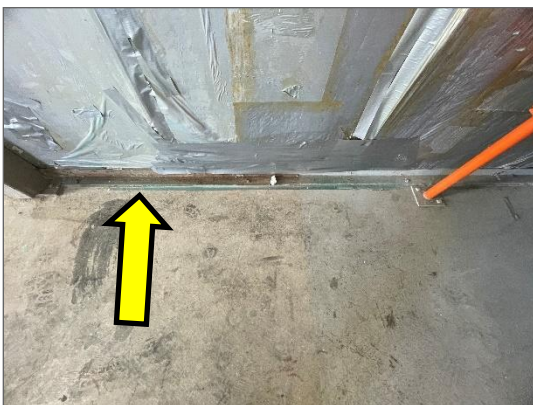
Photo 1

Grey caulking (photo 1), containing asbestos (sample S0002A, lab reference no.10016137), is present at the joint of the bottom flange of the beam and the poured concrete floor between Shaft 22 and Shaft 23 (Location 19). Grey caulking is assumed to be present in the same application throughout Level 6.

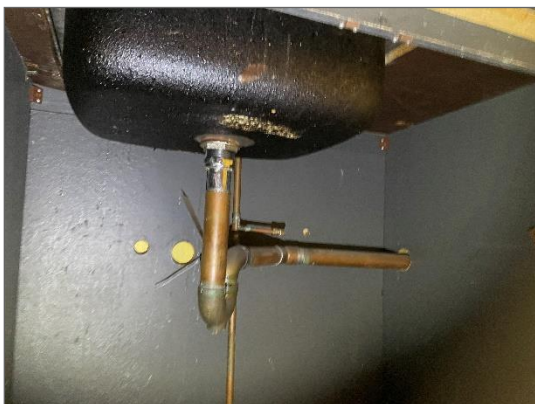
Photo 1

Black mastic (photo 1), presumed to contain asbestos, is present as a sink undercoating in the Corridor (Location 34).

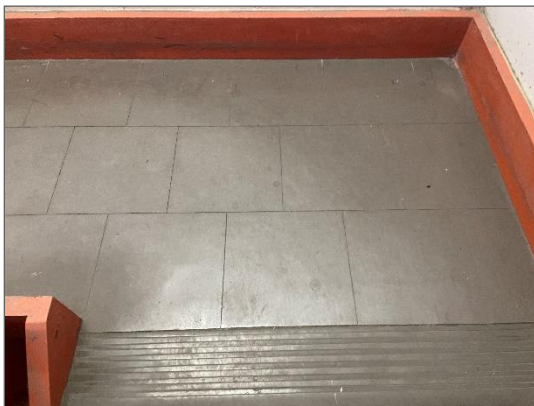
Photo 1

Vinyl floor tiles (12" x 12" brown) and mastic (photo 1), containing asbestos (previously sampled), are present in the stairwell shafts. Remaining vinyl floor tiles do not contain asbestos based on the date of installation as reported by the client. Mastic under non-asbestos vinyl floor tiles is presumed to contain asbestos.

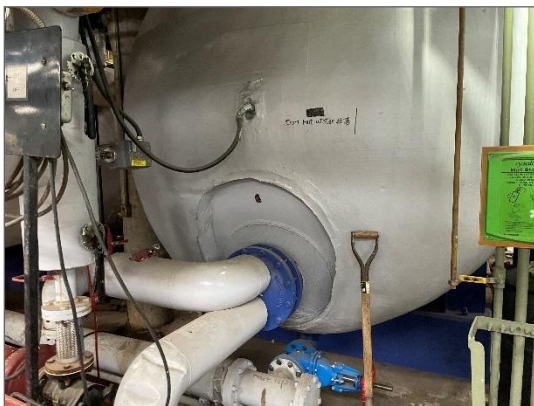
Photo 1

Parging cement (photo 1), containing asbestos (previously sampled), is present over fiberglass insulation on hot water tanks #1, #2, and #3 and three unidentified tanks in the Mechanical Room (Location 10).

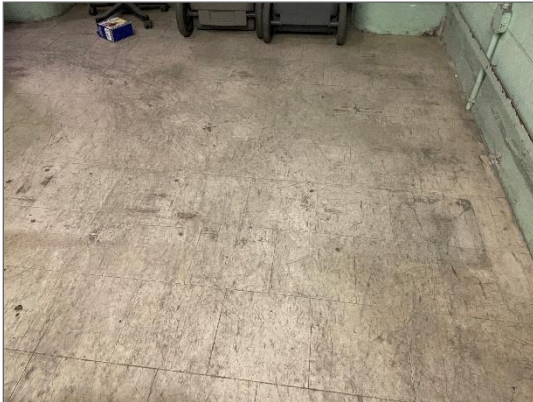
Photo 1

Vinyl floor tiles (12" x 12" beige with black streaks) and mastic (photo 1), containing asbestos (previously sampled), are present in the Vestibule and Telecom Room (Location 1) and the Records Storage Room (Location 2).

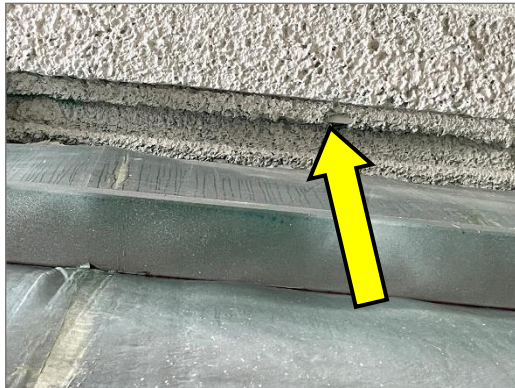
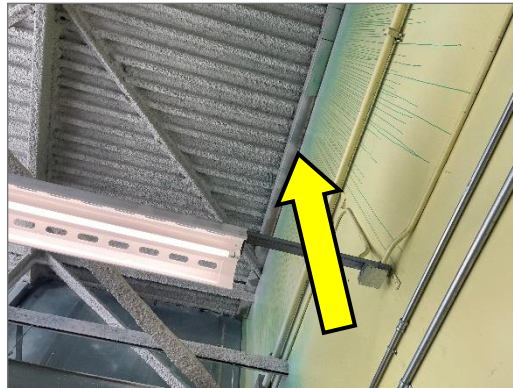
| ASBESTOS | | | | | | | | | | | |
|---|---|---|---|---|---|---|---|---|---|---|---|
| Structure | Beam Deck Joist | Fireproofing (Cementitious) (Photo 1 & 2) | F | | Encapsulant | C | Y | 2 (6) | () | SF | Repair following Type 2 asbestos procedures |

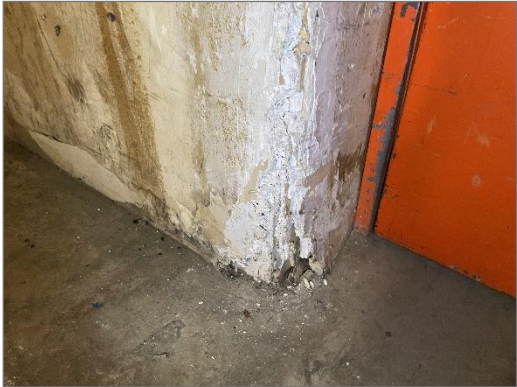
Photo 3

| ASBESTOS | | | | | | | | | | | |
|---|---|---|---|---|---|---|---|---|---|---|---|
| Wall | | Drywall and joint compound (Photo 3) | NF | | | B | Y | () | 4 (3) | SF | Type 2 clean up and repair |

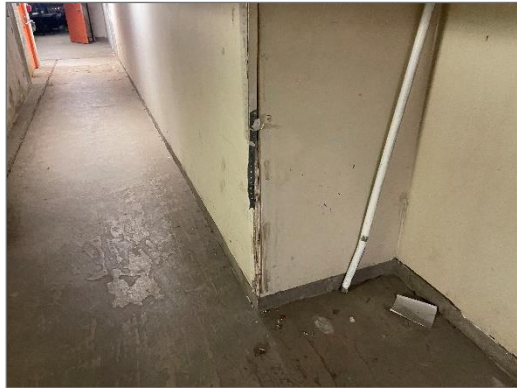
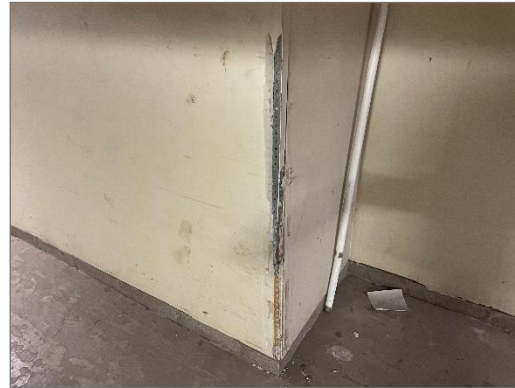
| ASBESTOS | | | | | | | | | | | |
|---|---|---|---|---|---|---|---|---|---|---|---|
| Wall | | Drywall and joint compound (Photo 4 & 5) | NF | | | B | Y | () | 3 (3) | SF | Type 1 removal and repair |

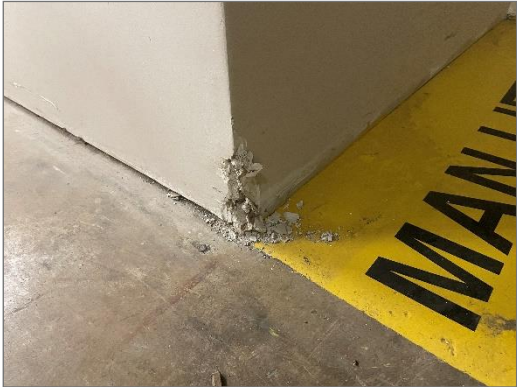
Photo 6

| ASBESTOS | | | | | | | | | | | |
|---|---|---|---|---|---|---|---|---|---|---|---|
| Wall | | Drywall and joint compound (Photo 6) | NF | | | A | Y | () | 3 (3) | SF | Clean up and repair using Type 2 asbestos procedures |

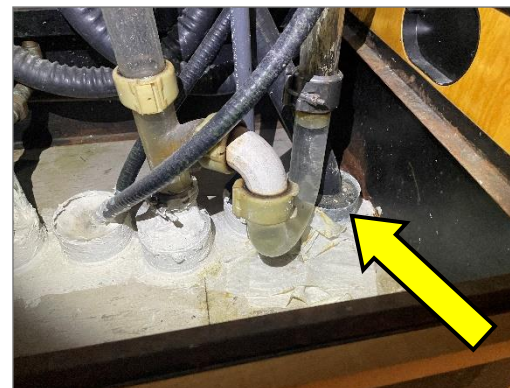
Photo 9

| ASBESTOS | | | | | | | | | | | |
|---|---|---|---|---|---|---|---|---|---|---|---|
| Other | Sink | Firestopping (friable) (Photo 9) | F | | Unjacketed | A | N | () | 2 (6) | SF | Type 2 repair |

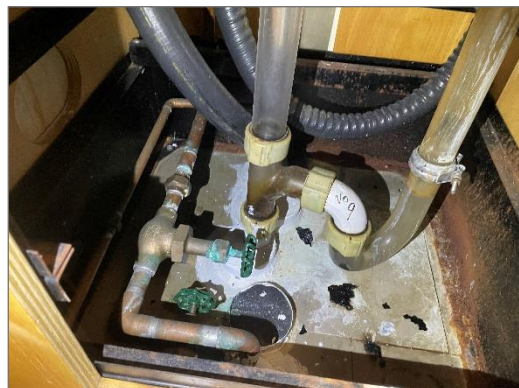
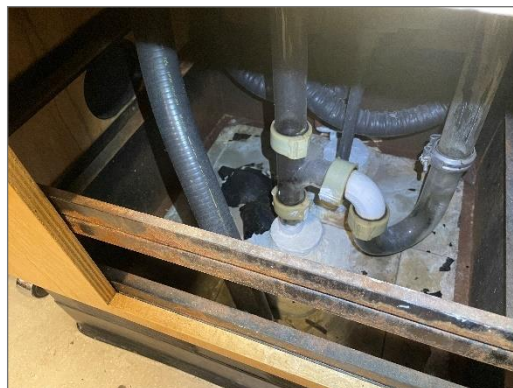
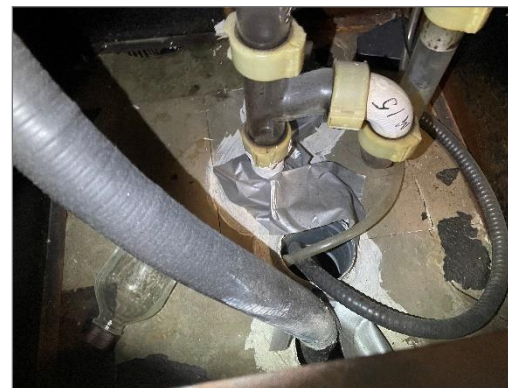
| ASBESTOS | | | | | | | | | | | |
|---|---|---|---|---|---|---|---|---|---|---|---|
| Other | Sink | Mastic, Black, UNDERCOATING<br>(Photos 10-12) | NF | Debris | | A | N | ( ) | 6 (3) | SF | Clean up following Type 1 asbestos procedures |

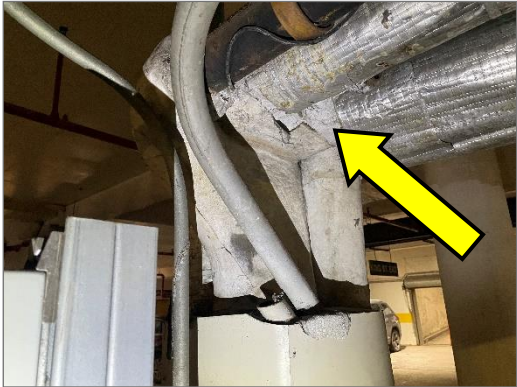
Photo 13

| ASBESTOS | | | | | | | | | | | |
|---|---|---|---|---|---|---|---|---|---|---|---|
| Piping | | Parging Cement (Photo 13) | F | Fitting | | C | Y | 4 (6) | () | EA | Type 2 repair |
