Asbestos Reassessment

St. Peter's Hospital
88 Maplewood Avenue,
Hamilton, Ontario

December 30, 2024

Pinchin File: 336568.061

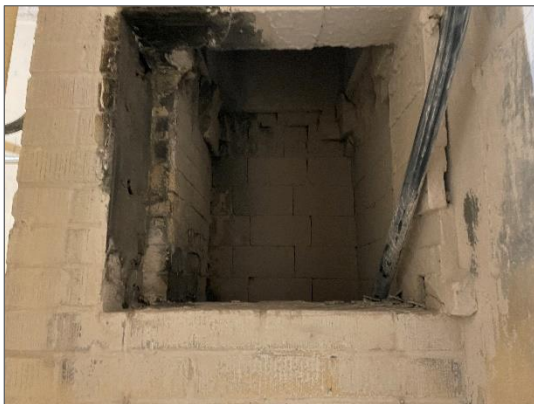
Photo 1

Refractory brick (photo 1), presumed to contain asbestos, is present in the redundant chimney within the Storage Room (Location 2).

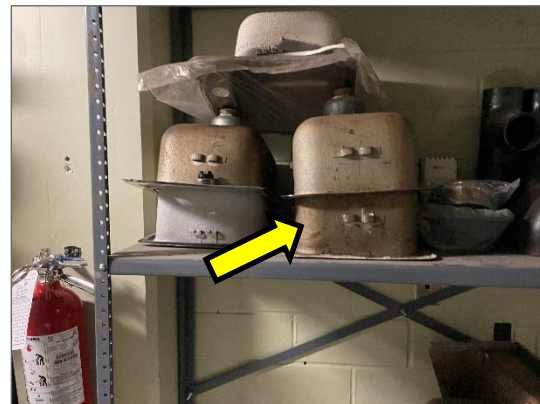
Photo 2

Gold undercoating (photo 2), presumed to contain asbestos, is present on stored sinks within a basement Storage Room (Location 12).

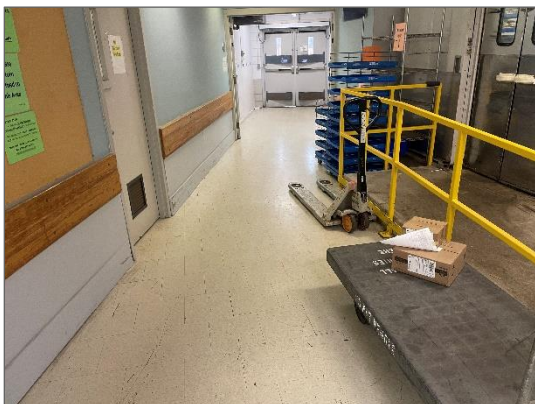
Photo 1

Size, Pattern/Colour, Photo #	Sample Number, lab ref no.	Asbestos Type (tile)	Asbestos Type (mastic)
12"x12", white with grey specks, photo 1	S002a-c, 1207419 HHS S10a	Chrysotile	None detected
12"x12", red with white streak	S003a-c, 1207419 ECOH 18439-02A-C HHS S01a-c	None detected	None detected
12"x12", purple	ECOH 18439-05A-C	None detected	None detected
12"x12", green ¹	ECOH 18439-03A-C HHS S08a-c	None detected	None detected
12"x12", yellow/orange	ECOH 18439-04A-C HHS S09a-c	None detected	None detected
12"x12", white with blue and pink streaks	ECOH 18439-01A-C HHS S02a-c	None detected	None detected

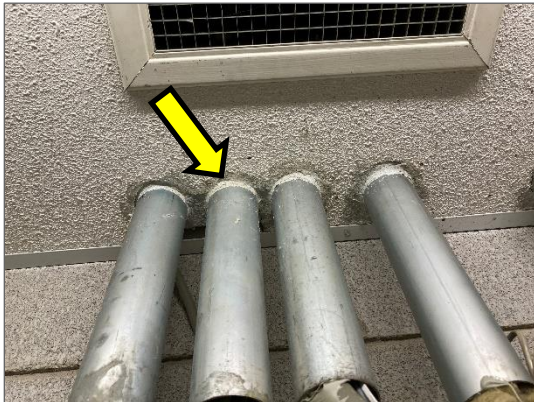
Photo 1

Firestopping (photo 1), containing chrysotile asbestos, is present at conduit penetrations in electrical closets throughout the East and West Wing (sample S0001A; lab reference no. b218647).

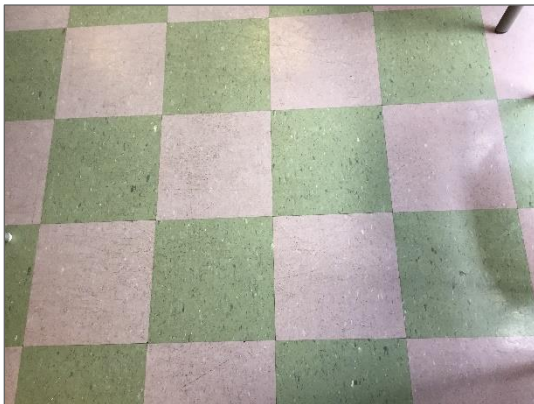
Photo 1

Levelling compound, containing chrysotile asbestos (HHS Sample S08a), is present associated with the 12" x 12" green and purple vinyl floor tiles on the Second Floor (photo 1).

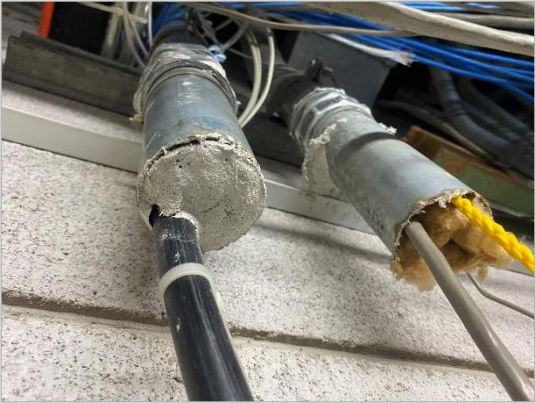
ASBESTOS											
System	Component	Material	Friable	Item	Covering	Access	Visible	Fair	Poor	Unit	Recommended Procedure
Other	Fire Stop	Parging Cement	F			C	Y	()	10 (3)	SF	Remove in accordance with Type 2 asbestos procedures

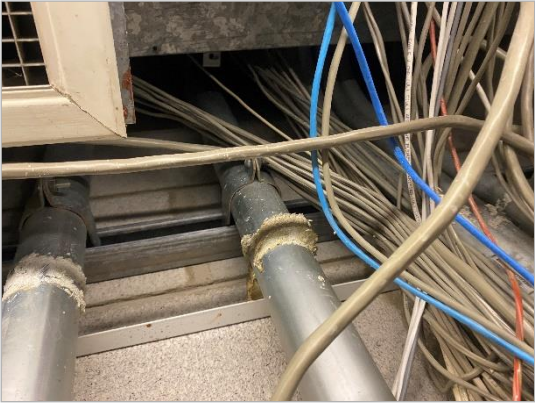
ASBESTOS											
System	Component	Material	Friable	Item	Covering	Access	Visible	Fair	Poor	Unit	Recommended Procedure
Other	Fire Stop	Parging Cement	F			C	Y	()	7 (3)	SF	Remove in accordance with Type 2 asbestos procedures

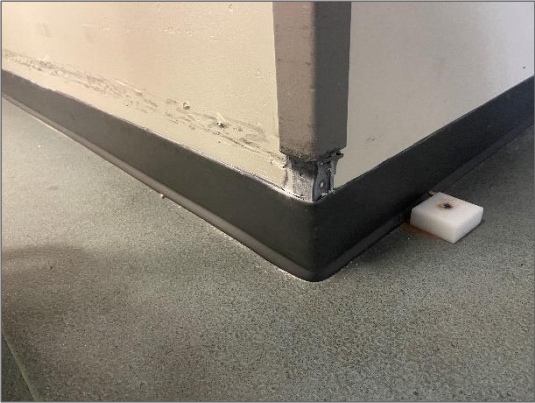
ASBESTOS											
System	Component	Material	Friable	Item	Covering	Access	Visible	Fair	Poor	Unit	Recommended Procedure
Wall		Drywall and joint compound	NF			A	Y	1 (7)	()	%	Type 1/Repair

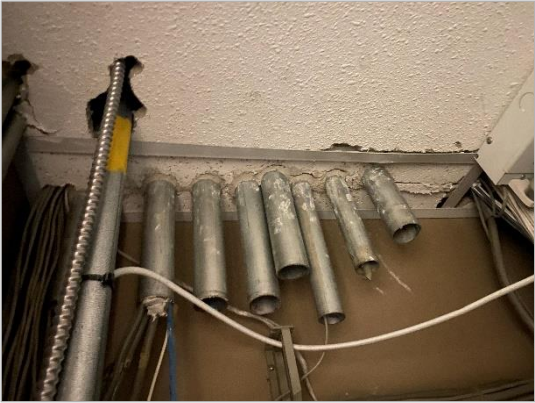
ASBESTOS											
System	Component	Material	Friable	Item	Covering	Access	Visible	Fair	Poor	Unit	Recommended Procedure
Other	Fire Stop	Parging Cement	F			C	Y	()	9 (3)	SF	Remove in accordance with Type 2 asbestos procedures

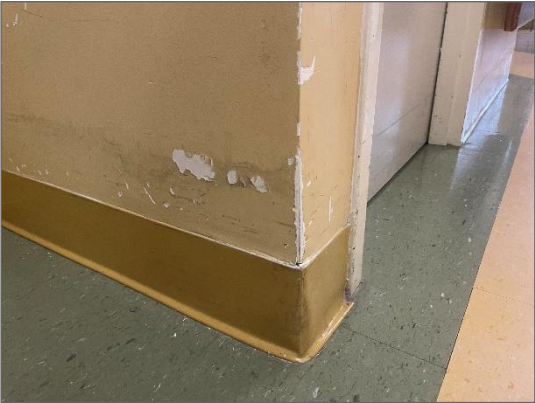
ASBESTOS											
System	Component	Material	Friable	Item	Covering	Access	Visible	Fair	Poor	Unit	Recommended Procedure
Wall		Drywall and joint compound	NF			A	Y	1 (7)	()	%	Type 1/Repair

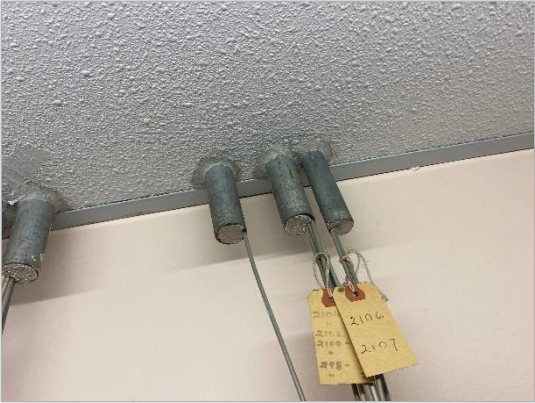
ASBESTOS											
System	Component	Material	Friable	Item	Covering	Access	Visible	Fair	Poor	Unit	Recommended Procedure
Other	Fire Stop	Parging Cement	F			C	Y	()	4 (3)	SF	Remove in accordance with Type 2 asbestos procedures

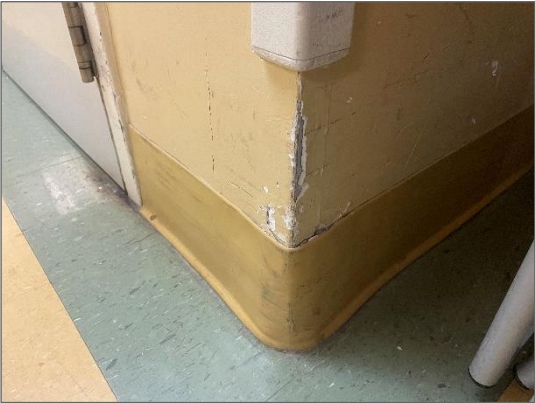
ASBESTOS											
System	Component	Material	Friable	Item	Covering	Access	Visible	Fair	Poor	Unit	Recommended Procedure
Wall		Drywall and joint compound	NF			A	Y	()	1 (3)	%	Type 1/Repair

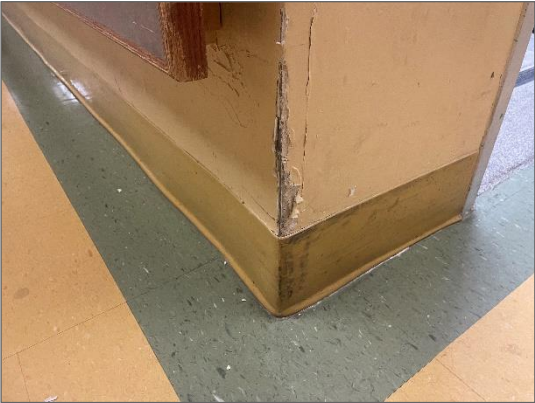
ASBESTOS											
System	Component	Material	Friable	Item	Covering	Access	Visible	Fair	Poor	Unit	Recommended Procedure
Wall		Drywall and joint compound	NF			A	Y	()	1 (3)	%	Type 1/Repair

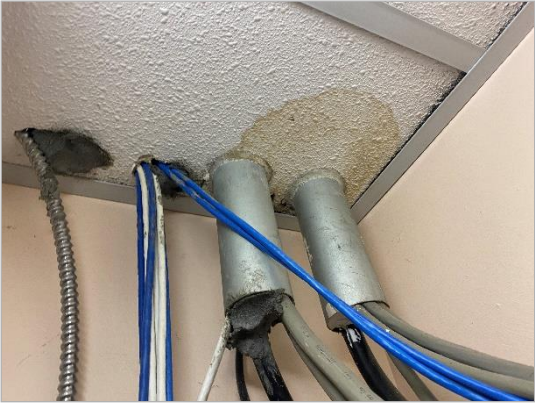
ASBESTOS											
System	Component	Material	Friable	Item	Covering	Access	Visible	Fair	Poor	Unit	Recommended Procedure
Other	Fire Stop	Parging Cement	F			C	Y	()	8 (3)	SF	Remove in accordance with Type 2 asbestos procedures

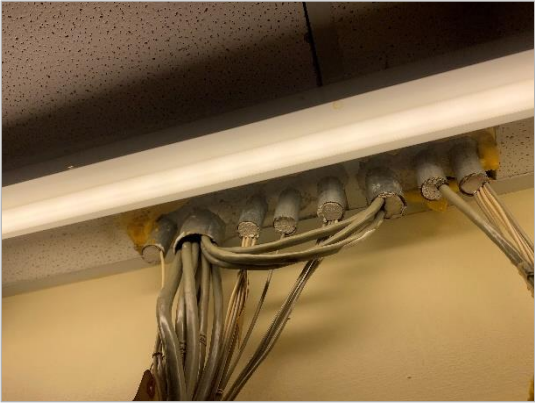
ASBESTOS											
System	Component	Material	Friable	Item	Covering	Access	Visible	Fair	Poor	Unit	Recommended Procedure
Other	Fire Stop	Parging Cement	F			C	Y	()	7 (3)	SF	Remove in accordance with Type 2 asbestos procedures

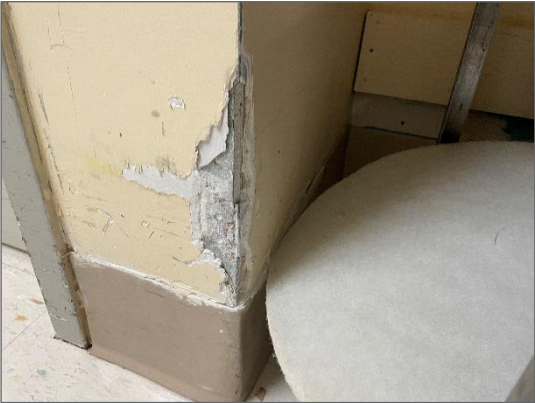
ASBESTOS											
System	Component	Material	Friable	Item	Covering	Access	Visible	Fair	Poor	Unit	Recommended Procedure
Wall		Drywall and joint compound	NF			A	Y	()	2 (3)	SF	Type 1/Repair

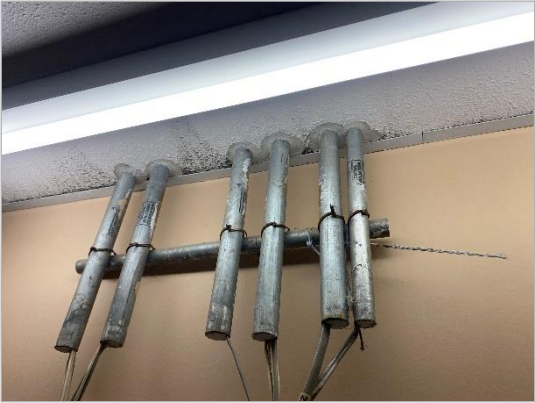
ASBESTOS											
System	Component	Material	Friable	Item	Covering	Access	Visible	Fair	Poor	Unit	Recommended Procedure
Other	Fire Stop	Parging Cement	F			C	Y	()	7 (3)	SF	Remove in accordance with Type 2 asbestos procedures

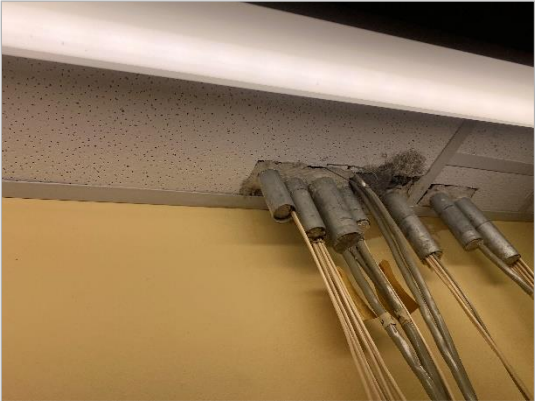
ASBESTOS											
System	Component	Material	Friable	Item	Covering	Access	Visible	Fair	Poor	Unit	Recommended Procedure
Other	Fire Stop	Parging Cement	F			C	Y	()	7 (3)	SF	Remove in accordance with Type 2 asbestos procedures

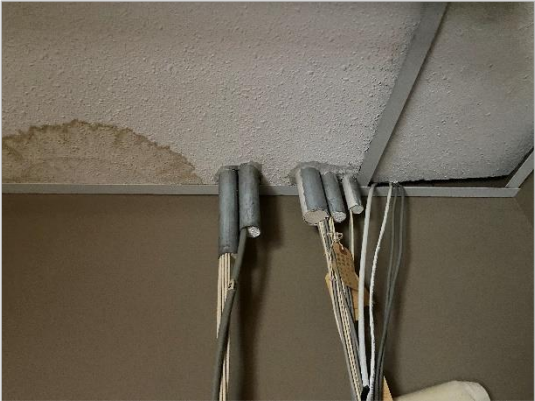
ASBESTOS											
System	Component	Material	Friable	Item	Covering	Access	Visible	Fair	Poor	Unit	Recommended Procedure
Other	Fire Stop	Parging Cement	F			C	Y	()	5 (3)	SF	Remove in accordance with Type 2 asbestos procedures

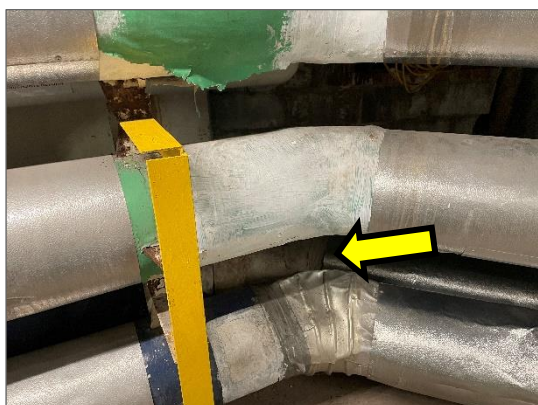
ASBESTOS											
System	Component	Material	Friable	Item	Covering	Access	Visible	Fair	Poor	Unit	Recommended Procedure
Piping		Parging Cement	F	Fitting		C	Y	2 (6)	()	EA	Type 2/Repair
