# Asbestos Reassessment

West Lincoln Memorial Hospital  
169 Main Street East, Grimsby,  
Ontario

## Hamilton Health Sciences

December 17, 2024

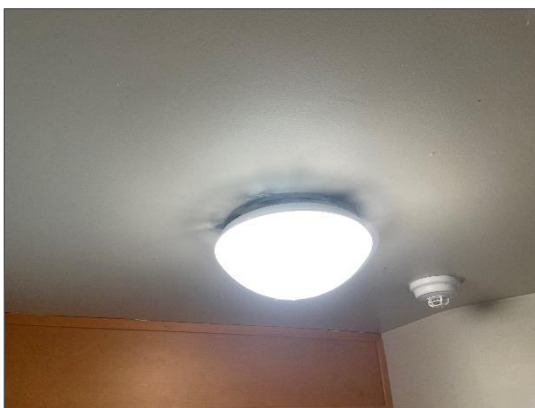
Photo 1

Paper heat shields (photo 1), containing chrysotile asbestos, are present in the Linen Closet (Location 2009), and the Janitor's Closet (Location 2023) within incandescent light fixtures (sample 0045A, lab reference no. 1407247).

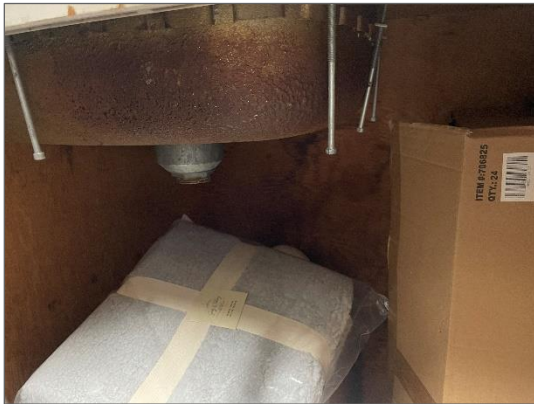
Photo 1

Gold mastic (photo 1), presumed to contain asbestos, is present as a sink undercoating in a Storage Room (Location 1026) and is assumed to be present in other locations throughout the Front Wing.

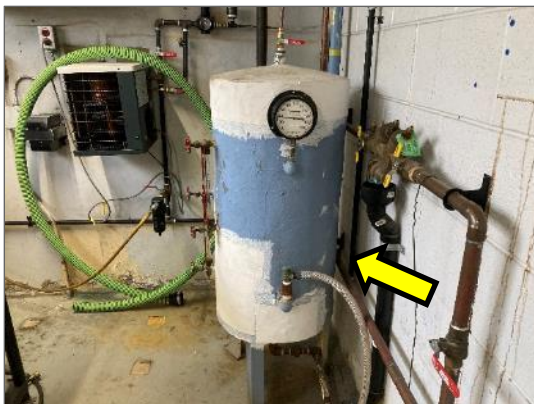
Photo 1 (2023 photo)

Parging cement (photo 1), containing chrysotile asbestos (samples 8 and 9, lab sample nos. 91B0073 and 91B0074), is present on a small cushion tank in the Mechanical Room (Location 1).

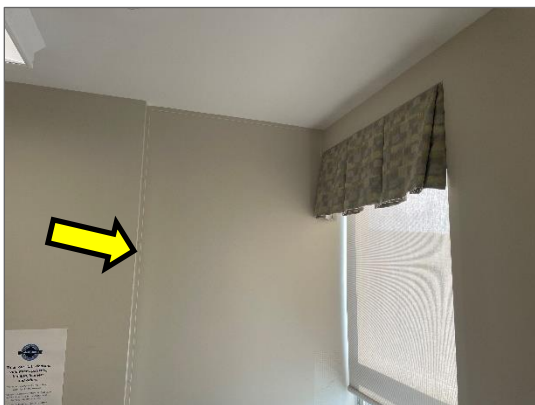
Photo 1

Transite board (photo 1), presumed to contain asbestos based on visual observation, is present as a partition wall between the Med Room (Location 1040) and the Kitchen (Location 1041) on the Ground Floor, and the Anesthesia Office (Location 2034) and the Kitchen (2035) on Level 1.

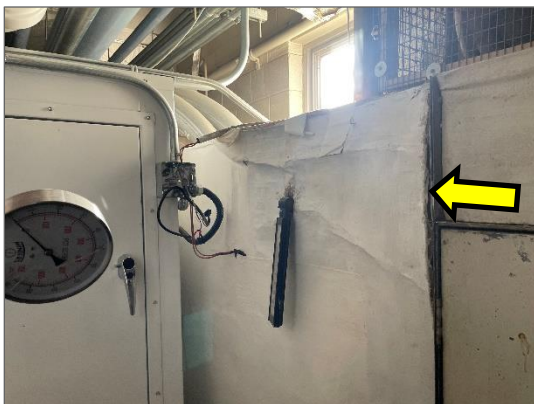
Photo 1

Paper (photo 1), containing chrysotile asbestos, is present in the Mechanical Room (Location 24) over fibreglass insulation on the supply ductwork (sample S072A-B, lab reference no. 1103843).

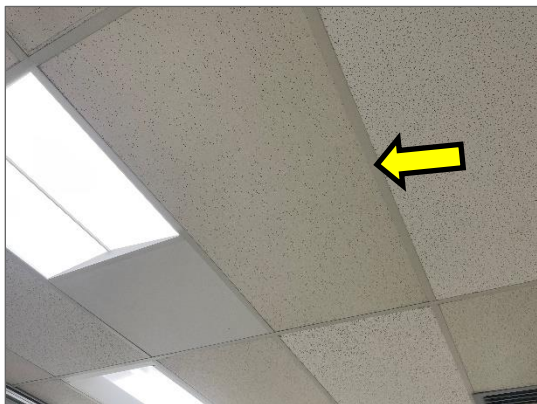
Photo 1

| Size, Type, Pattern, Photo # | Sample Number, lab ref no. | Asbestos Type |
|---|---|---|
| 24" x 48", lay-in, pinhole and texture pattern, photo 1 | 0030A, 1407247 | Amosite |

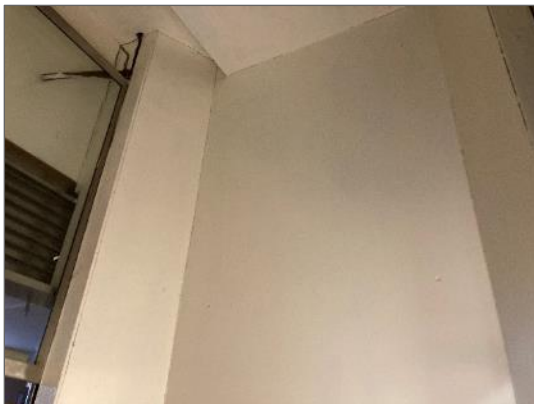
Photo 1

- Within a fume hood located in the Break Room (Location 21, photo 1); and
- As a soffit for the former vestibule entrance to the building within the Corridor (Location 27, photo 2).

Transite is presumed to contain asbestos based on visual observation.

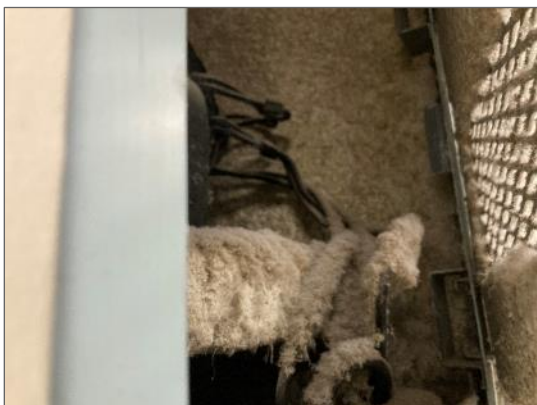
Photo 1 (photo from 2022)

Tamped firestopping (photo 1) is present inside electrical panels (photo 2) in the ER Wing on the Ground Floor. This material was sampled during the 2017 reassessment and was determined to contain amosite asbestos (ECOH samples 17429-WL-ASB-02A-C). The firestopping is not encapsulated.

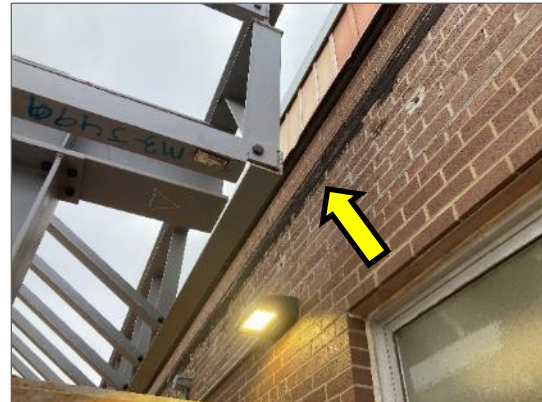
Photo 2

Brown/grey caulking (photo 2), containing chrysotile asbestos (sample S0017A, phase b, lab reference no. b273317), is present on the Exterior (Location 1028) masonry wall at the ER Entrance.

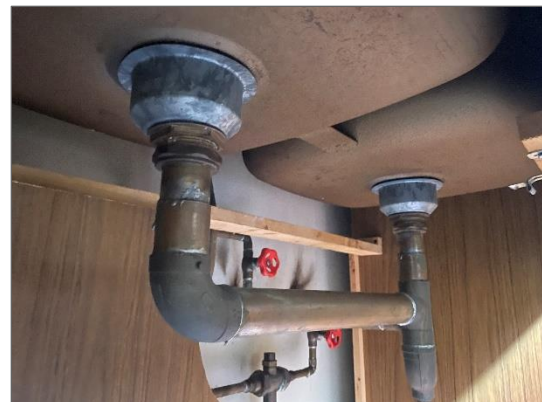
Photo 2

Gold mastic (photo 2), presumed to contain asbestos, is present as a sink undercoating in the Break Room (Location 21) and is assumed to be present in other locations throughout the ER Wing.

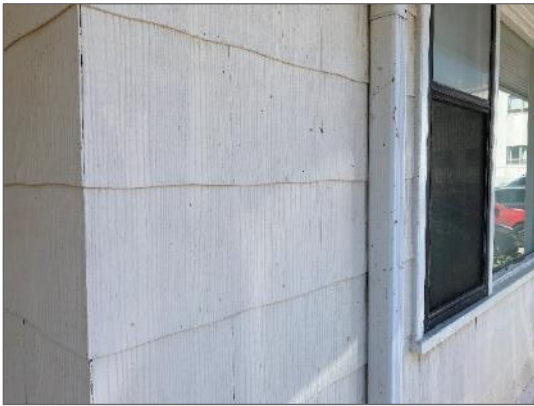
Photo 1

Transite board (photo 1), presumed to contain asbestos based on visual observation, is present as siding on the exterior of the building (Exterior, Location 26).

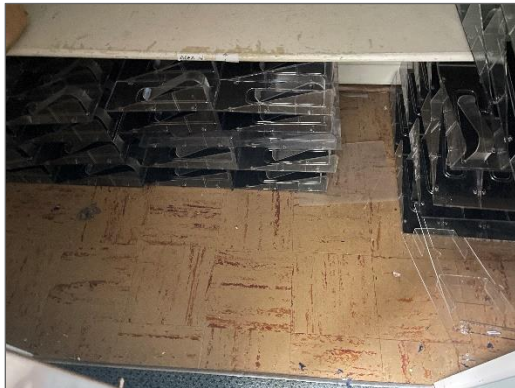
Photo 1

| Size, Pattern, Colour, Photo # | Sample Number, lab ref no. | Asbestos Type (tile) | Asbestos Type (mastic) |
|---|---|---|---|
| 9" x 9", beige with red streaks, photo 1 | 0060A, 1407247 | Chrysotile | Chrysotile |

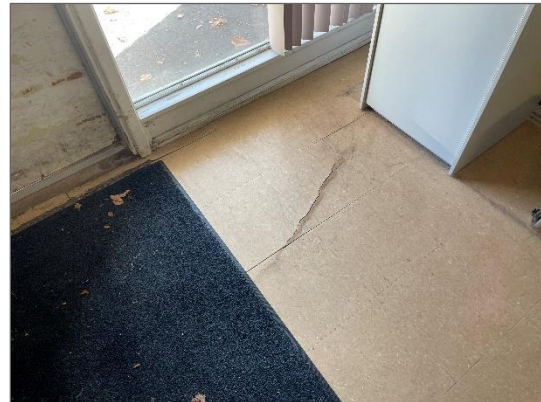
Photo 2

| Size, Pattern, Colour, Photo # | Sample Number, lab ref no. | Asbestos Type (tile) | Asbestos Type (mastic) |
|---|---|---|---|
| 12" x 12", beige with orange flecks, photo 2 | 0061A-C, 1407247 | None detected | Chrysotile |

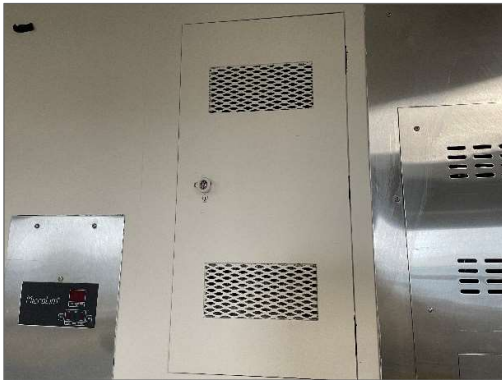
| ASBESTOS | | | | | | | | | | | |
|---|---|---|---|---|---|---|---|---|---|---|---|
| Other | Electrical Panel | Firestopping (friable), TAMPED, AMOSITE ASBESTOS | F | | | D | N | ( ) | 100 (4) | % | Photo 1 - Precautions for Work Which may Disturb ACM in Poor Condition |

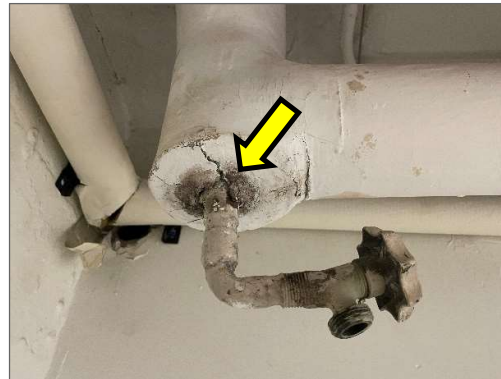
| ASBESTOS | | | | | | | | | | | |
|---|---|---|---|---|---|---|---|---|---|---|---|
| Piping | | Parging Cement | F | Fitting | | C | Y | (0) | 1 (6) | EA | Photo 3 – Repair using Type 2 Procedures |

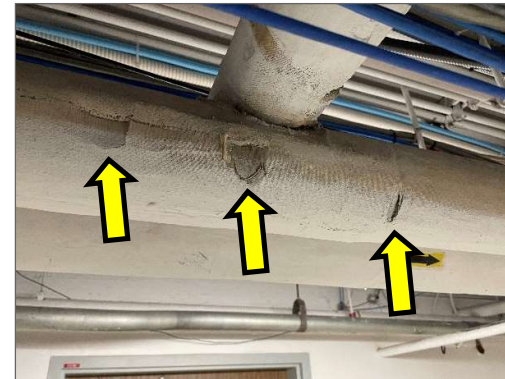
| ASBESTOS | | | | | | | | | | | |
|---|---|---|---|---|---|---|---|---|---|---|---|
| Piping | | Aircell | F | Insulation | | C | Y | 5 (6) | 2 (6) | LF | Photo 4 –Repair using Type 2 Procedures |

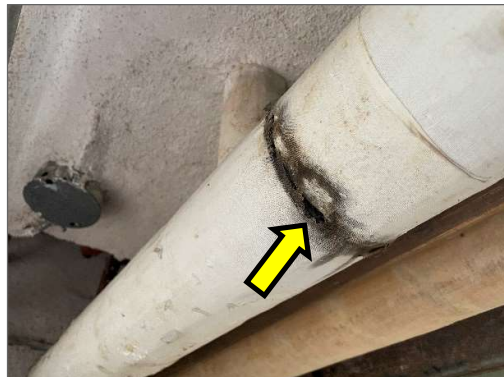
| ASBESTOS | | | | | | | | | | | |
|---|---|---|---|---|---|---|---|---|---|---|---|
| Piping | | Aircell | F | Insulation | | C | Y | 1 (6) | ( ) | LF | Photo 6 - Repair using Type 2 Procedures |

Mould was also observed on the jacketing of asbestos-containing pipe insulation.

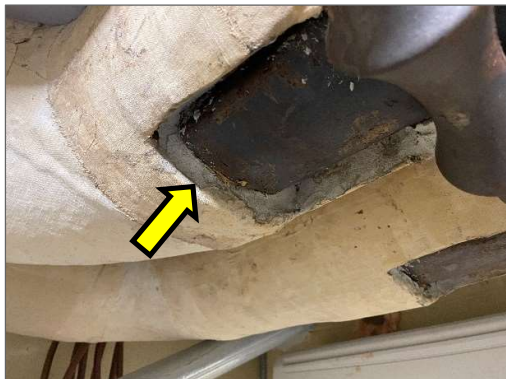
| System | Component | Material | Friable | Item | Covering | Access | Visible | Fair | Poor | Unit | Recommended Procedure |
|---|---|---|---|---|---|---|---|---|---|---|---|
| Piping | | Parging Cement, SUPPORT | F | Edge | Unjacketed | C | Y | 2 (6) | () | SF | Photo 7 - Repair using Type 2 procedures |

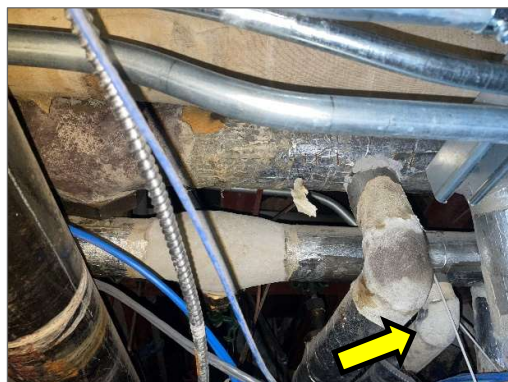
| System | Component | Material | Friable | Item | Covering | Access | Visible | Fair | Poor | Unit | Recommended Procedure |
|---|---|---|---|---|---|---|---|---|---|---|---|
| Piping | | Parging Cement | F | Fitting | | C | N | 1 (6) | () | SF | Photo 8 - Repair using Type 2 procedures |
