## **Hazardous Building Materials Assessment**

David Braley Research Centre  
20 Copeland Avenue, Hamilton,  
Ontario

January 14, 2021

Pinchin File: 269453.021

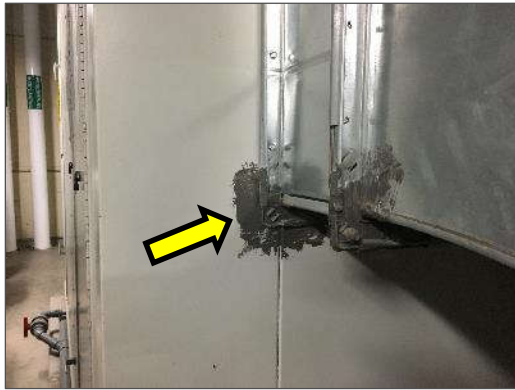
Photo 1

Grey duct mastic (Photo 1) present on seams and joints on ducts throughout the assessed area does not contain asbestos (samples S0001A-C).

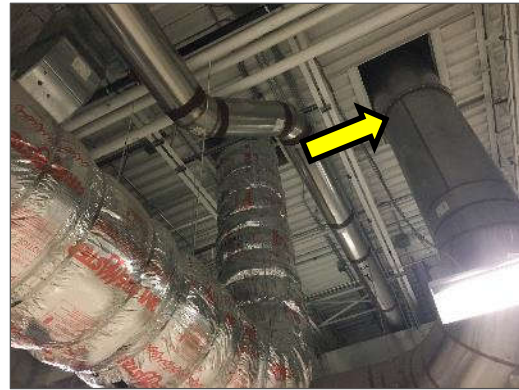
Photo 2

Red duct mastic (Photo 2) present on seams and joints on ducts throughout the assessed area does not contain asbestos (samples S0003A-C).

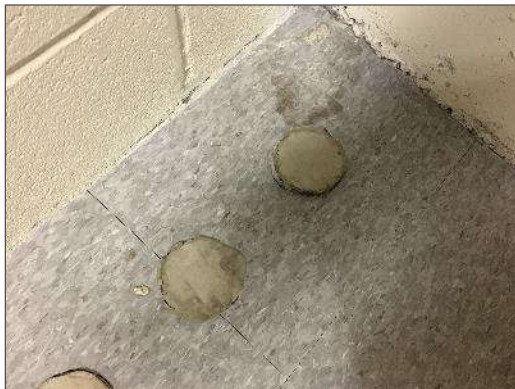
Photo 1

Firestopping sealant (Photo 1) present at conduit penetrations through floors throughout the assessed area does not contain asbestos (samples S0007A-C).

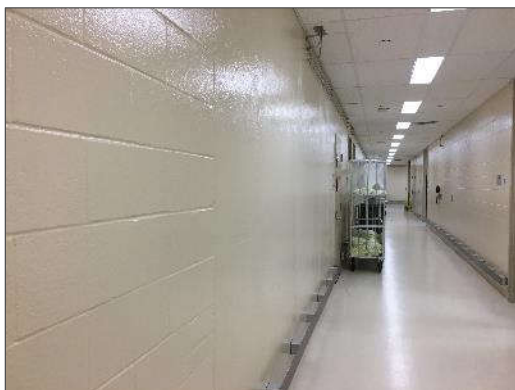
Photo 1

Textured paint (Photo 1) present on concrete block walls throughout the assessed area does not contain asbestos (samples S0004A-C).

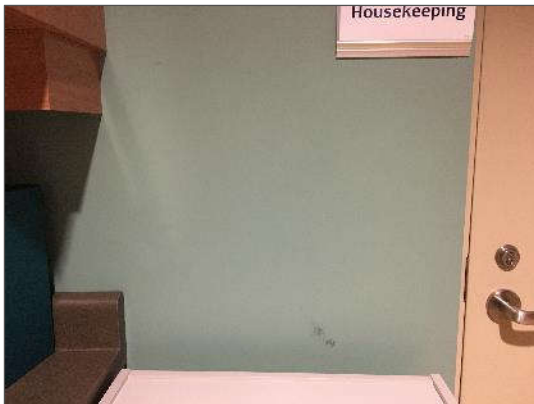
Sample Number, Photo #	Colour, Substrate Description	Location (Location #)	Lead (%)
L0006, Photo 5	Sea foam green, drywall	Third Floor (Location 3001)	0.0077%

Results below 0.009% are considered non-lead-containing paints or surface coatings in accordance with Surface Coating Materials Regulation.

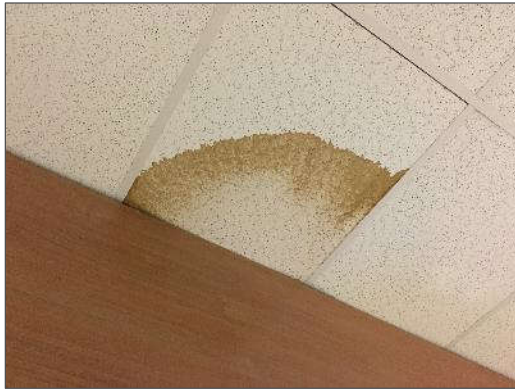
Photo 1

Water staining (Photo 1) is present on an acoustic ceiling tile on the Third Floor (Location 3001). There is approximately 4 sq. ft. of visible water staining.

Water staining was noted on one acoustic ceiling tile. Retain a qualified consultant to perform investigation and bulk sampling to determine if mould growth is present. As an alternative, the ceiling tile can be presumed to have mould growth and can be removed and disposed of using methods that comply with provincial guidelines.
