Asbestos Reassessment

McMaster University Medical
Centre (MUMC)
1200 Main Street West, Hamilton,
Ontario

January 14, 2019

Pinchin File: 217420.030

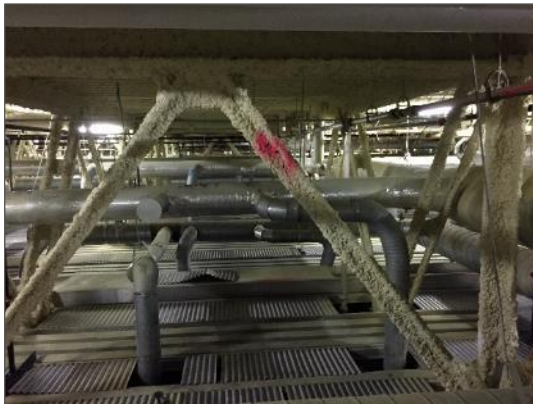
Where fireproofing is present above the double drywall ceilings above lay-in ceiling systems, the material between the top layer of drywall and the bottom flange of the beam above has not been encapsulated. Sprayed fireproofing is considered damaged where it is delaminating or where debris is present within the interstitial spaces; remaining fireproofing is in good condition.

Encapsulated asbestos-containing sprayed fireproofing on structural steel, Level 2M Interstitial.

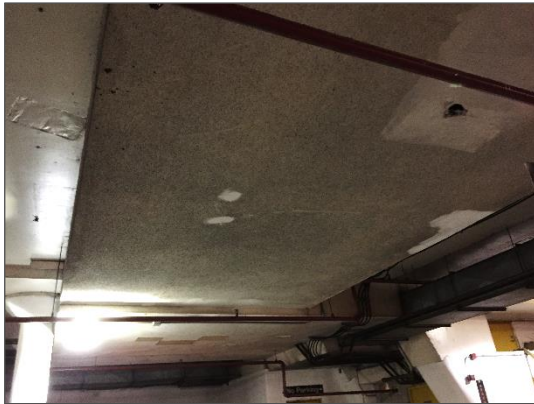
Sprayed texture finish, containing chrysotile asbestos (46653.004 sample 012A), is present on the drywall bulkhead within the southeast corner of the Yellow Parking Garage. Texture finish is a friable material, painted and ranges from damaged to good condition.

Asbestos-containing texture finish, Southeast corner of Yellow Parking Garage.

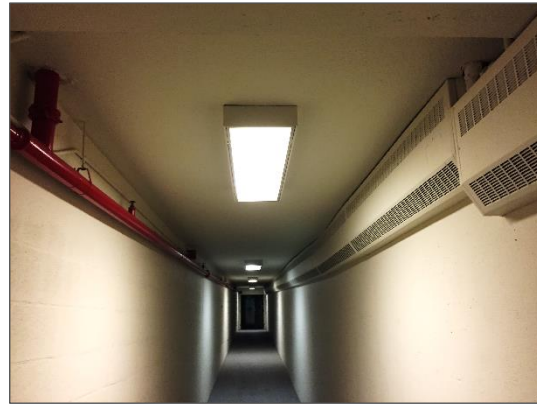
Sprayed texture finish, containing chrysotile asbestos, is present on the drywall ceiling of the parking level corridor from Elevator 22, adjacent to the King Street Exit (samples 2018-0017A-C). Texture finish is a friable material, painted and in good condition.

Asbestos-containing texture finish, Corridor from Elevator 22 to Parking Garage.

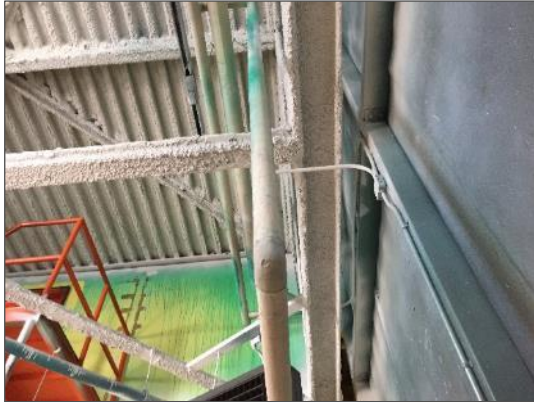
Parging cement, containing chrysotile asbestos (46653.004 samples 002 & 005), is present on the majority of insulated pipe fittings (elbows, valves, tees, hangers etc.) throughout the building. Parging cement is a friable insulation, jacketed with canvas or cheese cloth and is in good condition in the majority of the building. Some of the fittings in the MM Level are not jacketed and are considered to be in fair condition.

Asbestos-containing parging cement on pipe fitting, Level 6 Mechanical Penthouse.

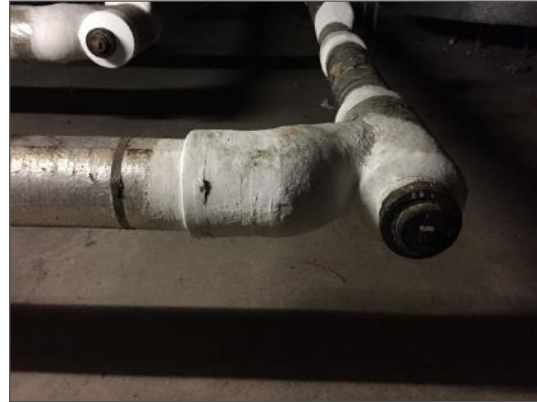
Asbestos-containing parging cement on pipe fittings, MM Level.

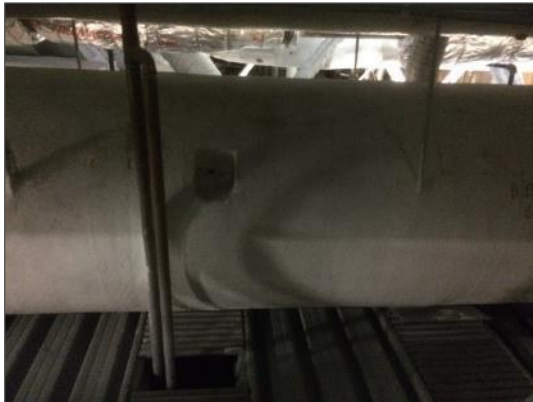
Preformed block/parging cement insulation, containing chrysotile asbestos (200249.001 sample 0001A), is present on exhaust duct systems in the interstitial spaces, service shafts, and Level 6 Electrical Substations. Exhausts from the kitchen area were reported to be randomly insulated with insulation containing chrysotile asbestos. In 2014 ECOH collected insulation samples from exhaust ducting associated with Shaft 47 and also found the material to contain chrysotile asbestos (samples 15319-ACM-01A to C). Preformed block and parging cement insulation are friable and in good condition.

Asbestos-containing insulation on exhaust ducting, Interstitial.

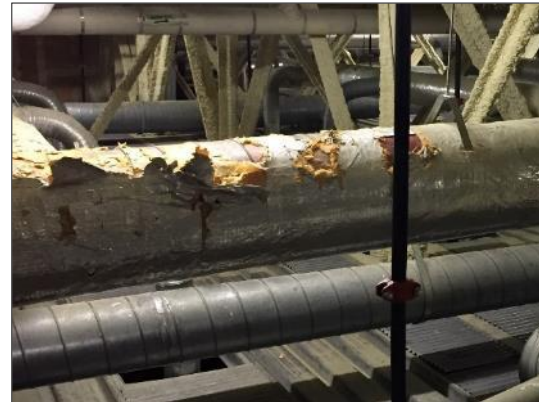
Brown/red duct mastic, containing chrysotile asbestos (samples 16262-MUMC-ASB-05A), is present on ductwork within Shaft 42 and was observed throughout the interstitial spaces. Mastic is non-friable and in good condition.

Asbestos-containing brown/red mastic on ducts, Interstitial.

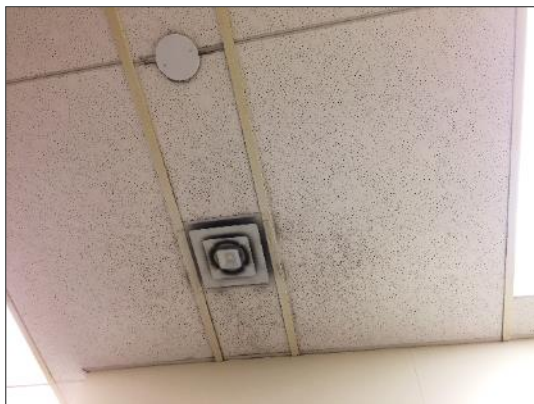
Ceiling tiles are considered to be potentially friable and are in good condition.

Asbestos-containing lay-in ceiling tiles, large and small pinhole pattern, Level 1 Room 1J8.

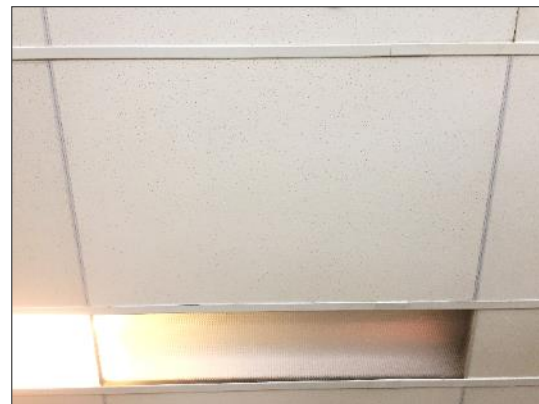
Non-asbestos lay-in ceiling tiles, uniform pinhole pattern, Level 4 Stairwell 56.

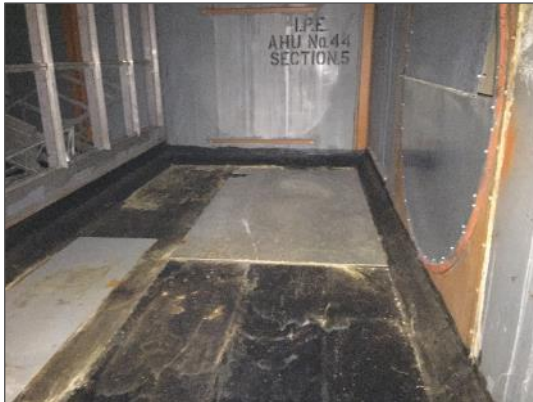
Transite board, presumed to contain asbestos based on visual observation, is present within fume hoods throughout the building, the majority of which are present within the third and fourth floor laboratories. It is also present under lab counters and as cabinet liners randomly in lab areas. Transite board is also present within the unabated air handling units in the Level 6 Penthouse and Tower 74 and 76 exhausts. Transite is non-friable and is in good condition.

Transite board in air handling unit, Level 6 Mechanical Penthouse.

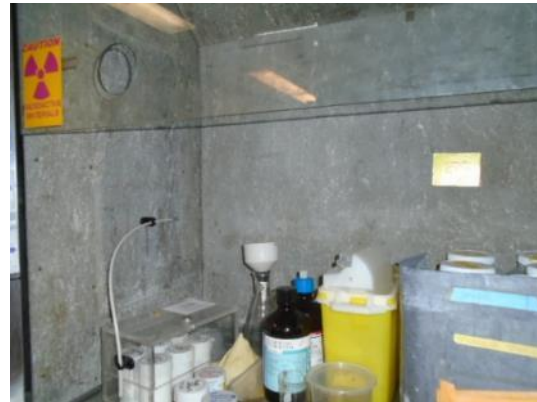
Transite board in typical fume hood, Level 4 Laboratory.

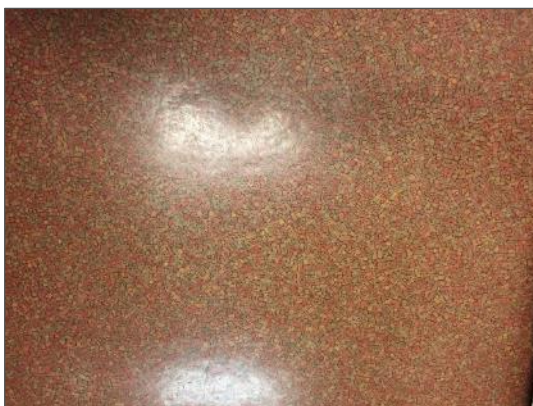
Asbestos-containing vinyl sheet flooring, red square pattern, Level 4 Area 4BC2.

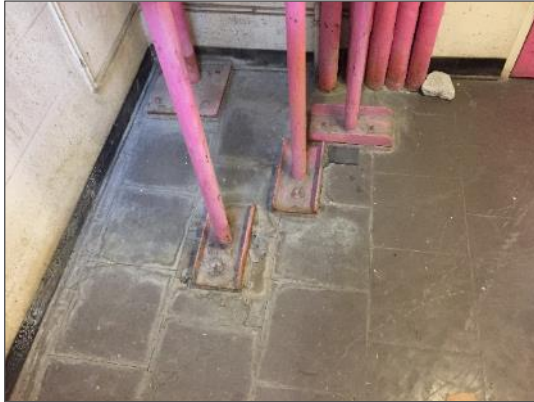
Asbestos-containing 12" x 12" vinyl floor tiles, dark brown with brown flecks.

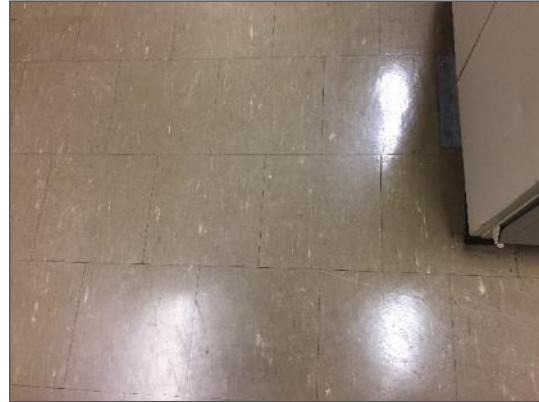
Asbestos-containing 12" x 12" vinyl floor tiles, brown with white flecks.

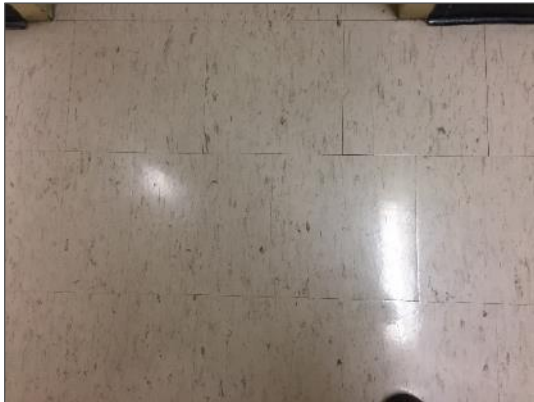
Asbestos-containing 12" x 12" vinyl floor tiles, white with brown flecks.

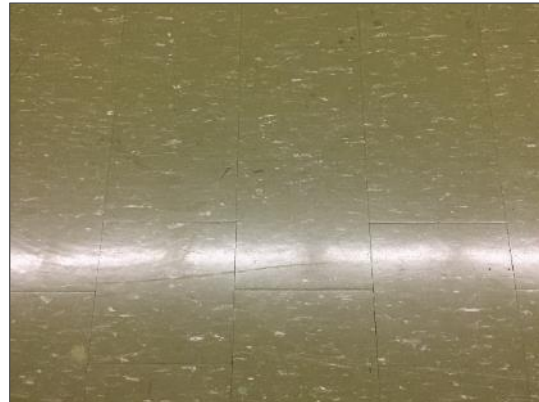
Asbestos-containing 12" x 12" vinyl floor tiles, green with white flecks.

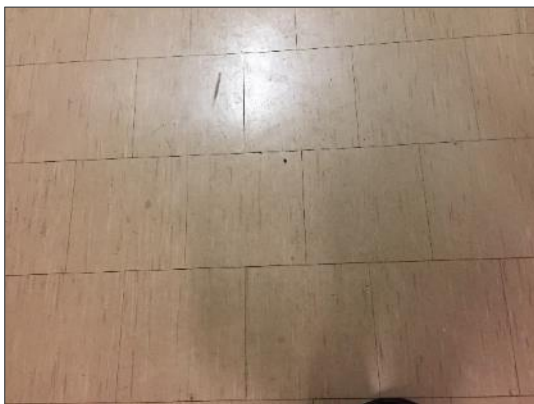
Asbestos-containing 12" x 12" vinyl floor tiles, beige with brown lines.

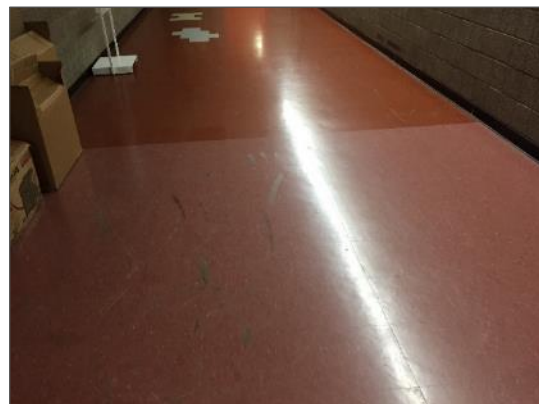
Asbestos-containing 12" x 12" vinyl floor tiles, red with white flecks.

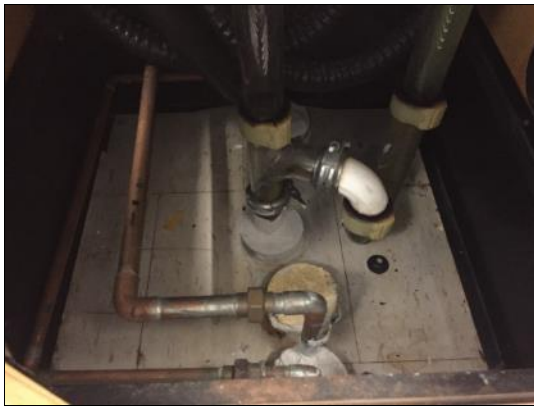
Parging cement firestopping, presumed to contain asbestos (previously sampled), is present around pipe penetrations throughout the building, most notably beneath sinks and fume hoods within the third and fourth floor laboratories. The firestopping is a friable material and is in good condition.

Asbestos-containing parging cement firestopping is present at pipe penetrations below laboratory sinks.

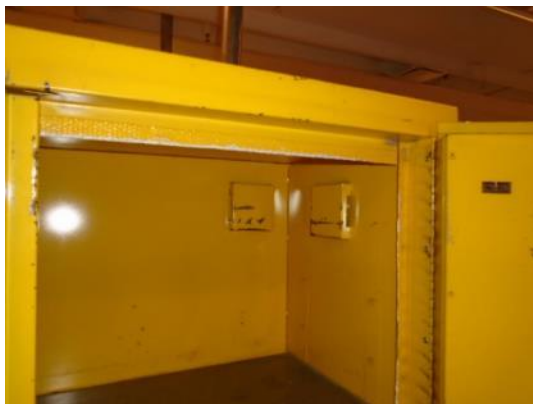
Textile gaskets, containing chrysotile asbestos (200199.011 sample 0003A, 200199.048 sample S002A, and 94333.030 sample 0001A), were previously identified along the perimeter of the doors inside flammable cabinets within Laboratory 4N3, Laboratory 4N36, and Room 4N43 and are presumed present in other locations within the building. Textile gaskets are non-friable and in good condition.

Asbestos-containing textile gaskets on typical flammable storage cabinet, Level 3 Laboratory.

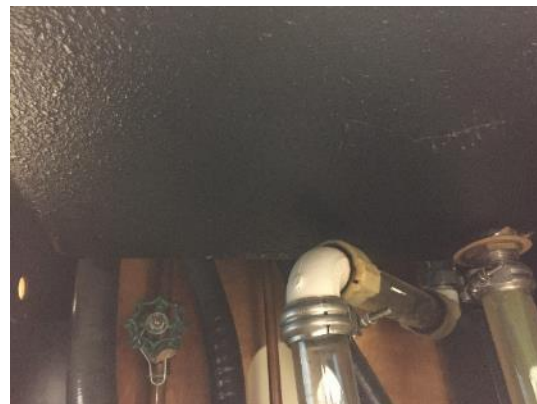
Black mastic, containing chrysotile asbestos (ECOH sample 16262-MUMC-ASB-07A), was observed as sink undercoating in Level 4 Lab 4H25 and various other laboratories previously renovated, and is presumed to be present on sinks in laboratories and classrooms throughout the lab areas. Mastic is non-friable and in good condition.

Asbestos-containing black mastic sink undercoating, Level 4 Laboratory.

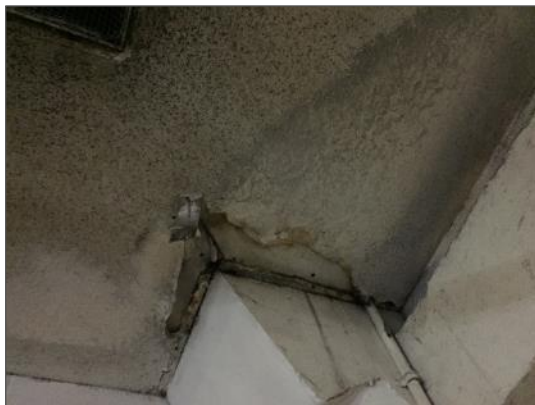
Photo 1 - Damaged asbestos-containing texture finish on bulkhead, Southeast corner of Yellow Parking.

Material, Quantity & Condition, Photo Number	Location	Recommended Procedure
Texture finish, 5 square feet damaged and 10 square feet of debris, Photos 1 & 2	Parking Garage, Southeast Corner of Yellow Parking near Shaft 29	Remove, clean-up, and repair in accordance with Type 2 asbestos abatement procedures
Vinyl floor tiles (12" x 12" dark brown with flecks), 5 square feet loose, Photo 3	Stair 56 between Level 1 and MM	Clean-up/remove in accordance with Type 1 asbestos abatement procedures

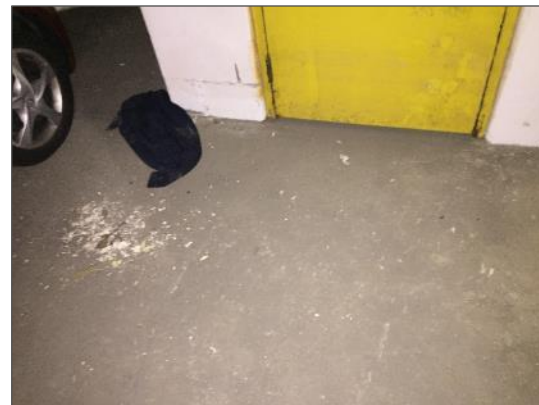
Photo 2 - Asbestos-containing texture finish debris, Southeast corner of Yellow Parking.

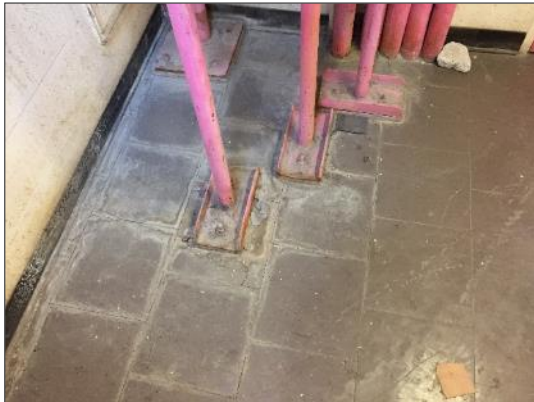
Photo 3 - Damaged asbestos-containing vinyl floor tiles, Stairwell 56 between Level 1 and Level MM.

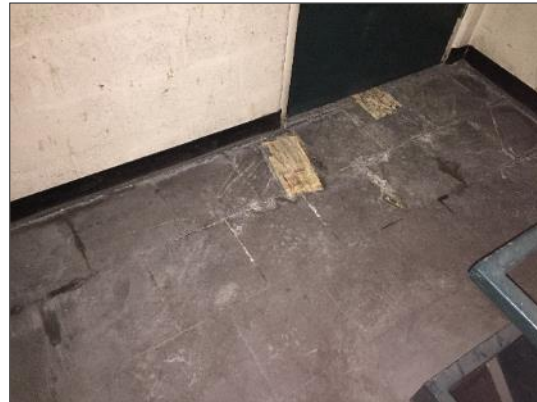
Photo 4 - Damaged asbestos-containing vinyl floor tiles, Stairwell 42 between Level 1 and Level MM.

Material, Quantity & Condition, Photo Number	Location	Recommended Procedure
Vinyl floor tiles (12" x 12" dark brown with flecks), 5 square feet loose, Photo 4	Stair 42 between Level 1 and MM	Clean-up/remove in accordance with Type 1 asbestos abatement procedures
Drywall joint compound, 5 square feet damaged and 5 square feet of debris, Photo 5	Level 1 Exit Corridor at Shaft 88	Remove, clean-up, and repair in accordance with Type 1 asbestos abatement procedures
Drywall joint compound, 6 square feet damaged, Photo 6	Level 3 Corridor near Courtyard 2 and Shaft 74	Remove, clean-up, and repair in accordance with Type 1 asbestos abatement procedures
Drywall joint compound, 5 square feet damaged, Photo 7	Level 6 near Elevator Machine Room 23	Remove, clean-up, and repair in accordance with Type 1 asbestos abatement procedures
Drywall joint compound, 2 square feet damaged and 1 square foot debris, Photo 8	Level 6 near Glycol Station	Remove, clean-up, and repair in accordance with Type 1 asbestos abatement procedures

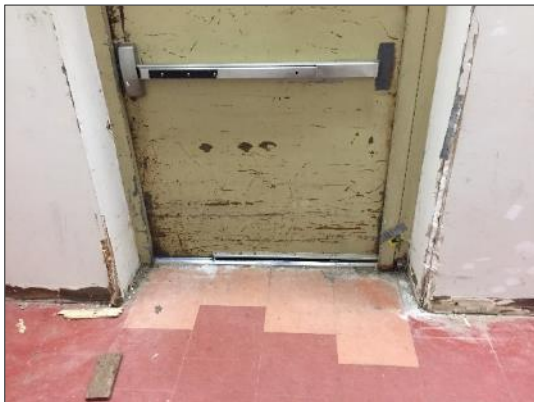
Photo 5 - Damaged asbestos-containing drywall joint compound and debris, Level 1 Exit Corridor at Shaft 88.

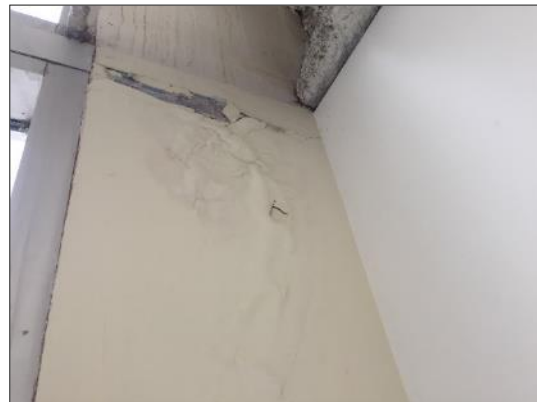
Photo 6 - Damaged asbestos-containing drywall joint compound, Level 3 near Courtyard 2 and Shaft 74.

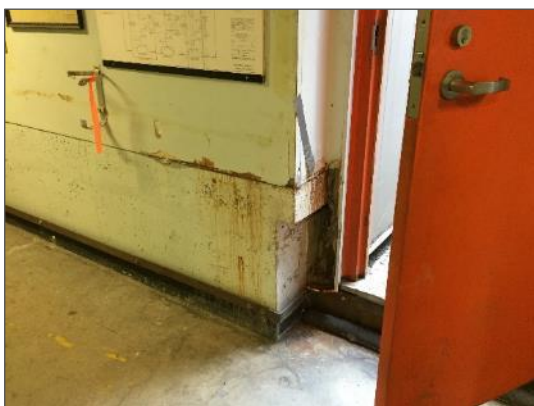
Photo 7 - Damaged asbestos-containing drywall joint compound, Level 6 near Elevator Room 23.

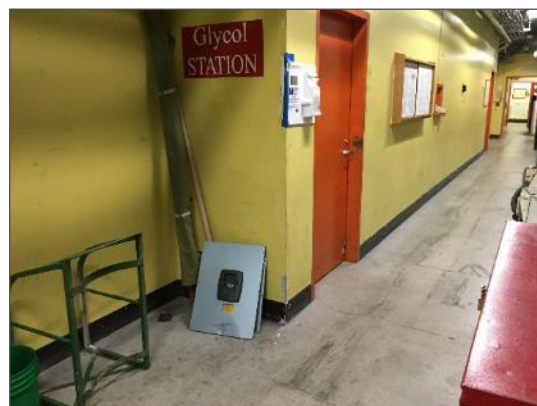
Photo 8 - Damaged asbestos-containing drywall joint compound, Level 6 near Glycol Station.

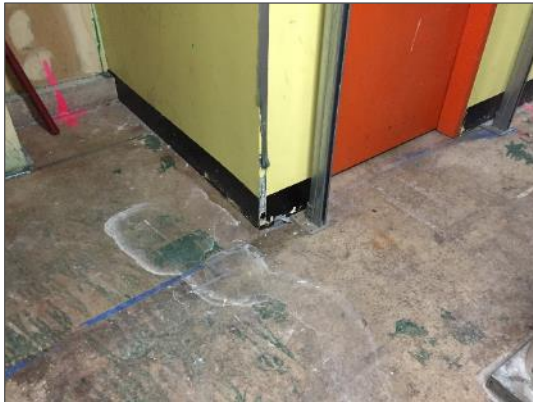
Photo 9 - Damaged asbestos-containing drywall joint compound and debris, Level 6 near Shaft 52.

Drywall joint compound, 2 square feet damaged and 10 square foot debris, Photo 9	Level 6 near Shaft 52	Remove, clean-up, and repair in accordance with Type 1 asbestos abatement procedures
