# FINAL **Asbestos Reassessment**

St. Peter's Hospital  
88 Maplewood Avenue, Hamilton,  
Ontario

January 16, 2019

Pinchin File: 217420.030

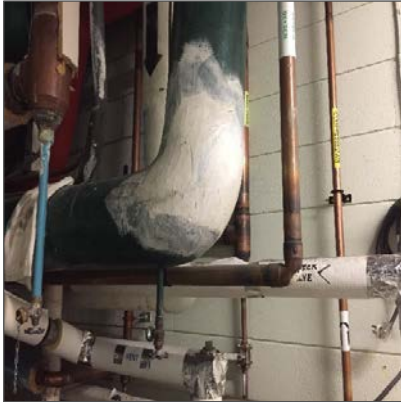
Parging cement, containing chrysotile asbestos (previously reported), is present on pipe fittings (elbows, valves, tees, hangers etc.) on the majority of insulated pipe fittings within the Steam Tunnel and Boiler Room. Parging cement is a friable insulation, jacketed with canvas and is in good condition.

Asbestos-containing parging cement on pipe fitting, Steam Tunnel.

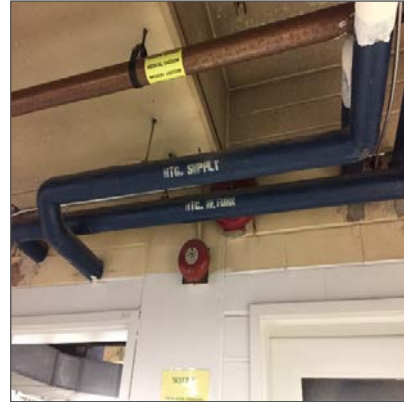
Asbestos-containing parging cement on pipe fittings, Boiler Room.

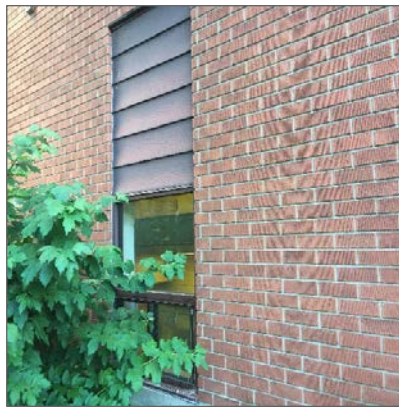
Caulking, containing chrysotile asbestos, is present at exterior windows of the Boiler House (previously sampled). Caulking is non-friable and is in good condition.

Asbestos-containing caulking at exterior window frame, Boiler House.

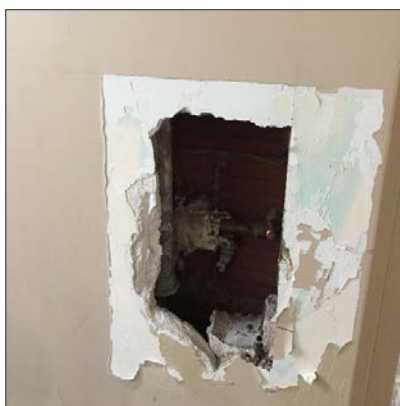
A white corrugated paper insulation (trade name Aircell), presumed to contain asbestos based on previous reports, is present on straight sections of hot water system pipes. Aircell is a friable insulation, jacketed with canvas and ranges from damaged to good condition.

Asbestos-containing Aircell pipe insulation within wall cavity, Level 2 Office Area.

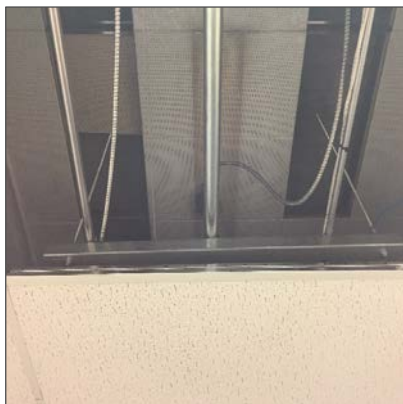
Paper, containing chrysotile asbestos (K13105 sample 006), is wrapped around fibreglass batts of the 1' x 2' perforated metal pan tiles on the first floor. The paper is non-friable and in good condition.

Asbestos-containing paper above metal pan ceiling tiles, First Floor Corridor.

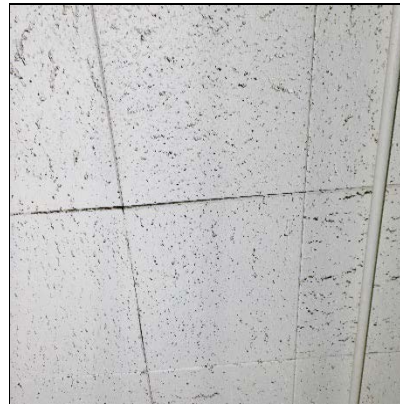
Non-asbestos 12" x 12" glued-on ceiling tiles, random fissure pattern, Basement Room S005 (photo from previous assessment).

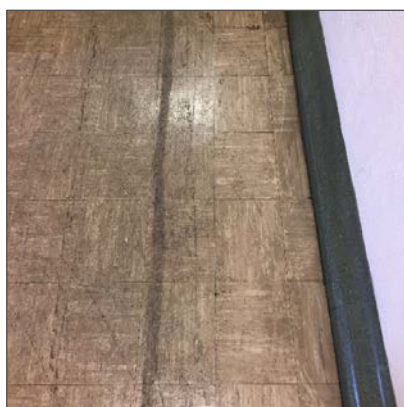
Photo 1 - Asbestos-containing 12"x12" white and beige streaks vinyl floor tile within Level 1 Corridor.

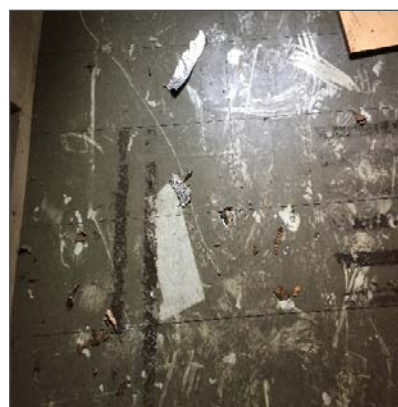
Photo 2 - Presumed asbestos-containing 12"x12" grey and dark grey flakes vinyl floor tile within Level 1 Room S105C.

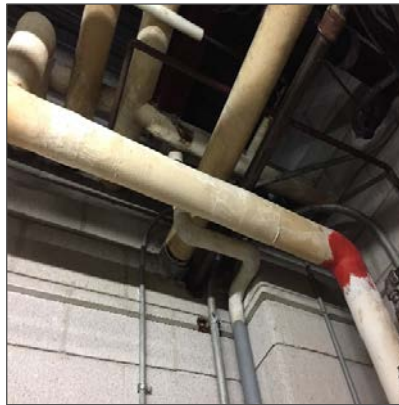
Parging cement, containing chrysotile asbestos, is present on pipe fittings (elbows, valves, tees, hangers etc.) on domestic hot water systems throughout the utility rooms and Mechanical Penthouses (200249.062 sample 0001A and 217420.002 sample 0001A). Parging cement is a friable insulation, jacketed with canvas and is in good condition.

Asbestos-containing paring cement on pipe fittings, Basement Mechanical Room.

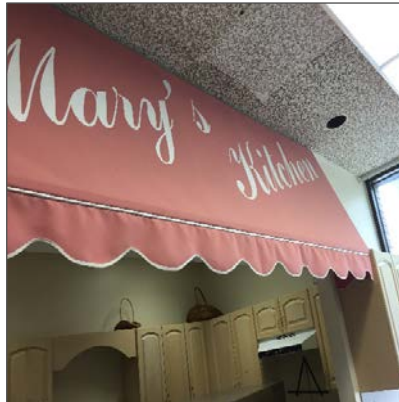
The 12" x 24" glued-on acoustic ceiling tiles with a large fissure pattern were determined to be non-asbestos by analysis (HHS samples S04a-c, March 22, 2013). Sampling by ECOH in 2017 also determined these ceiling tiles to be non-asbestos (samples 174-SPH-EW1-03A-C). A non-asbestos coating is present on the surface of these tiles.

Non-asbestos 12" x 24" glued-on ceiling tiles with large fissure pattern, adhered with presumed asbestos-containing mastic, Level 1 Easy Street Area.

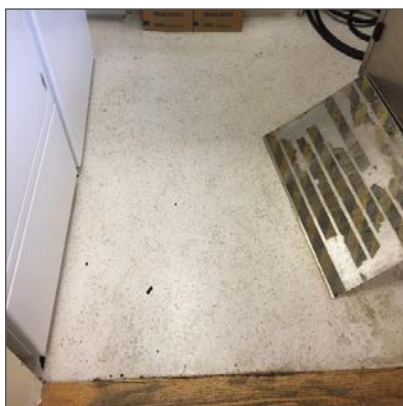
Photo 1 – Non-asbestos vinyl sheet flooring, stone, white, blue and brown pattern, Level 1 Easy Street Area, East Wing.

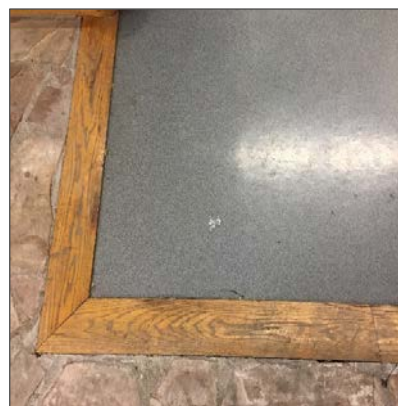
Photo 2 – Non-asbestos vinyl sheet flooring, blue, Level 1 Easy Street Area, East Wing.

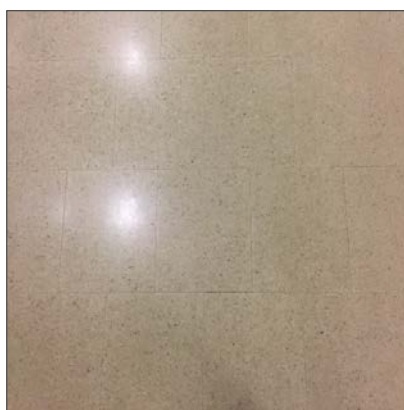
Photo 1 – Asbestos-containing 12" x 12" vinyl floor tiles, white with grey specks, Basement Corridor.

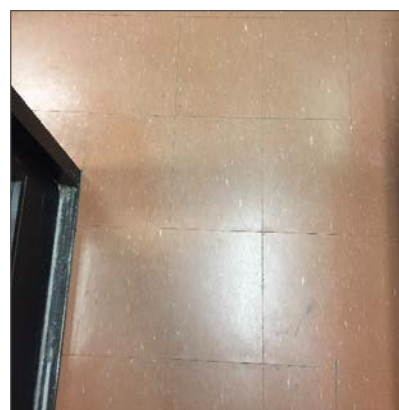
Photo 2 – Non-asbestos 12" x 12" vinyl floor tiles, red/brown with flecks, Level 1 Information Desk.

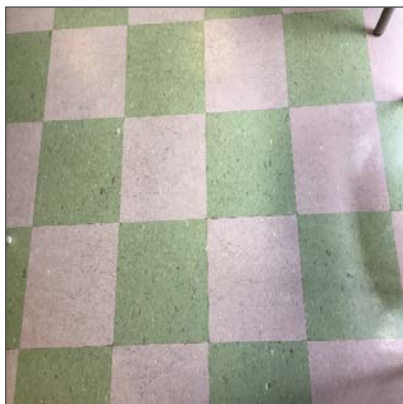
Photo 3 – Non-asbestos 12" x 12" vinyl floor tiles, purple and green with flecks, Second Floor Corridor Lounge Area.

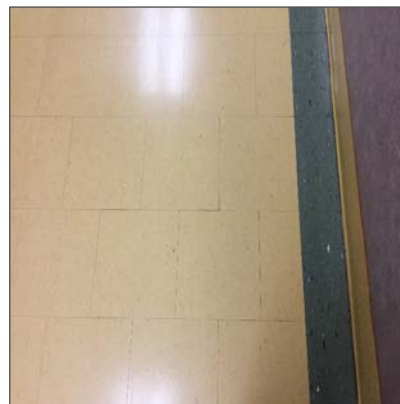
Photo 4 – Non-asbestos 12" x 12" vinyl floor tiles, green and yellow with flecks, Second Floor Corridor.

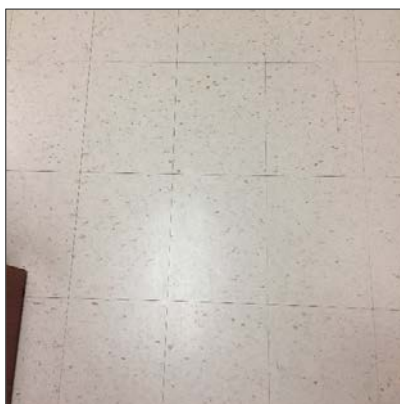
Photo 5 – Non-asbestos 12" x 12" vinyl floor tiles, off-white with multi-colour flecks, Second Floor Corridor.

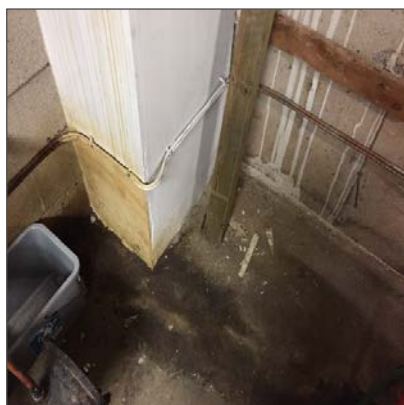
Photo 1 – Damaged asbestos-containing drywall joint compound and debris, Basement Mechanical Room, West Wing.

| Material, Quantity & Condition, Photo # | Location | Recommended Procedure |
|---|---|---|
| Drywall joint compound, 2 linear feet in poor condition and 8 square feet of debris, Photo 1 | Basement Mechanical Room in West Wing | Clean-up and repair in accordance with Type 1 asbestos procedures |

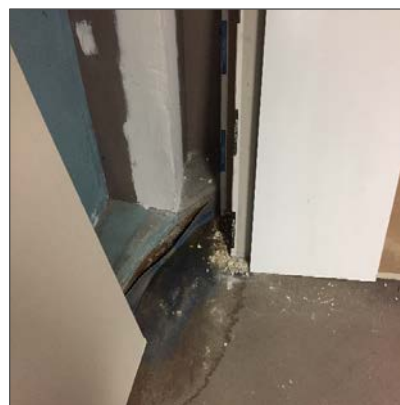
Photo 2 – Asbestos-containing drywall joint compound debris, Basement Storage Room at Entrance to South Wing, West Wing.

| Material, Quantity & Condition, Photo # | Location | Recommended Procedure |
|---|---|---|
| Drywall joint compound, 5 square feet of debris, Photo 2 | Basement Storage Area in West Wing at Entry to South Wing | Clean-up and repair in accordance with Type 1 asbestos procedures |

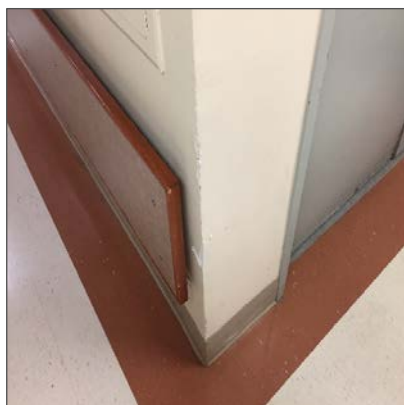
Photo 3 – Damaged asbestos-containing drywall joint compound on wall, Level 3 Corridor at Tub/Shower Room, West Wing.

| Material, Quantity & Condition, Photo # | Location | Recommended Procedure |
|---|---|---|
| Drywall joint compound, 3 linear feet in poor condition, Photo 3 | Level 3 Corridor at Tub/Shower Room, West Wing | Repair in accordance with Type 1 asbestos procedures |

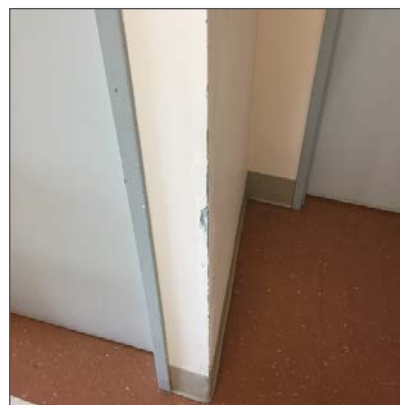
Photo 4 – Damaged asbestos-containing drywall joint compound on wall, Level 4 Corridor at Room E423, East Wing.

| Material, Quantity & Condition, Photo # | Location | Recommended Procedure |
|---|---|---|
| Drywall joint compound, 4 linear feet in poor condition, Photo 4 | Level 4 Corridor at Room E423, East Wing | Repair in accordance with Type 1 asbestos procedures |

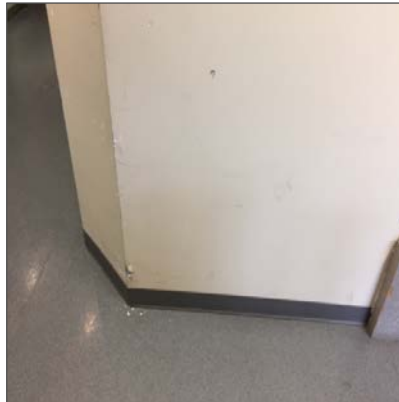
Photo 5 – Damaged asbestos-containing drywall joint compound and debris, Level 1 Easy Street Area, East Wing.

| Material, Quantity & Condition, Photo # | Location | Recommended Procedure |
|---|---|---|
| Drywall joint compound, 2 linear feet in poor condition and 2 square feet of debris, Photo 5 | Level 1 Easy Street Area, East Wing | Clean-up and repair in accordance with Type 1 asbestos procedures |

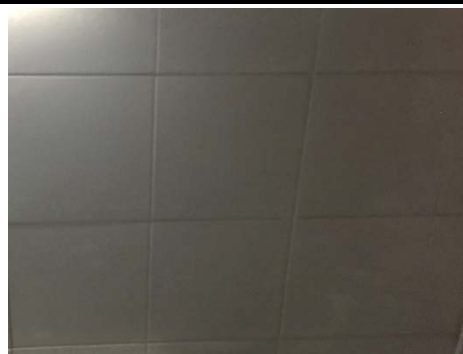
| <b>TABLE V</b><br>Summary of Ceiling Tiles (CT) | | | | |
|---|---|---|---|---|
| CT5 | 1x2 Metal Pan Tile w/ Pinholes | Sampled in a Previous ECOH Reassessment | Asbestos-Containing Paper Backing | |
