FINAL
Asbestos
Reassessment

West Lincoln Memorial Hospital
169 Main Street East, Grimsby,
Ontario

January 17, 2019

Pinchin File: 217420.030

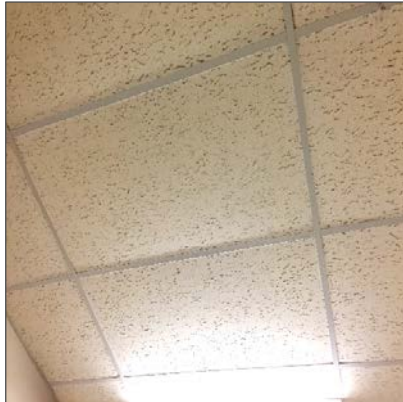
Sampling performed by ECOH since Pinchin's last reassessment identified one type of lay-in acoustic ceiling tile which contains chrysotile asbestos (ECOH samples 17429-WL-FWG-04A-C). These ceiling tiles are 24" x 48" lay-in with a length-wise fissure and small pinhole pattern and are present in the Ground Floor Corridor.

Photo 1 – Asbestos-containing 24" x 48" lay-in ceiling tiles, length-wise fissure and small pinholes, Ground Floor Corridor.

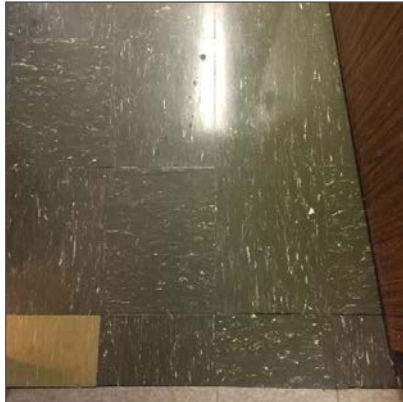
The vinyl floor tiles are non-friable and are in good condition.

Photo 1 - Asbestos-containing 12" x 12" vinyl floor tiles, green with white streaks and yellow with white streaks, Basement Office #1.

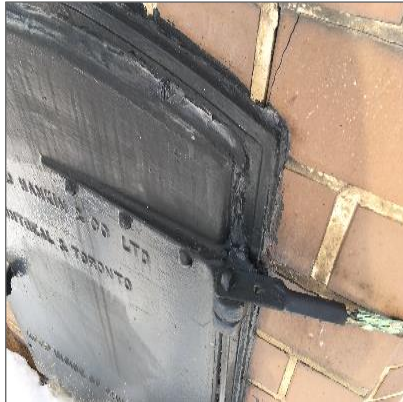
Black caulking, containing chrysotile asbestos, was observed around the exterior frame of the chimney door (samples S064A-C). Caulking is non-friable and is in good condition.

Asbestos-containing black caulking around the exterior frame of the chimney door – Exterior of Boiler Room (samples S064A-C).

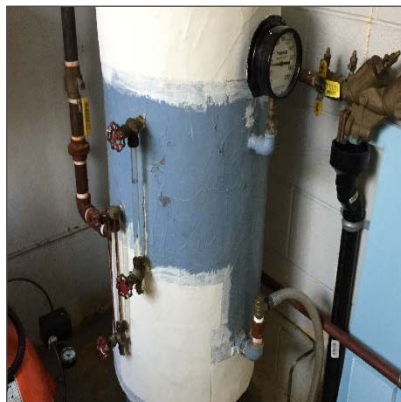
Parging cement, containing chrysotile asbestos (samples 91B0066 1-5), is present on a small cushion tank in the Basement Mechanical Room. Parging cement is a friable insulation, jacketed with canvas and in good condition.

Asbestos-containing parging cement insulation on cushion tank, Basement East Mechanical Room.

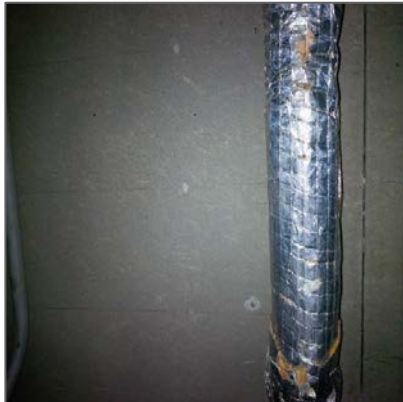
Transite is non-friable and is in good condition.

Transite board above plaster ceiling, Basement Medical Storage Room.

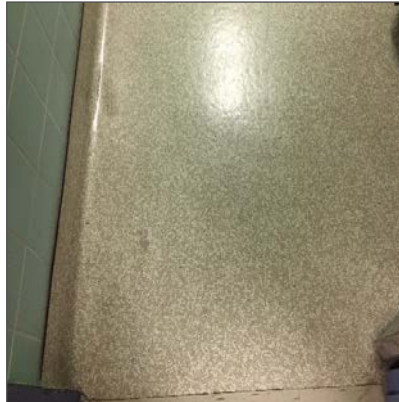
The vinyl sheet flooring is non-friable but can become friable upon removal. Vinyl sheet flooring is in good condition.

Asbestos-containing vinyl sheet flooring, brown with white squares, Ground Floor Barrier-Free Shower Room.

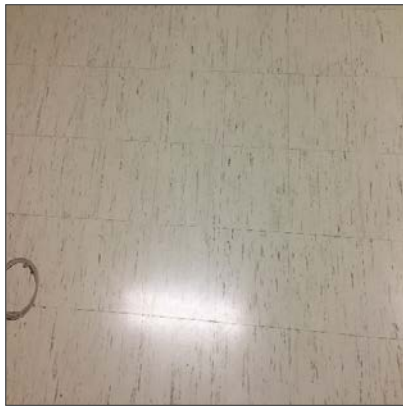
The vinyl floor tiles and mastic are non-friable and are in good condition.

Photo 1 – Asbestos-containing 9" x 9" vinyl floor tiles and mastic, beige with grey streaks, Basement Main Corridor.

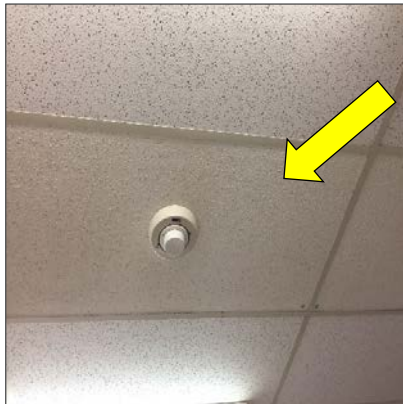
Ceiling tiles are considered to be potentially friable and are in good condition.

Asbestos-containing 24" x 48" lay-in ceiling tiles, pinhole and texture pattern, Basement ECG Department.

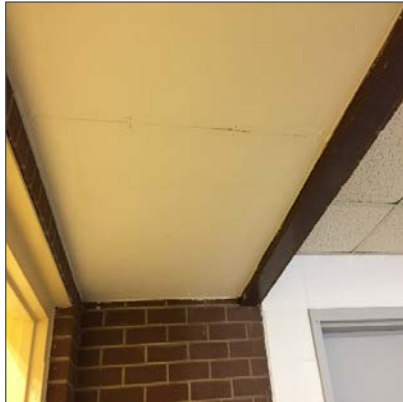
Transite is in good condition.

Transite board on former soffit, Basement Corridor, ER Department.

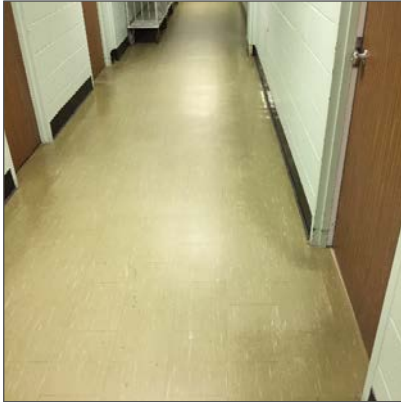
The vinyl floor tiles and mastic are non-friable and are in good condition.

Photo 1 – Asbestos-containing 12" x 12" vinyl floor tiles, yellow with white streaks, Basement Main Corridor.

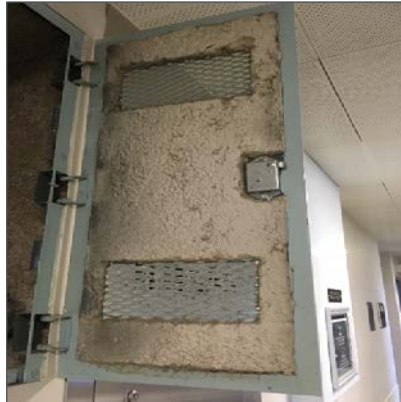
Tamped firestopping is present inside electrical panels in the ER Wing on the Ground Floor. This material was sampled during the 2017 reassessment and was determined to contain Amosite asbestos (samples 17429-WL-ASB-02A-C). The firestopping is a friable material and is in good condition, but is not encapsulated.

Asbestos-containing tamped firestopping in electrical panel (photo from previous assessment).

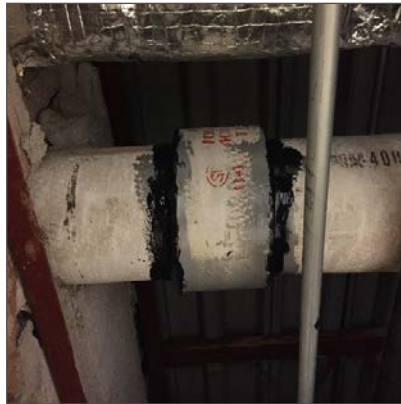
Transite pipe is present as rain water leaders in several locations throughout this section of the building. Transite is a non-friable material which is presumed to contain asbestos based on visual observation. Transite is in good condition.

Transite rain water leader, Halfway Café Lounge.

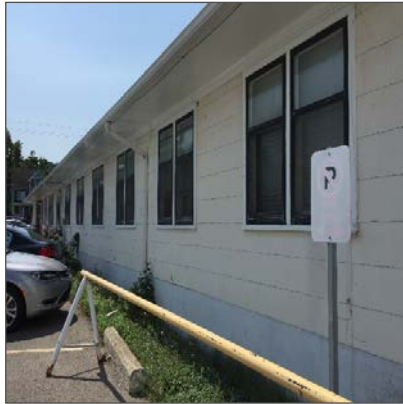
Transite board, presumed to contain asbestos based on visual observation, is present as siding on the exterior of the building. Transite is non-friable and is in good condition.

Transite exterior siding, Building Exterior.

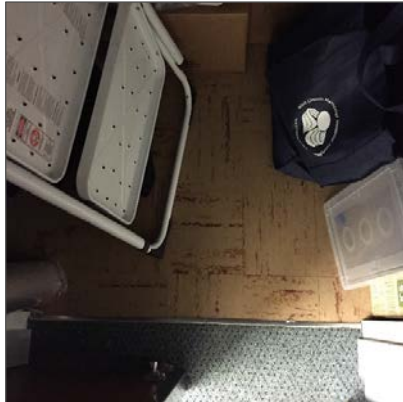
The vinyl floor tiles and mastic are non-friable and are range from damaged to good condition.

Asbestos-containing 9" x 9" vinyl floor tiles, beige with red streaks, Stationery Closet.

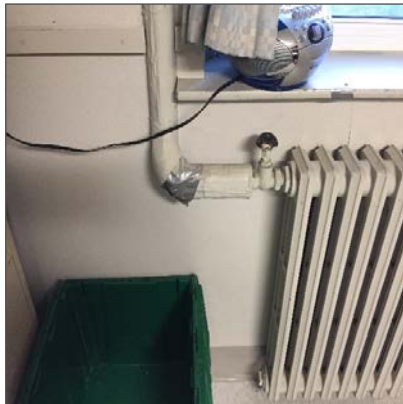
Photo 1 – Asbestos-containing parging cement on pipe fitting, fair condition, Office across from Boiler Room, Front Wing Basement.

Material, Quantity, Condition, & Photo #	Location	Recommended Procedure
Parging cement on pipe fitting, 1 fitting, fair condition, Photo 1	Office across from Boiler Room, Basement of Front Wing	Repair in accordance with Type 2 asbestos procedures
Parging cement on pipe fittings, 3 fittings, fair condition, Photo 2	Mechanical Room 1, East Basement of Middle Wing	Repair in accordance with Type 2 asbestos procedures
Parging cement on pipe fitting, 1 fitting, fair condition, Photo 3	Mechanical Room 1, East Basement of Middle Wing	Repair in accordance with Type 2 asbestos procedures
Parging cement on pipe fitting, 2 hangers, fair condition, Photo 4	Electrical Room at File Rooms, East Basement of Middle Wing	Repair in accordance with Type 2 asbestos procedures
Parging cement on pipe fitting, 1 fitting, fair condition, Photo 5	Basement Mechanical Room, ER Wing	Repair in accordance with Type 2 asbestos procedures

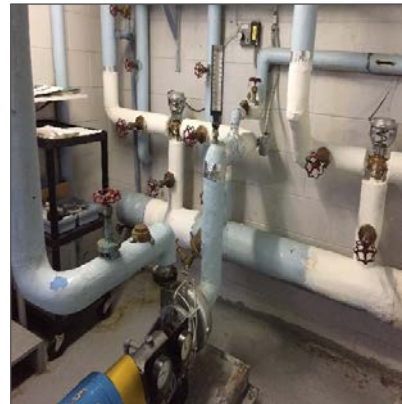
Photo 2 – Asbestos-containing parging cement on pipe fittings, fair condition, Mechanical Room 1, East Basement of Middle Wing.

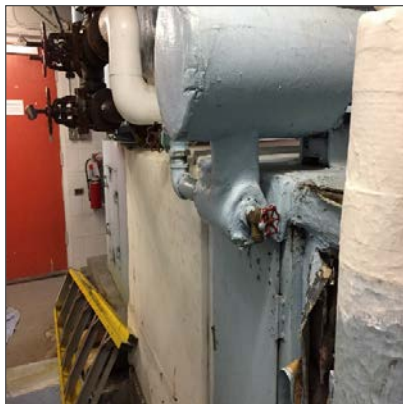
Photo 3 – Asbestos-containing parging cement on pipe fitting, fair condition, Mechanical Room 1, East Basement of Middle Wing.

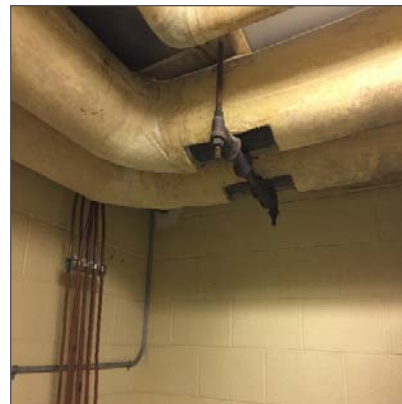
Photo 4 – Asbestos-containing parging cement unjacketed at pipe hangers, fair condition, Electrical Room at File Storage, East Basement of Middle Wing.

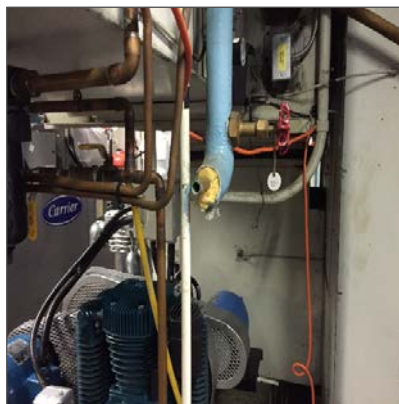
Photo 5 – Damaged asbestos-containing parging cement on pipe fitting, Basement Mechanical Room, ER Wing.

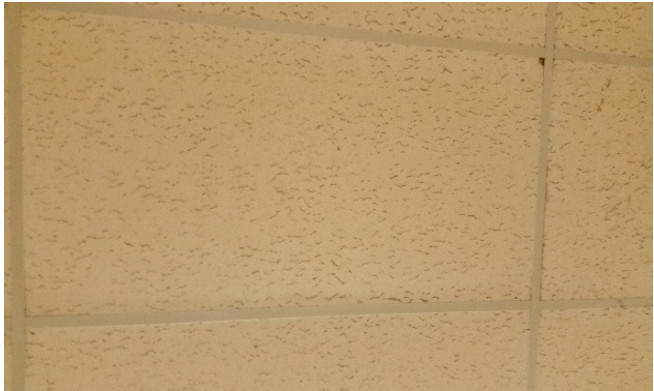
TABLE V Summary of Ceiling Tiles (CT)				
MIN	Description	Sample Number	Results	Photograph
CT4	2'x4' Ceiling Tile - Fissures and Small Pinholes	17429-WL-FWG-04A to 04C	2% Chrysotile
