Asbestos Reassessment

Hamilton General Hospital
237 Barton Street East,
Hamilton, Ontario

January 13, 2025

Pinchin File: 336568.061

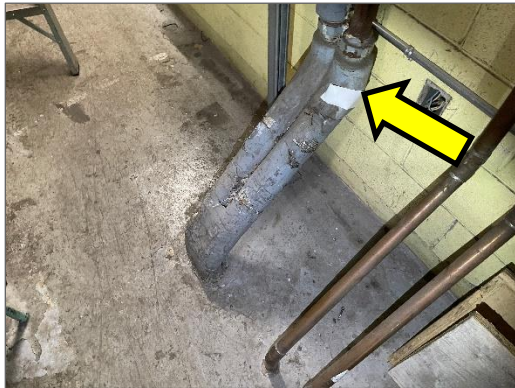
Photo 1

Remaining pipes are either uninsulated or insulated with fiberglass or other non-asbestos insulation such as mineral fibre or elastomeric foam insulation.

Pipes insulated with friable and non-friable asbestos insulations may also be present in inaccessible spaces such as above solid ceilings, in chases, in column enclosures and within shafts.

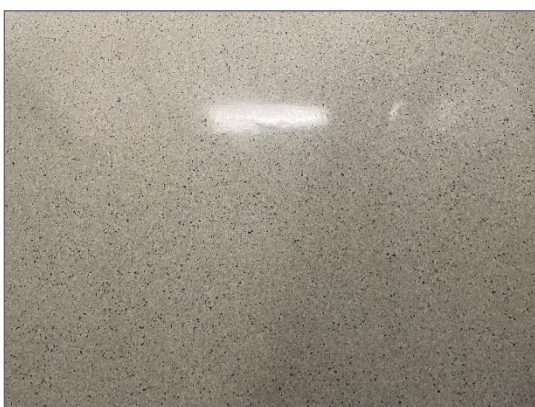
Photo 1

Remaining sheet flooring present throughout the East Wing is presumed to be non-asbestos based on historical knowledge of the type of flooring (linoleum without a paper backing layer).

Mastic under linoleum sheet flooring throughout the second floor does not contain asbestos (S0013A-C, lab reference no. b250814). Mastic under remaining sheet flooring throughout the East Wing is presumed to contain asbestos until further sampling can prove otherwise.

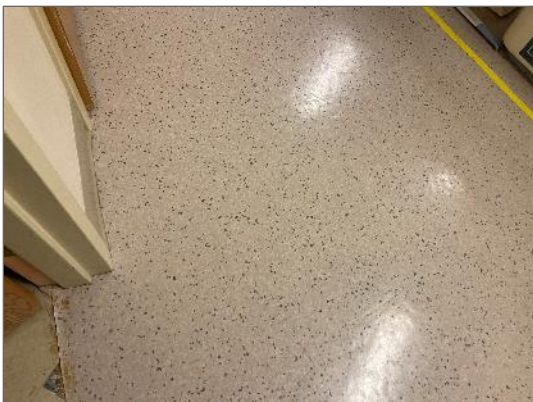
Photo 1

Remaining sheet flooring present throughout the Main Building is presumed to be non-asbestos based on the type of flooring (linoleum without paper backing layer).

Mastic under sheet flooring throughout the Main Building does not contain asbestos (samples S0010A-C, S0011A-C, S0012A-C, S0013A-C, S0014A-C, S0015A-C, and S0016A-C, lab reference no. b260248).

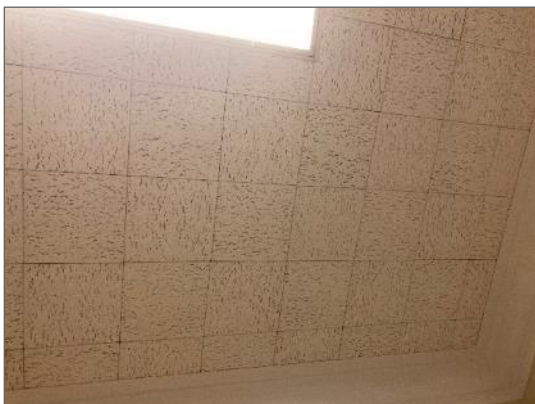
Photo 1

Size, Type, Pattern, Photo #	Sample Number, lab ref no.	Asbestos Type (tile)	Asbestos Type (mastic)
12" x 12", glue-on, scattered dot and fissures, photo 1	023A, b54869	Chrysotile and Amosite	Presumed
12" x 12", glue-on, medium and small pinholes, photo 2	ECOH samples 17429-HGMC2-04A-C	Amosite	Presumed
24" x 24", lay-in, pinhole and texture	019A-C, b54869	None detected	N/A

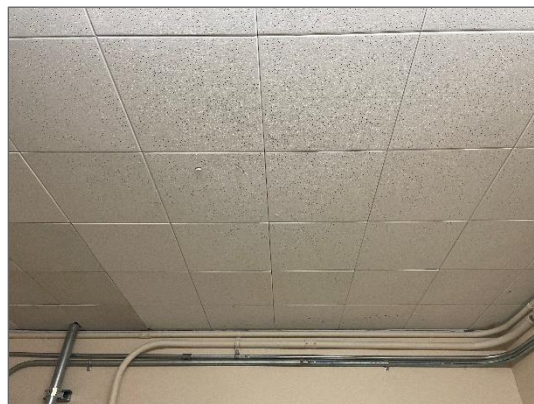
Photo 2

Sampling performed by ECOH in 2017 confirmed the remaining patterns of acoustic ceiling tiles to be non-asbestos (refer to the ECOH bulk sampling report in Appendix II of the Asbestos Analytical Results Report on the HMIS 2.0 online database).

All remaining types of acoustic ceiling tile are presumed to be non-asbestos based on the date of manufacture determined from the date stamp applied to the top of the tiles. The tiles were manufactured after asbestos stopped being used in acoustic ceiling tiles.

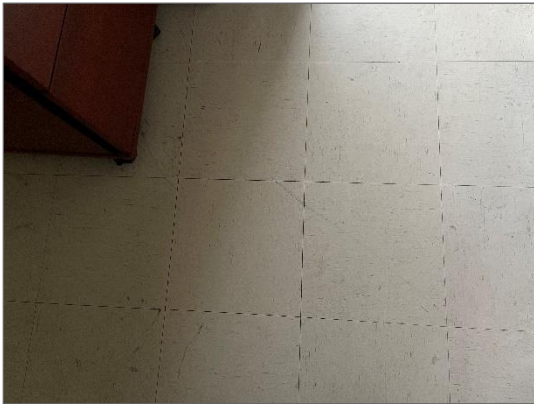
Photo 1

Size, Pattern, Colour, Photo #	Sample Number, lab ref no.	Asbestos Type (tile)	Asbestos Type (mastic)
12" x 12", beige with black line, photo 1	018A-C, b54869	Chrysotile	None detected
12" x 12", beige with brown streaks	S0004A-C, 71962345	None detected	None detected
12" x 12", cream with blue flecks	S0006A-C, 71962345	None detected	None detected
12" x 12", pink dense fleck	S0007A-C, 71962345	None detected	None detected

Asbestos-containing vinyl floor tiles are present below non-asbestos sheet flooring throughout the Wing. The asbestos-containing tiles should also be assumed to be present under non-asbestos vinyl floor tiles. Mastic below the floor tiles is presumed to contain asbestos.

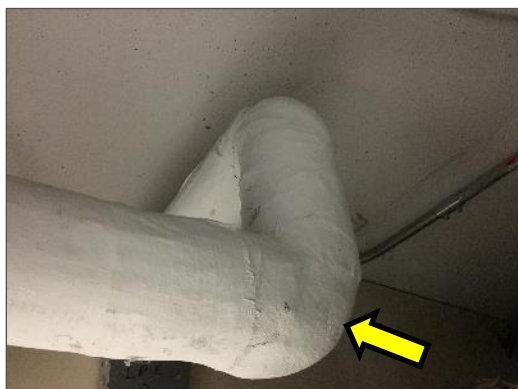
Photo 1

Remaining pipes are either uninsulated or insulated with non-asbestos fibreglass.

Pipes insulated with asbestos-containing insulations may be present in inaccessible spaces such as above solid ceilings, in chases, in column enclosures and within shafts.

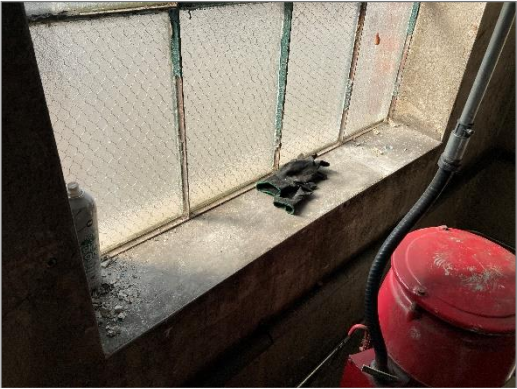
ASBESTOS											
System	Component	Material	Friable	Item	Covering	Access	Visible	Fair	Poor	Unit	Recommended Procedure
Other	Debris	Caulking, white	NF			B	Y		2	SF	Clean up using Type 2 asbestos procedures
