# Asbestos Reassessment

Juravinski Hospital  
711 Concession Street,  
Hamilton, Ontario

January 8, 2025

Pinchin File: 336568.061

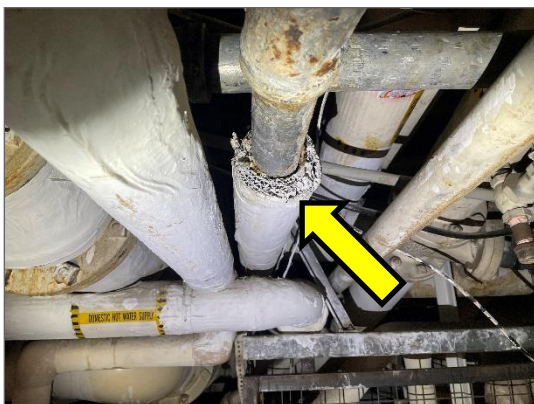
Photo 3

A white corrugated paper insulation (trade name Aircell, photo 3), containing chrysotile asbestos (previously reported), is present on straight sections of hot water heating system pipes throughout the Basement of the M Wing.

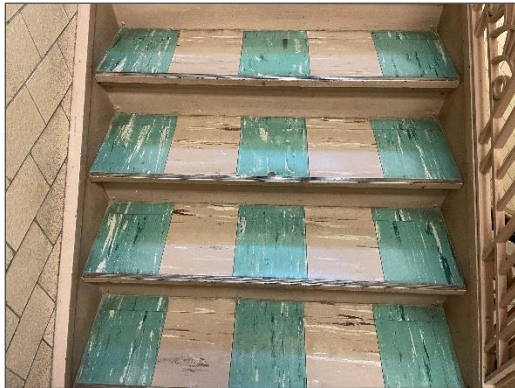
Photo 3

| Size, Colour/Pattern, Photo # | Sample Number, Lab ref no. | Asbestos Type (tile) | Asbestos Type (mastic) |
|--|---|---|---|
| 9" x 9", green with white flecks, photo 3 | 052a, b54898<br>2018-0001A, b195703 | Chrysotile | Chrysotile |

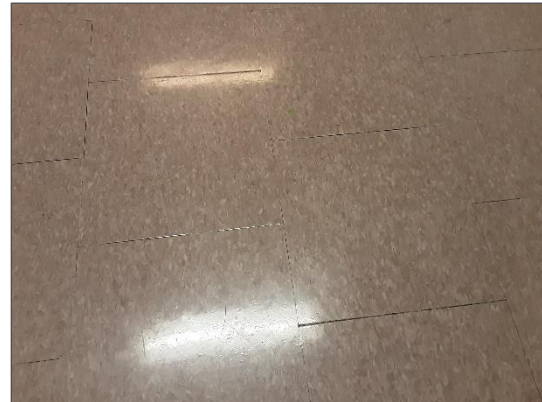
Photo 4

| Size, Colour/Pattern, Photo # | Sample Number, Lab ref no. | Asbestos Type (tile) | Asbestos Type (mastic) |
|--|---|---|---|
| 9" x 9", brown flecks, photo 4 | 022a, b54893 | Chrysotile | Chrysotile |

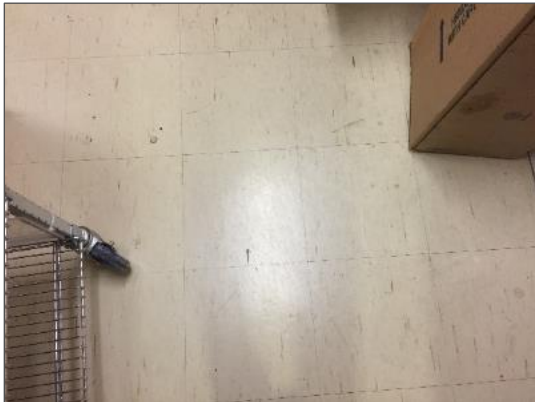
Photo 3 (photo taken during previous assessment)

| Size, Colour/Pattern, Photo # | Sample Number, Lab ref no. | Asbestos Type (tile) | Asbestos Type (mastic) |
|--|---|---|---|
| 12" x 12", beige with brown lines, photo 3 | 009a, b54892 | Chrysotile | None detected |

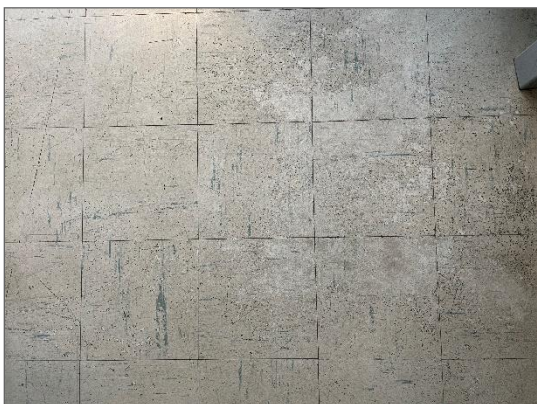
Photo 3

| Size, Colour/Pattern, Photo # | Sample Number, Lab ref no. | Asbestos Type (tile) | Asbestos Type (mastic) |
|---|---|---|--|
| 9" x 9", white with blue lines, photo 3 | 020a, b54893 | Chrysotile | None detected |

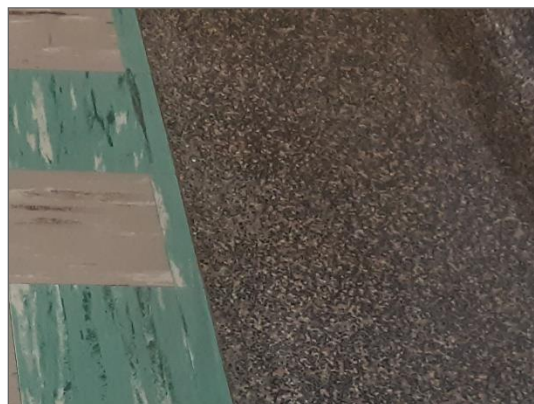
Photo 4

| Size, Colour/Pattern, Photo # | Sample Number, Lab ref no. | Asbestos Type (tile) | Asbestos Type (mastic) |
|---|---|---|--|
| 9" x 9", black and green flecks, photo 4 | 035a, b54895 | None detected | Chrysotile |

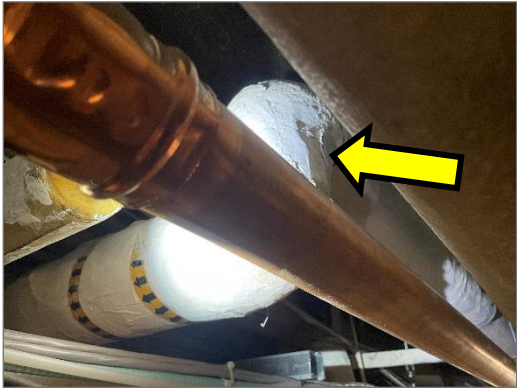
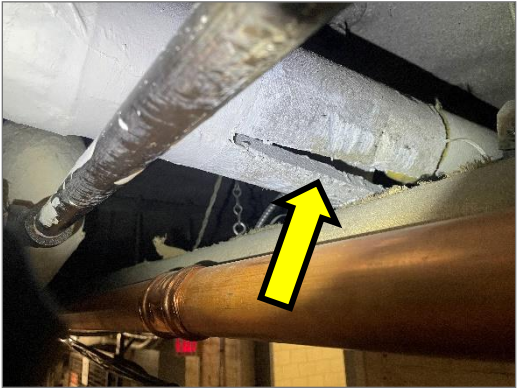
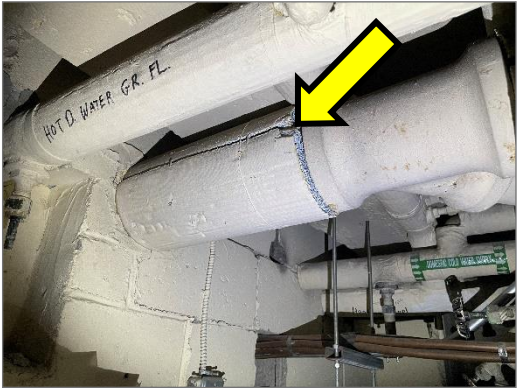
| ASBESTOS | | | | | | | | | | | |
|---|---|---|---|---|---|---|---|---|---|---|---|
| Piping | | Aircell | F | Insulation | | C | Y | 1 (6) | ( ) | LF | Type 2/ Repair |
| Piping | | Aircell | F | Insulation | | C | Y | 5 (6) | ( ) | LF | Type 2/ Repair |

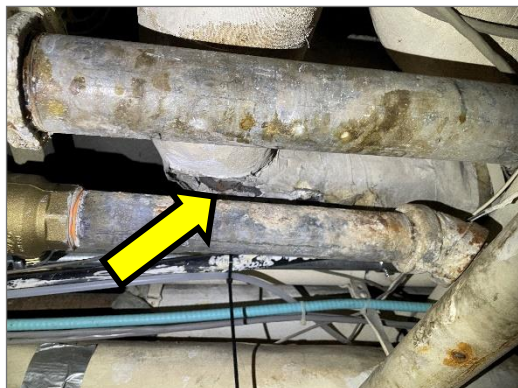
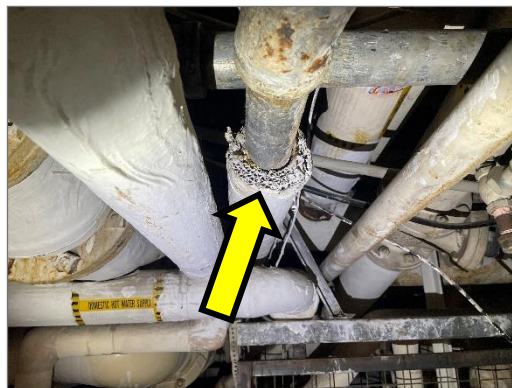
| ASBESTOS | | | | | | | | | | | |
|---|---|---|---|---|---|---|---|---|---|---|---|
| Piping | | Parging Cement | F | Fitting | | C | Y | () | 1 (3) | % | Type 2 Glove/bag |
| Piping | Hot Water Heating | Aircell | F | | | C | Y | 1 (6) | () | % | Type 2/ Repair |

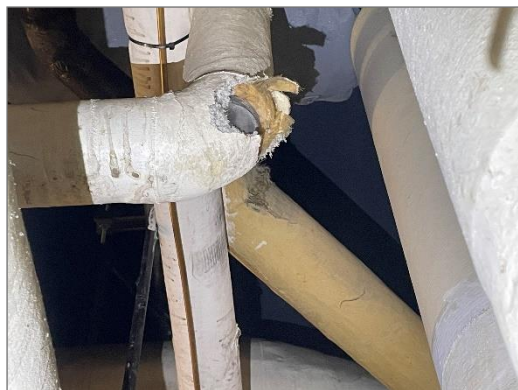
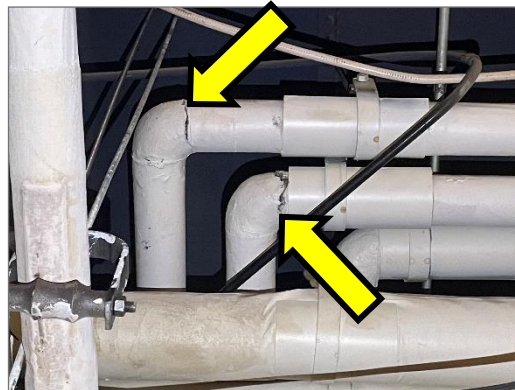
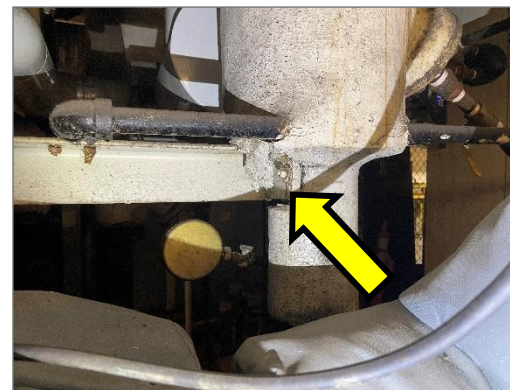
| System | Component | Material | Friable | Item | Covering | Access | Visible | Fair | Poor | Unit | Recommended Procedure |
|---|---|---|---|---|---|---|---|---|---|---|---|
| Piping | | Parging Cement | F | Fitting | | C | Y | 2 (6) | 1 (3) | EA | Type 2 Repair/ Glove/bag Removal |
