# Asbestos Reassessment

McMaster University Medical  
Centre (MUMC)  
1200 Main Street West,  
Hamilton, Ontario

January 23, 2025

Pinchin File: 336568.061

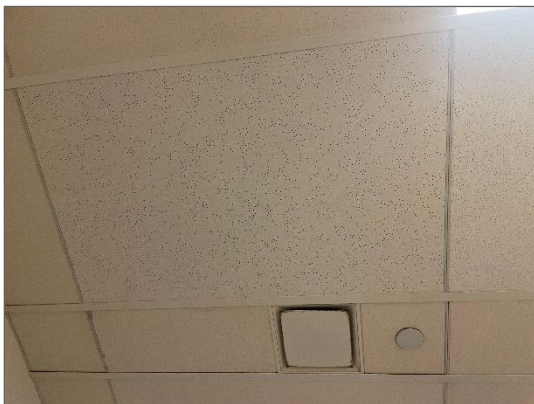
Photo 1

Rough plaster (photo 1) is present sporadically on perimeter shaft walls in the interstitial spaces (all quads, Locations 9001-9004). Seven samples of rough plaster were collected (samples S001A-C, lab reference no. b182855, S0014A-C, lab reference no. b247200, and sample S0031A, lab reference no. 10016154) and it was found that four samples contained actinolite/tremolite asbestos, with two samples containing more than 0.5% asbestos which is the definition of an asbestos-containing material under O. Reg. 278/05. The variable asbestos content is a result of vermiculite mixed into the plaster during

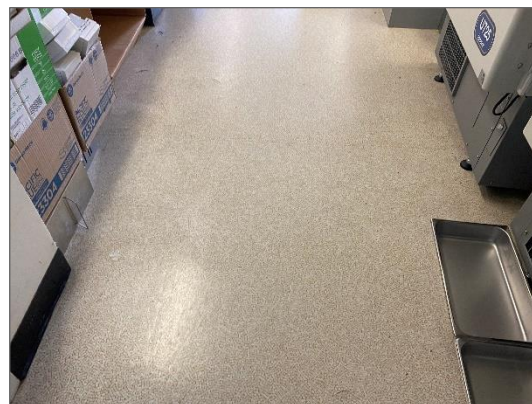
Photo 2

| Pattern, Colour, Photo # | Sample Number, Lab Ref No. | Asbestos |
|---|---|---|
| Brown with white squares photo 2 | 038A, b54506 | Yes |

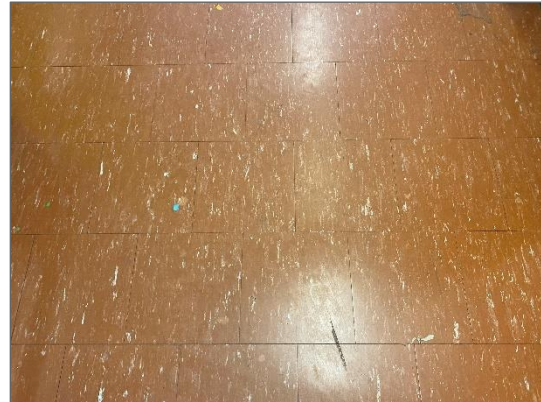
Photo 2

| Size, Pattern, Colour, Photo # | Example Location (Quad, Location #) | Sample Number, lab reference no. | Asbestos (tile) | Asbestos (mastic) |
|---|---|---|---|---|
| 12" x 12", red with white streaks, photo 2 | Biochem Teaching Lab (Purple, Location 1044) | 015A, b54379 | Yes | Yes |

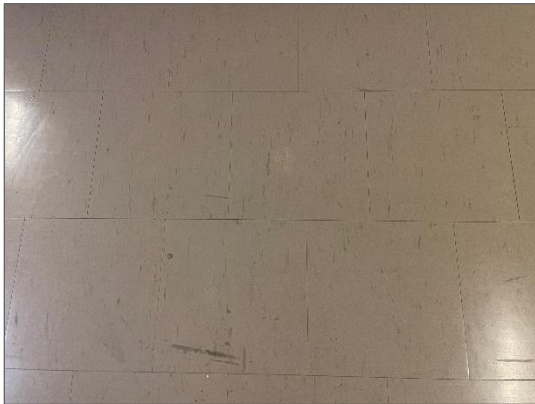
Photo 3

| Size, Pattern, Colour, Photo # | Example Location (Quad, Location #) | Sample Number, lab reference no. | Asbestos (tile) | Asbestos (mastic) |
|---|---|---|---|---|
| 12" x 12", beige with brown lines, photo 3 | Corridor/Storage (Purple, Location 1017) | 020A, b54380 | Yes | Yes |

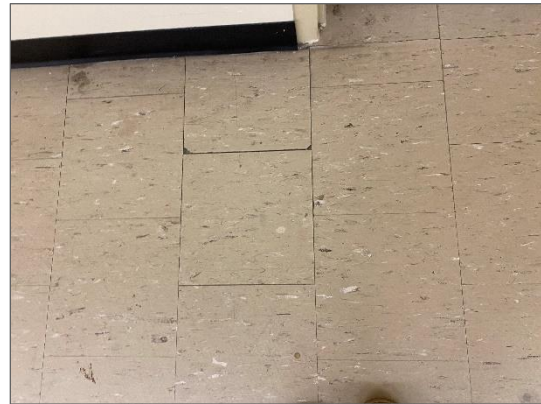
Photo 4

| Size, Pattern, Colour, Photo # | Example Location (Quad, Location #) | Sample Number, lab reference no. | Asbestos (tile) | Asbestos (mastic) |
|---|---|---|---|---|
| 12" x 12", beige with black and white streaks, photo 4 | Female Locker Room (Purple, Location 1034) | S022a, b54381 | Yes | Yes |

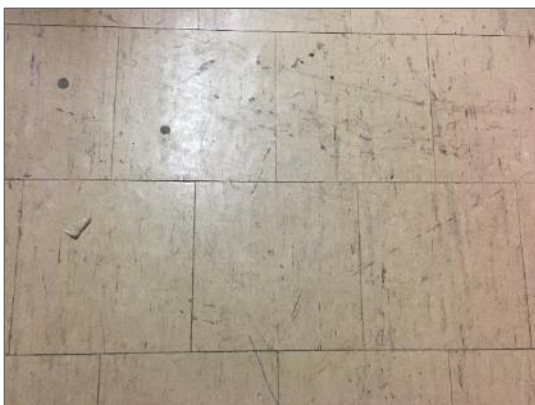
Photo 5

| Size, Pattern, Colour, Photo # | Example Location (Quad, Location #) | Sample Number, lab reference no. | Asbestos (tile) | Asbestos (mastic) |
|---|---|---|---|---|
| 12" x 12", beige with black streaks, photo 5 | Maintenance Shop (Red, Location 1012) | S023a, b54381 | Yes | Yes |

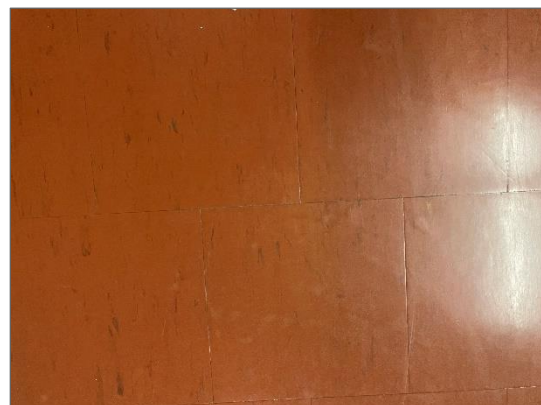
Photo 6

| Size, Pattern, Colour, Photo # | Example Location (Quad, Location #) | Sample Number, lab reference no. | Asbestos (tile) | Asbestos (mastic) |
|---|---|---|---|---|
| 12" x 12", red with black streaks, photo 6 | Corridor (Blue, Location 1026) | S025a, b54381 | Yes | Yes |

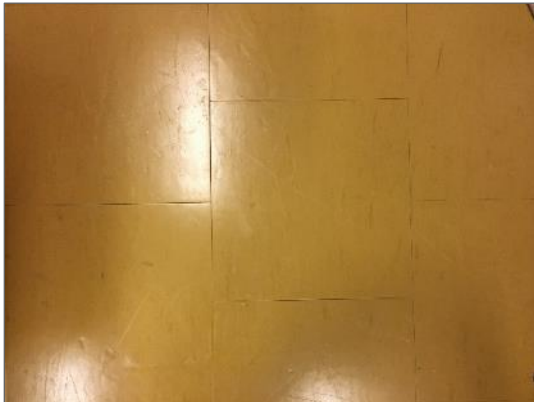
Photo 7

| Size, Pattern, Colour, Photo # | Example Location (Quad, Location #) | Sample Number, lab reference no. | Asbestos (tile) | Asbestos (mastic) |
|---|---|---|---|---|
| 12" x 12", yellow, photo 7 | Office (Blue, Location 1108) | S026a-c, b54381 | Yes | None Detected |

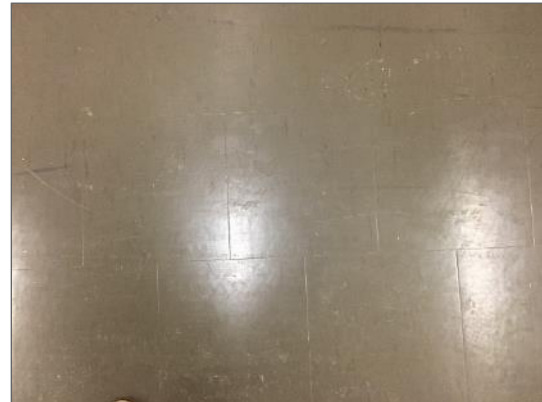
Photo 8

| Size, Pattern, Colour, Photo # | Example Location (Quad, Location #) | Sample Number, lab reference no. | Asbestos (tile) | Asbestos (mastic) |
|---|---|---|---|---|
| 12" x 12", brown with dark brown streaks, photo 8 | Corridor (Blue, 1015) | 027A, b54505 | Yes | Presumed |

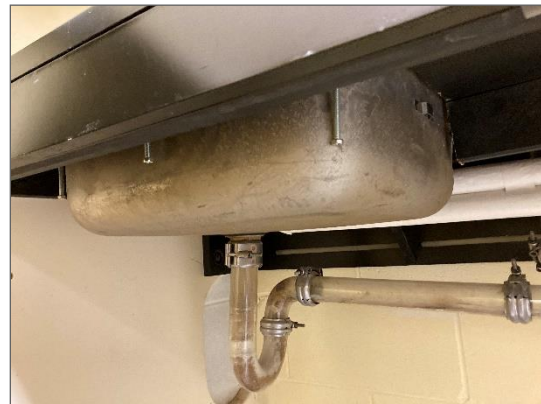
Photo 2

Gold mastic (photo 2), containing asbestos, is present as an undercoating on sinks throughout the building (sample 0001A, lab reference no. b129908 and sample S0023A, lab reference no. 10016154).

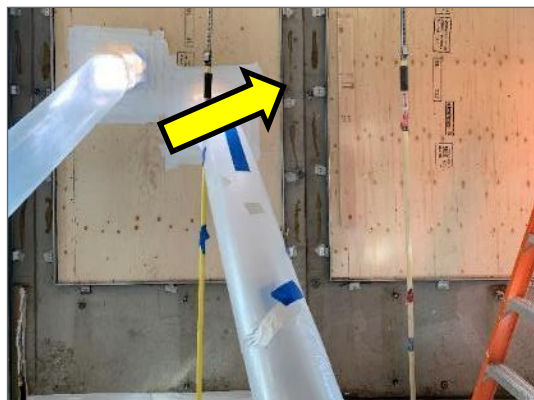
Photo 3 (photo from renovation project)

Adhesive (photo 3), containing asbestos (sample S0021A, lab reference no. b261784), is present behind rigid insulation on exterior precast panels. The material was discovered during a renovation project and is assumed to be present in similar applications in the building.

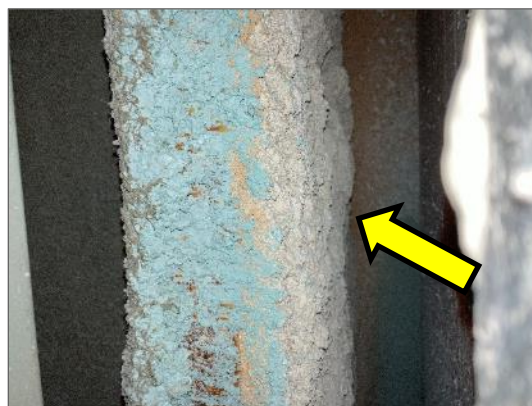
| Trade Name/Type, Photo # | Observations | Locations | Asbestos Type |
|---|---|---|---|
| Residual Monokote MK3 (spray-applied cementitious fireproofing), Photo 2 | Backside of columns,<br><b>unencapsulated</b> | Level 1 of Mechanical shafts 33, 34, 53, 55, 58, 73, 78 and presumed in others | Chrysotile |

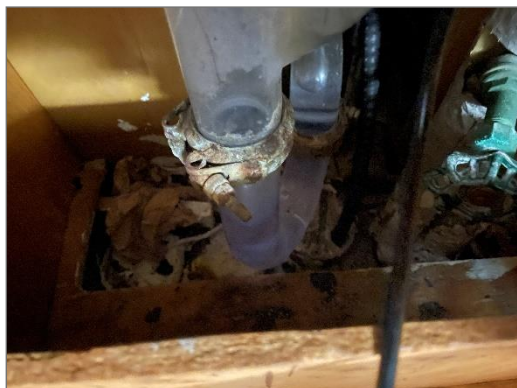
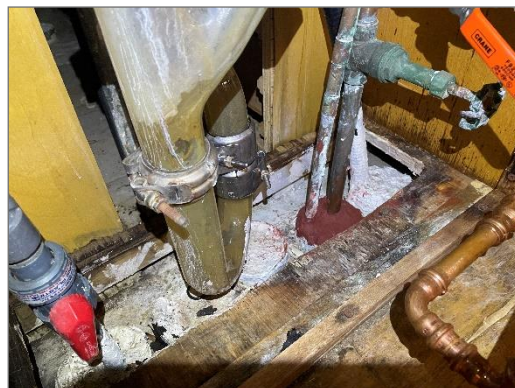
| ASBESTOS | | | | | | | | | | | |
|---|---|---|---|---|---|---|---|---|---|---|---|
| Other | Sink | Mastic, Black, UNDERCOATING (Photo 7 & 8) | NF | Debris | | A | N | () | 2 (3) | SF | Clean up following Type 1 asbestos procedures |
