Asbestos Reassessment

St. Peter's Hospital
88 Maplewood Avenue,
Hamilton, Ontario

December 30, 2024

Pinchin File: 336568.061

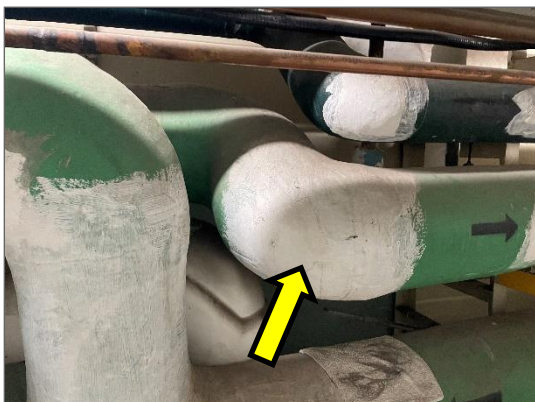
Photo 1

Remaining pipes in the Boiler House and Steam Tunnel are either uninsulated or insulated with non-asbestos fibreglass.

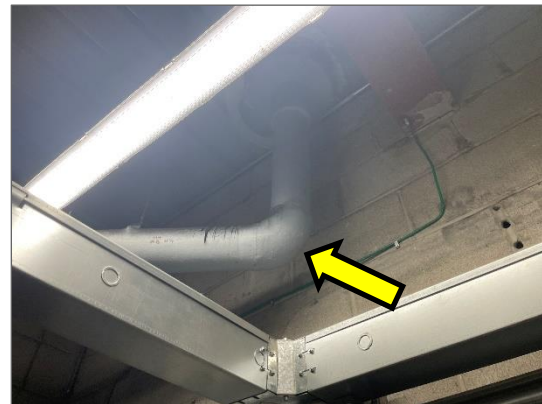
Photo 2

Parging cement (photo 2), presumed to contain asbestos is present on pipe fittings (elbows) on the rainwater leader system within the Elevator Mechanical Room (Location 5004).
