# Asbestos Reassessment

West Lincoln Memorial Hospital  
169 Main Street East, Grimsby,  
Ontario

## Hamilton Health Sciences

December 17, 2024

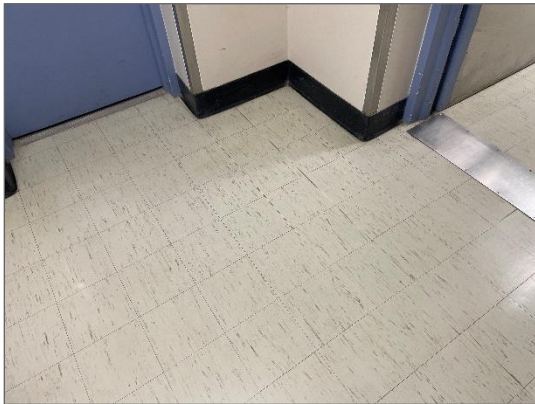
Photo 3

| Size, Pattern, Colour, Photo # | Sample Number, lab ref no. | Asbestos Type (tile) | Asbestos Type (mastic) |
|---|---|---|---|
| 9" x 9", beige with grey streaks, photo 3 | 0019A, 1407247 | Chrysotile | Chrysotile |

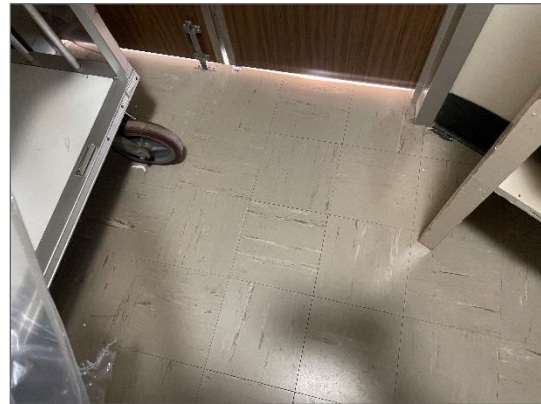
Photo 4

| Size, Pattern, Colour, Photo # | Sample Number, lab ref no. | Asbestos Type (tile) | Asbestos Type (mastic) |
|---|---|---|---|
| 9" x 9", grey with brown and white streaks, photo 4 | 0044A, 1407247 | Chrysotile | Chrysotile |

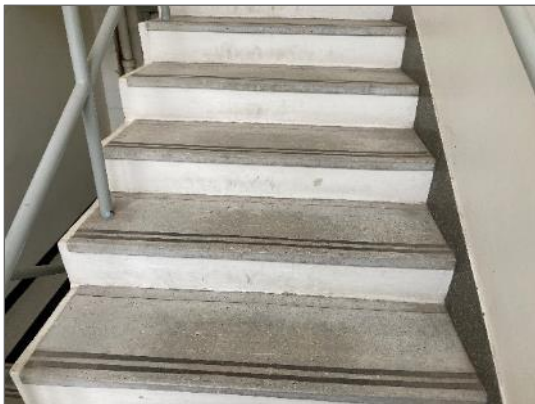
Photo 5 (2023 photo)

| Size, Pattern, Colour, Photo # | Sample Number, lab ref no. | Asbestos Type (tile) | Asbestos Type (mastic) |
|---|---|---|---|
| Stair tread, grey, photo 5 | N/A | Presumed | Presumed |

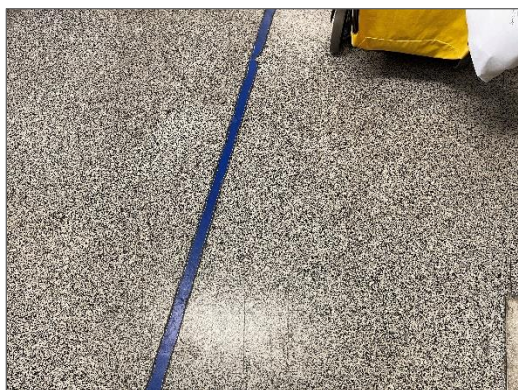
Photo 3

| Size, Pattern, Colour, Photo # | Sample Number, lab ref no. | Asbestos Type (tile) | Asbestos Type (mastic) |
|---|---|---|---|
| 12" x 12", black and white flecks, photo 3 | 2018-0007A-C,<br>b195704 | None detected | Chrysotile |

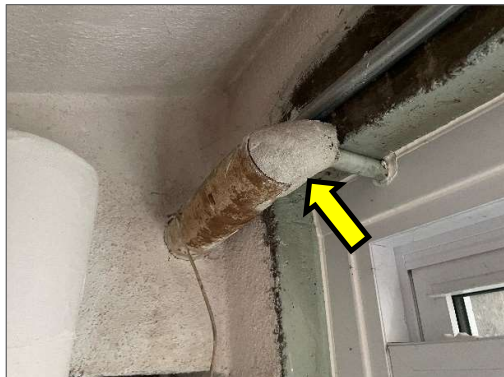
| ASBESTOS | | | | | | | | | | | |
|---|---|---|---|---|---|---|---|---|---|---|---|
| Piping | | Parging Cement | F | Fitting | | C | Y | 1 (6) | ( ) | EA | Photo 5 - Repair using Type 2 Procedures |

Mould was also observed on the jacketing of asbestos-containing pipe insulation.
