# FINAL **Asbestos Reassessment**

St. Peter's Hospital  
88 Maplewood Avenue, Hamilton,  
Ontario

January 16, 2019

Pinchin File: 217420.030

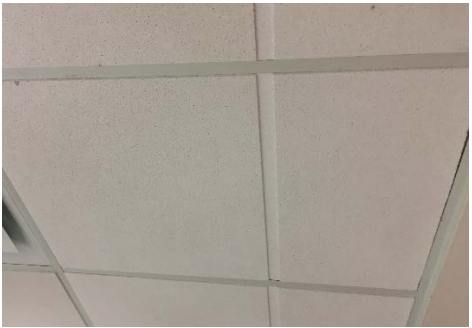
| <b>TABLE V</b><br>Summary of Ceiling Tiles (CT) | | | | |
|---|---|---|---|---|
| CT1 | Ceiling Tile<br>2x4 Light<br>Pinprick | Not Sampled<br>New Ceiling<br>Tile | N/A | |

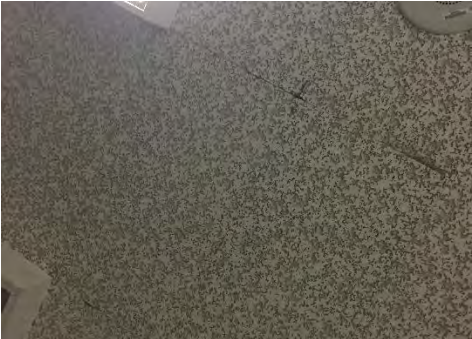
The 12" x 24" glued-on acoustic ceiling tiles with a large fissure pattern were determined to be non-asbestos by analysis (HHS samples S04a-c, March 22, 2013). Sampling by ECOH in 2017 also determined these ceiling tiles to be non-asbestos (samples 174-SPH-EW1-03A-C). A non-asbestos coating is present on the surface of these tiles.

| <b>TABLE V</b><br>Summary of Ceiling Tiles (CT) | | | | |
|---|---|---|---|---|
| CT2 | 1x2 Glue on<br>Large Fissure<br>Pattern | 17429-SPH-<br>EW1-03A to<br>03C | None<br>Detected | |

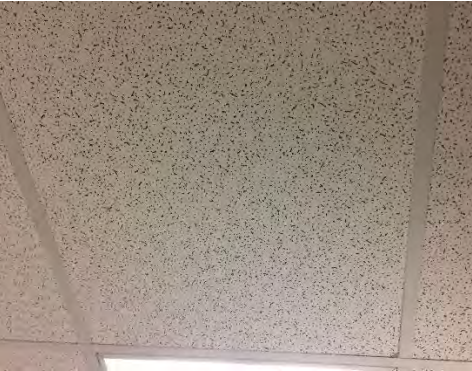
| <b>TABLE V</b><br>Summary of Ceiling Tiles (CT) | | | | |
|---|---|---|---|---|
| CT3 | Ceiling Tile<br>2x4 Starfleck w/<br>Pinhole | Not Sampled<br>New Ceiling<br>Tile (Installed<br>in 2008) | N/A | |

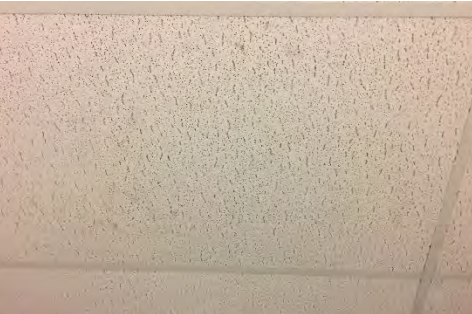
| <b>TABLE V</b><br>Summary of Ceiling Tiles (CT) | | | | |
|---|---|---|---|---|
| CT4 | Ceiling Tile<br>2x4 Width<br>Fissures w/<br>Random Pinhole | Not Sampled<br>New Ceiling<br>Tile (Installed<br>in 2008) | N/A | |

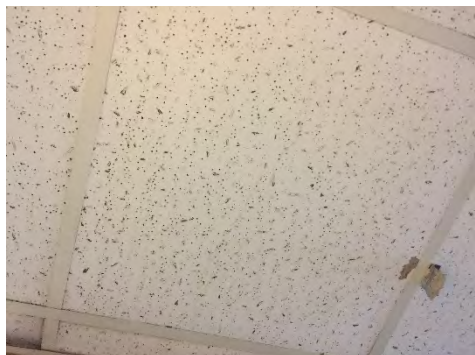
| <b>TABLE V</b><br>Summary of Ceiling Tiles (CT) | | | | |
|---|---|---|---|---|
| CT6 | Ceiling Tile 2x4 Long Skinny Random Fissures w/ Random Pinhole | 17429-SPH-EW0-04A to 04C | None Detected | |

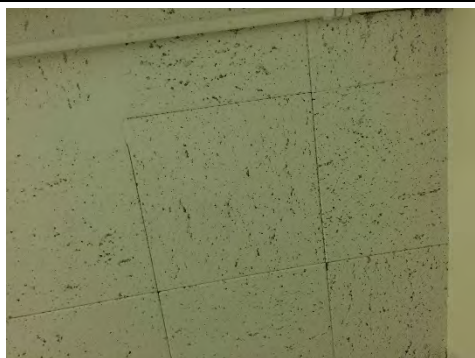
| <b>TABLE V</b><br>Summary of Ceiling Tiles (CT) | | | | |
|---|---|---|---|---|
| CT7 | 1x1 Glue-on Random Fissures/Flecks and Pinholes | 17429-SPH-S0-07A to 07C | None Detected | |

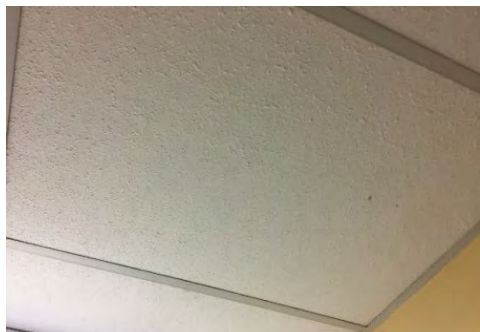
| <b>TABLE V</b><br>Summary of Ceiling Tiles (CT) | | | | |
|---|---|---|---|---|
| CT8 | Ceiling Tile 2x4 Textured Finish | Not Sampled New Ceiling Tile | N/A | |
