FINAL
Asbestos
Reassessment

West Lincoln Memorial Hospital
169 Main Street East, Grimsby,
Ontario

January 17, 2019

Pinchin File: 217420.030

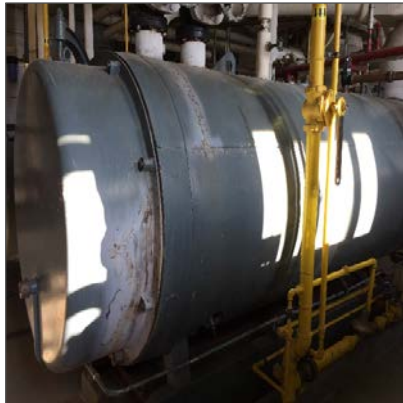
Due to the presence of metal jacketing on the boilers in the Boiler Room, it was not possible to determine if asbestos-containing insulation is present beneath the jacket. Destructive testing is required prior to demolition. It was common in boiler construction in the past to install asbestos-containing refractory materials, or a layer of asbestos-containing insulation between the boiler plate and the internal refractory materials. The exterior chimney is constructed with brick, however asbestos-containing refractory may be present inside the Chimney.

Suspect asbestos-containing insulation below metal jacketing on boiler, Basement Boiler Room.

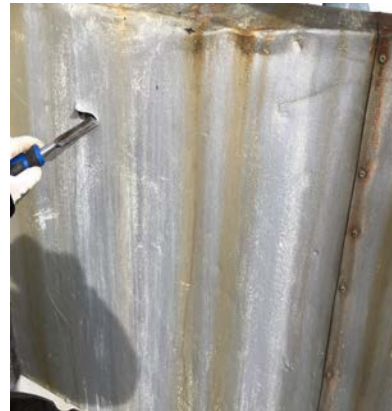
Preformed block insulation, containing amosite asbestos, covered with parging cement, containing chrysotile asbestos, is present on boiler breeching at the exterior of the Boiler Room to the Chimney (samples S063A-C). Both insulations are friable, jacketed with metal jacketing and are in good condition.

Asbestos-containing preformed block and parging cement insulation below metal jacketing on boiler breeching, Exterior of Basement Boiler Room to Chimney.

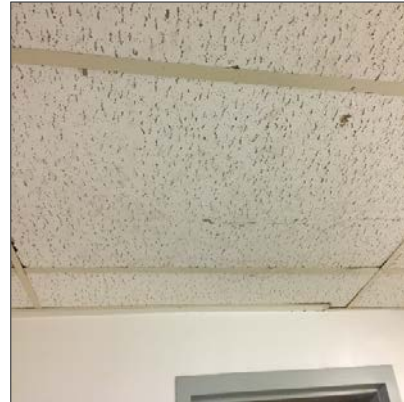
Photo 2 – Non-asbestos 24" x 48" lay-in ceiling tile, pinhole, indent, and deep width-wise fissures, Basement Corridor.

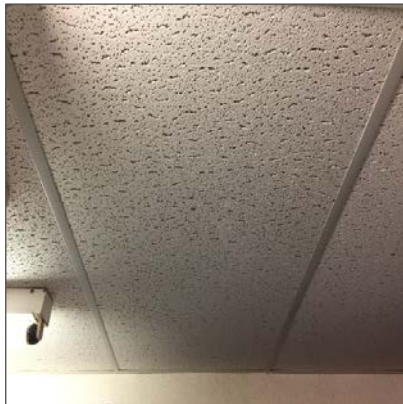
Photo 3 – Non-asbestos 24" x 48" lay-in ceiling tiles, dense pinhole and width-wise fissure, Basement Office at Sprinkler Room.

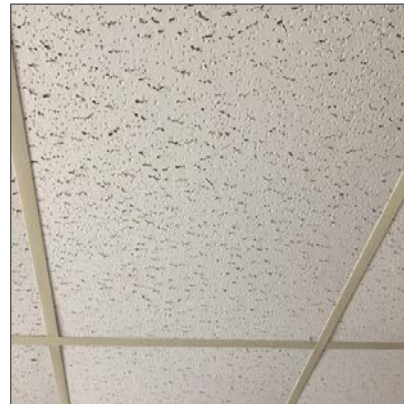
Photo 4 – Non-asbestos 24" x 24" lay-in ceiling tiles, pinhole, indent, and width-wise fissures, Basement Office.

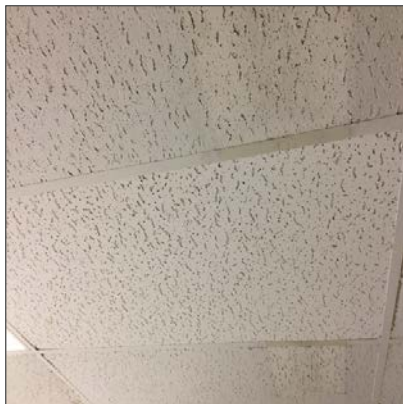
Photo 5 - 24" x 48" lay-in ceiling tile, pinhole and fewer width-wise fissure, Basement Corridor.

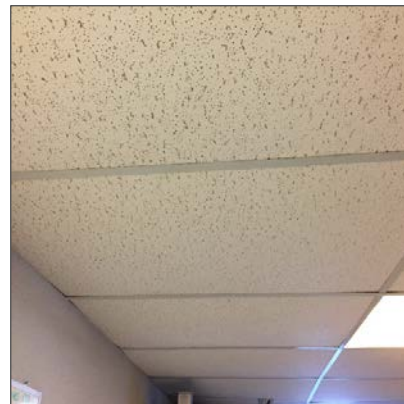
Photo 6 – Non-asbestos 24" x 48" lay-in ceiling tiles, pinhole and short width-wise fissures, Office across from Boiler Room, Basement.

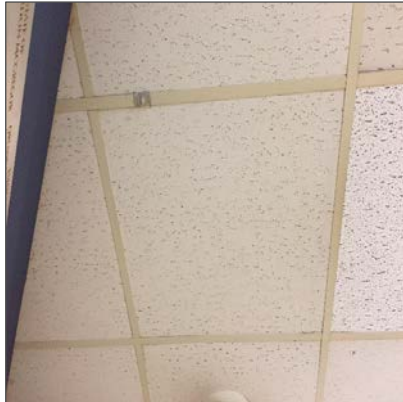
Photo 7 – Non-asbestos 24" x 24" lay-in ceiling tiles, few pinhole and width-wise fissure, Ground Floor Front Entrance.

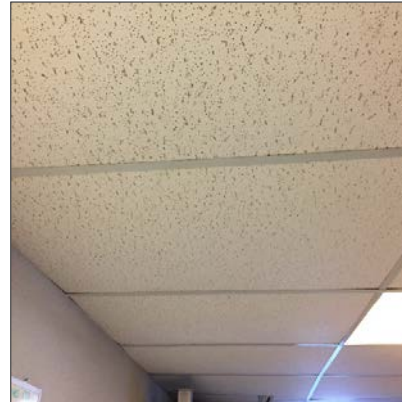
Photo 8 – Non-asbestos 24" x 48" lay-in ceiling tiles, pinhole and short width-wise fissures, Office across from Boiler Room, Basement.

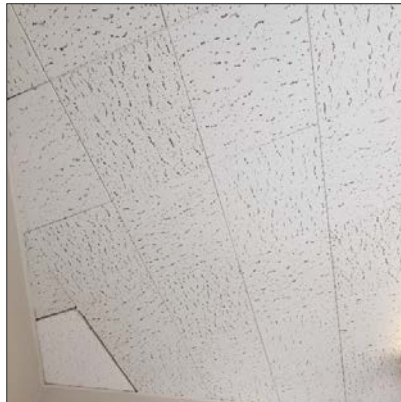
Photo 9 – Non-asbestos 12" x 12" glued-on ceiling tiles, pinhole and fissures, First Floor Corridor.

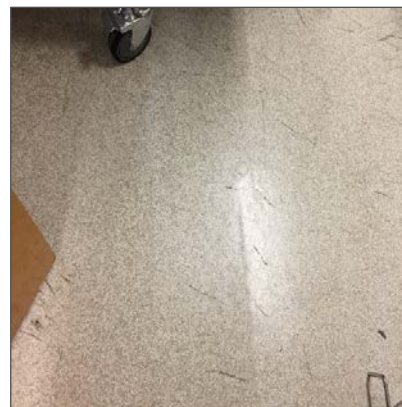
The vinyl sheet flooring is non-friable but can become friable upon removal. Vinyl sheet flooring is in good condition. Mastic, where presumed to be asbestos-containing, is a non-friable material.

Photo 2 – Asbestos-containing vinyl sheet flooring, grey and white square pattern, First Floor Medical Storage.

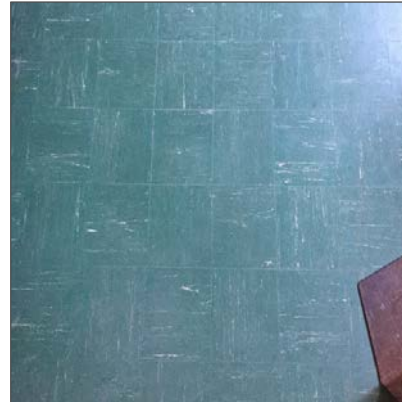
The vinyl floor tiles are non-friable and are in good condition.

Photo 2 - Asbestos-containing 9" x 9" vinyl floor tiles, green with white streaks, Basement Inventory Storage.

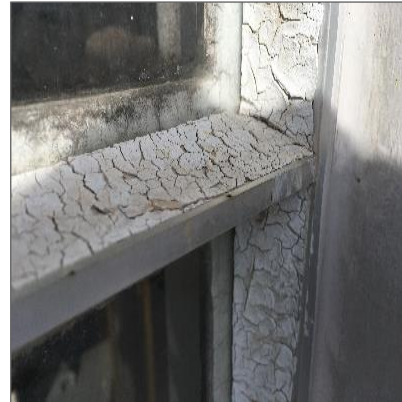
Asbestos-containing white caulking at interior windows – Boiler Room (samples S066A-C).

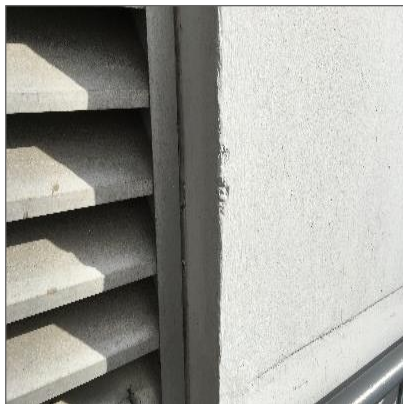
Non-asbestos grey caulking was observed around the exterior frames of louvres, windows and doors at the Boiler Room (samples S067A-C).

Non-asbestos grey caulking around the exterior frames of louvres – Exterior Boiler Room (samples S067A-C).

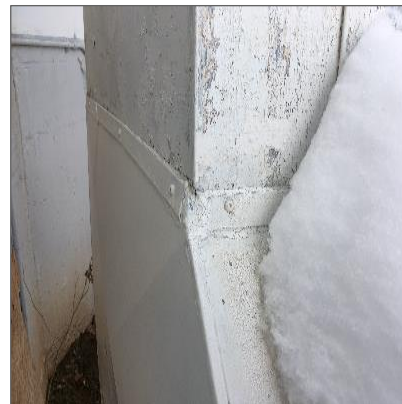
Non-asbestos white caulking at the pleats on the exterior duct work for the HVAC unit – Exterior Boiler Room (samples S068A-C).

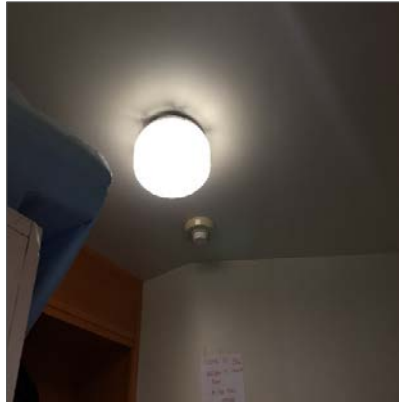
Asbestos-containing paper heat shield in incandescent light fixture, First Floor Storage Closet.

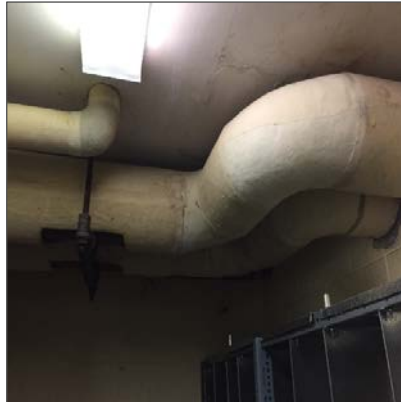
Asbestos-containing parging cement on pipe fittings, Basement File Storage Room.

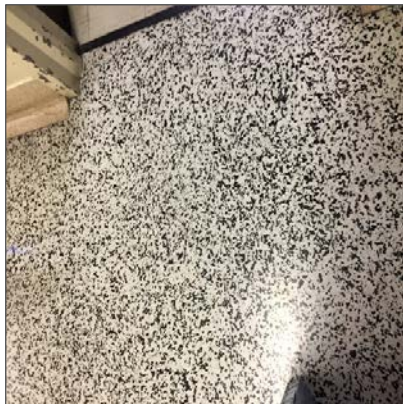
Photo 3 – Non-asbestos 12" x 12" vinyl floor tiles, larger white and black flecks, First Floor Corridor and Operating Room.

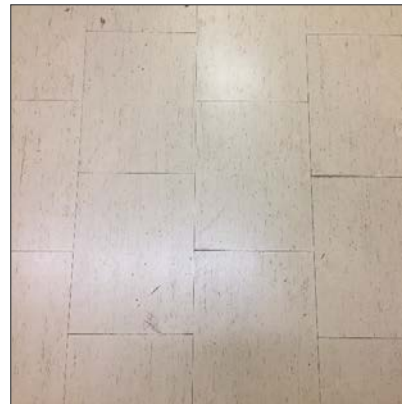
Photo 4 – Asbestos-containing 12" x 12" vinyl floor tiles, beige with thin brown streaks, Basement Locker Room at ER Wing.

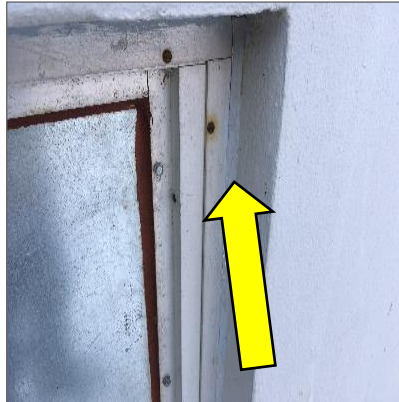
Non-asbestos grey caulking was observed at the exterior window in Mechanical Room #1 (samples S070A-C).

Non-asbestos grey caulking on window, Mechanical Room #1.

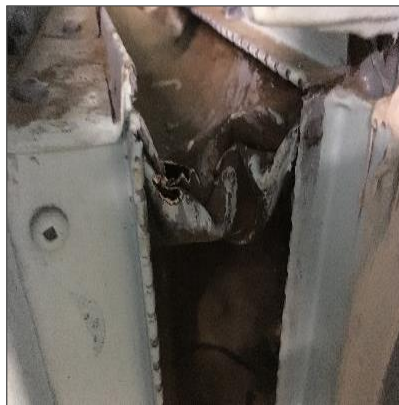
Non-asbestos textile vibration dampers are present at duct connections in Mechanical Room #1 (samples S069A-C).

Non-asbestos textile vibration damper, Mechanical Room #1.

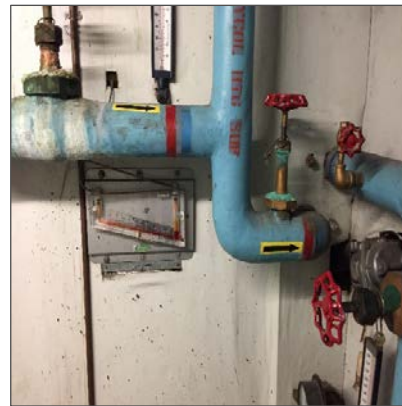
Asbestos-containing parging cement on pipe fittings, Basement Mechanical Room.

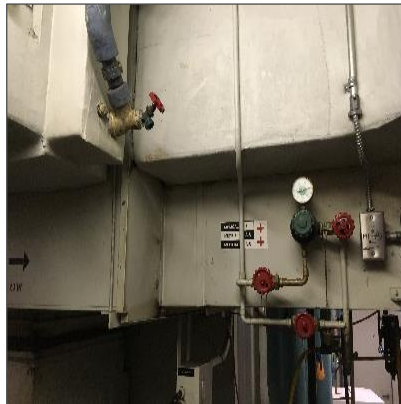
Asbestos-containing paper over fiberglass insulation – Mechanical Room #3 (sample S072A-C).

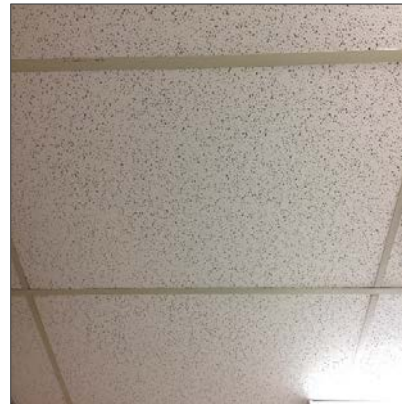
Non-asbestos 24" x 48" lay-in ceiling tiles, pinhole and small fleck pattern, Basement ECG Department.

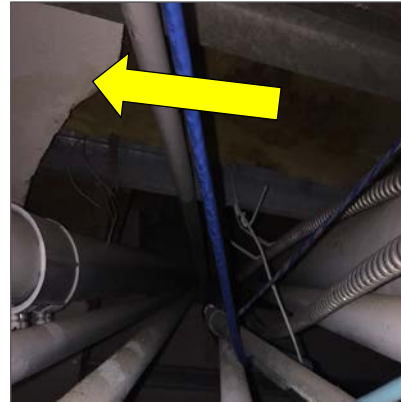
Transite board above slanted lay-in ceiling tiles, north end of Basement Main Corridor.

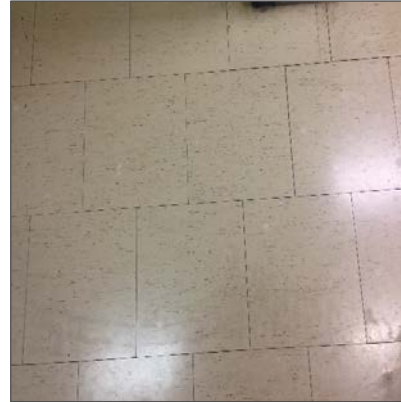
Photo 2 - Asbestos-containing 12" x 12" vinyl floor tiles, beige with thin brown streaks, Basement Locker Room at ER Wing.

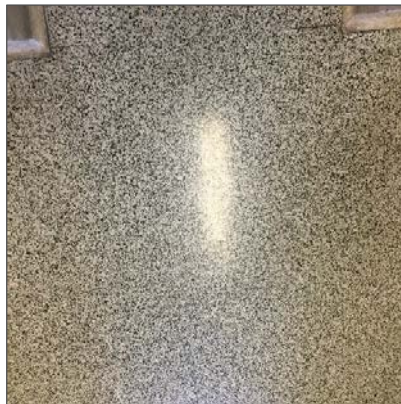
Photo 3 – Asbestos-containing mastic under non-asbestos 12" x 12" vinyl floor tiles, smaller black and white flecks, Ground Floor ER Corridor.

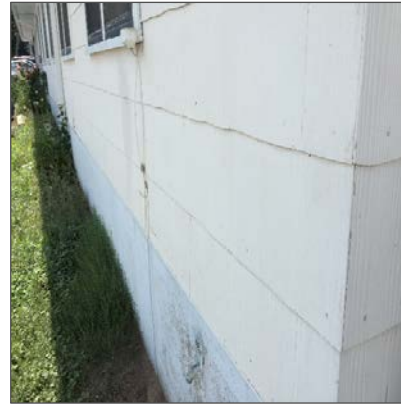
Transite exterior siding, Building Exterior.
