FINAL
Asbestos
Reassessment

Hamilton General Hospital
237 Barton Street East, Hamilton,
Ontario

Hamilton General Hospital, 237 Barton Street East, Hamilton, Ontario
Hamilton Health Sciences

January 16, 2019
Pinchin File: 217420.030
FINAL

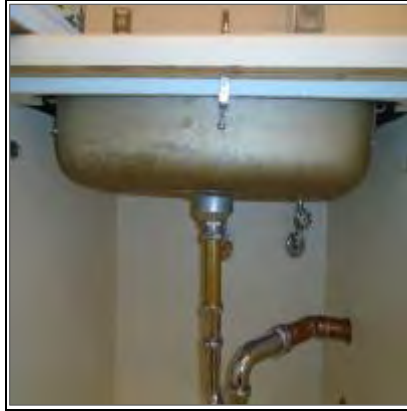
Asbestos-containing metallic undercoating on the bottom of a sink, Level 2 Operating Area.

Metallic undercoating, containing chrysotile asbestos, is present on sinks within the Main Building (200249.059 sample 007A). Sink undercoating is non-friable and in good condition.

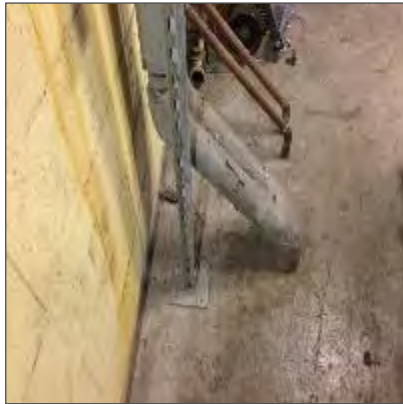
Asbestos-containing paring cement on pipe fittings, East Wing Mechanical Penthouse.

Parging cement, containing chrysotile asbestos, is present on pipe fittings (elbows) at the south wall of the Penthouse (46653.007 sample S013A). Parging cement is a friable insulation, jacketed with canvas and is in good condition.

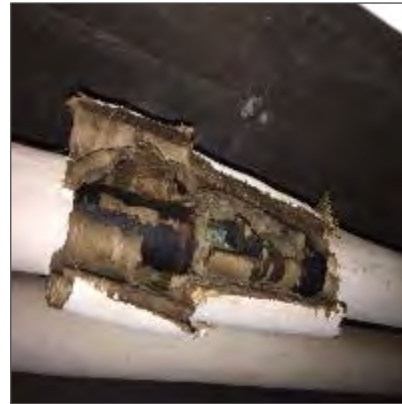
Suspect asbestos-containing Sweatwrap on pipe straight, Basement.

Sweatwrap insulation, (brown layered paper, presumed to contain asbestos, is present on straight sections of chilled water return system pipes in the Basement. Sweatwrap insulation is considered non-friable. Sweatwrap is jacketed with canvas and is in fair to good condition, with the exception of approximately five square feet of debris present within the Crawlspace on the far end of the Corridor. Presumed asbestos-containing parging cement is present at hangers supporting the pipe. Parging cement is a friable insulation and is in good condition.

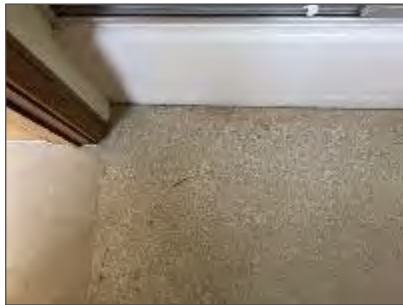
Photo 3 – Non-asbestos vinyl sheet flooring, beige pebble pattern, Level 1 South-west Former Washroom.

Pattern, Colour and Photo Number	Paper Backing (Yes/No)	Locations	Sample Number	Asbestos Type
Light grey pebbles, Photo 1	Yes	Basement Group/Storage Rooms, Level 1 Washrooms	2018-0001A-C	None Detected
Red with streaks, Photo 2	No	Main Stairwell	2018-0002A-C	None Detected
Beige pebbles, Photo 3	Yes	Level 1 South-west Former Washroom	2018-0003A-C	None Detected

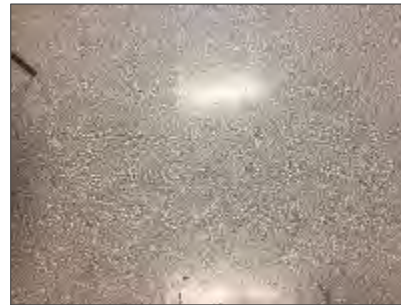
Photo 4 – Non-asbestos vinyl sheet flooring, dark grey pebble pattern, Level 1 Kitchen Area.

Vinyl sheet flooring (dark grey pebble pattern) observed in the Kitchen is presumed to be non-asbestos based on the lack of a paper backing layer (underpad).

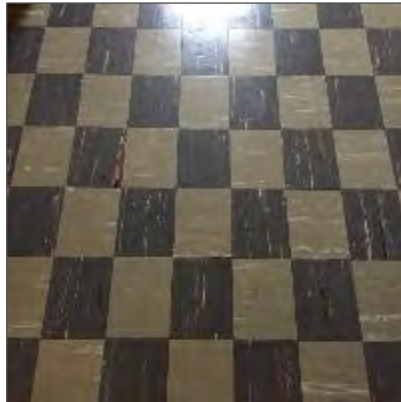
Photo 1 – Asbestos-containing 9" x 9" vinyl floor tile, green/grey in checker pattern, Second Floor Intern's Room.

Size, Pattern, Colour and Photo Number	Locations	Sample Number	Asbestos Type (tile)	Asbestos Type (mastic)
9" x 9" green/grey in checker pattern, Photo 1	First and Second Floor Corridors, Lounges and some Intern's Rooms	2018-0004A-C	Chrysotile	Chrysotile

The vinyl floor tiles and mastic are non-friable and are in good condition.

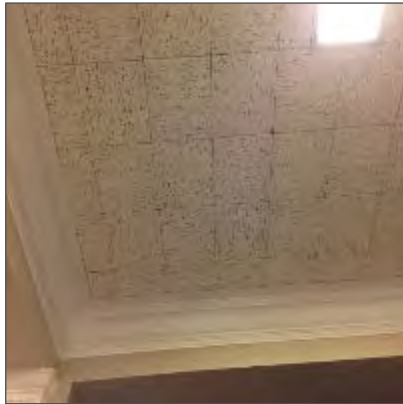
Asbestos-containing 12" x 12" glued-on ceiling tiles, scattered dot and fissure pattern, Storage Room adjacent to Margaret Charter's Auditorium, Level 1 McMaster Wing.

The 12" x 12" glue-on ceiling tiles present in the Margaret Charter's Auditorium and adjacent Storage Rooms contain chrysotile and amosite asbestos (46653.007 sample 023A). This type of ceiling tile has pattern of scattered dot and fissures. Ceiling tiles are considered to be potentially friable and are in good condition.

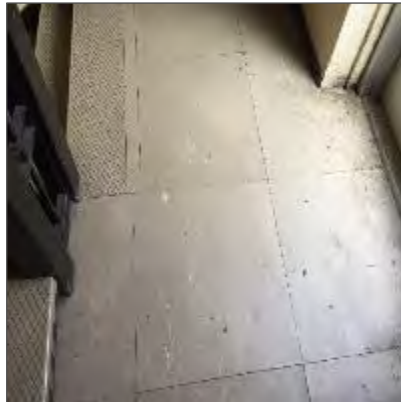
Non-asbestos brown vinyl flooring, Stairwell to Basement.

Non-asbestos brown vinyl flooring is present within the Stairwell to the Basement (samples 2018-0005A-C).

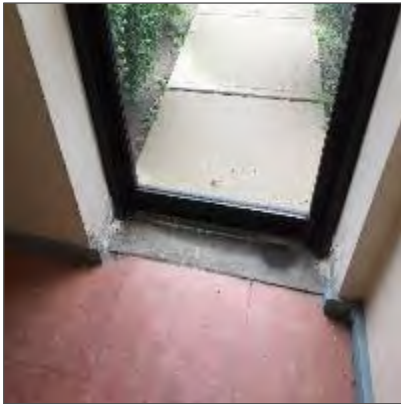
Photo 1 - Damaged asbestos-containing plaster and debris at exit door, Intern's Residence, Main Stairwell.

Material, Quantity & Condition, Photo #	Location	Recommended Procedure
Plaster, 3 square feet in poor condition and 4 square feet of debris, Photo 1	Ground Floor of Intern's Residence at exit in Main Stairwell	Remove, clean-up, and repair in accordance with Type 2 asbestos abatement procedures
Plaster, 1 square foot in fair condition, Photo 2	Interns' Residence, Level 2 Washroom adjacent to Main Stairwell	Repair in accordance with Type 2 asbestos abatement procedures

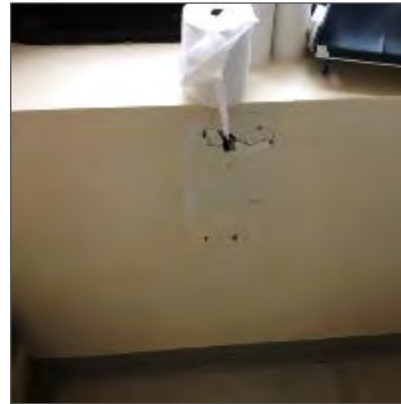
Photo 2 – Damaged asbestos-containing plaster on wall, Intern's Residence, Level 2 Washroom adjacent to Main Stairwell.

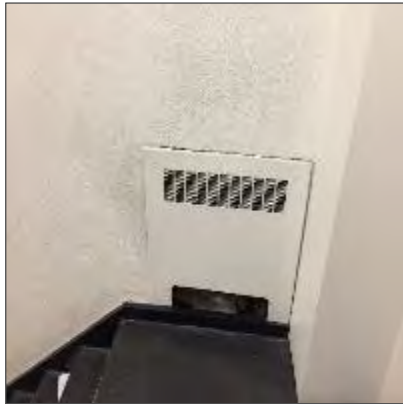
Photo 7 – Asbestos-containing plaster debris below radiator, Landing between Level 1 and 2, South Stairwell of McMaster Wing.

Textured plaster, 3 square feet of debris below radiator, Photo 7	Landing between Level 1 and Level 2, South Stairwell of McMaster Wing	Clean-up in accordance with Type 2 asbestos abatement procedures
Textured plaster, 3 square feet of debris below radiator, Photo 8	Landing between Level 2 and Level 3, South Stairwell of McMaster Wing	Clean-up in accordance with Type 2 asbestos abatement procedures
Presumed Sweatwrap pipe insulation, 5 square feet of debris	Crawlspace access at far end of East Wing Basement Corridor	Limit access to Type 2 procedures, sample the material to determine if it is asbestos-containing and/or clean-up in accordance with Type 2 asbestos abatement procedures.

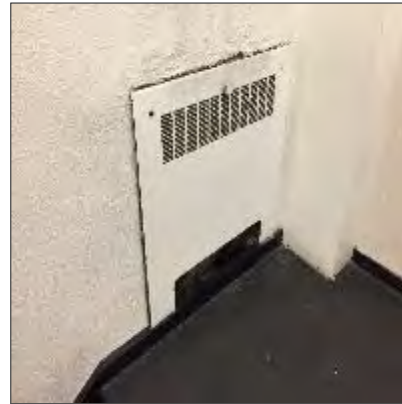
Photo 8 – Asbestos-containing plaster debris below radiator, Landing between Level 2 and 3, South Stairwell of McMaster Wing.

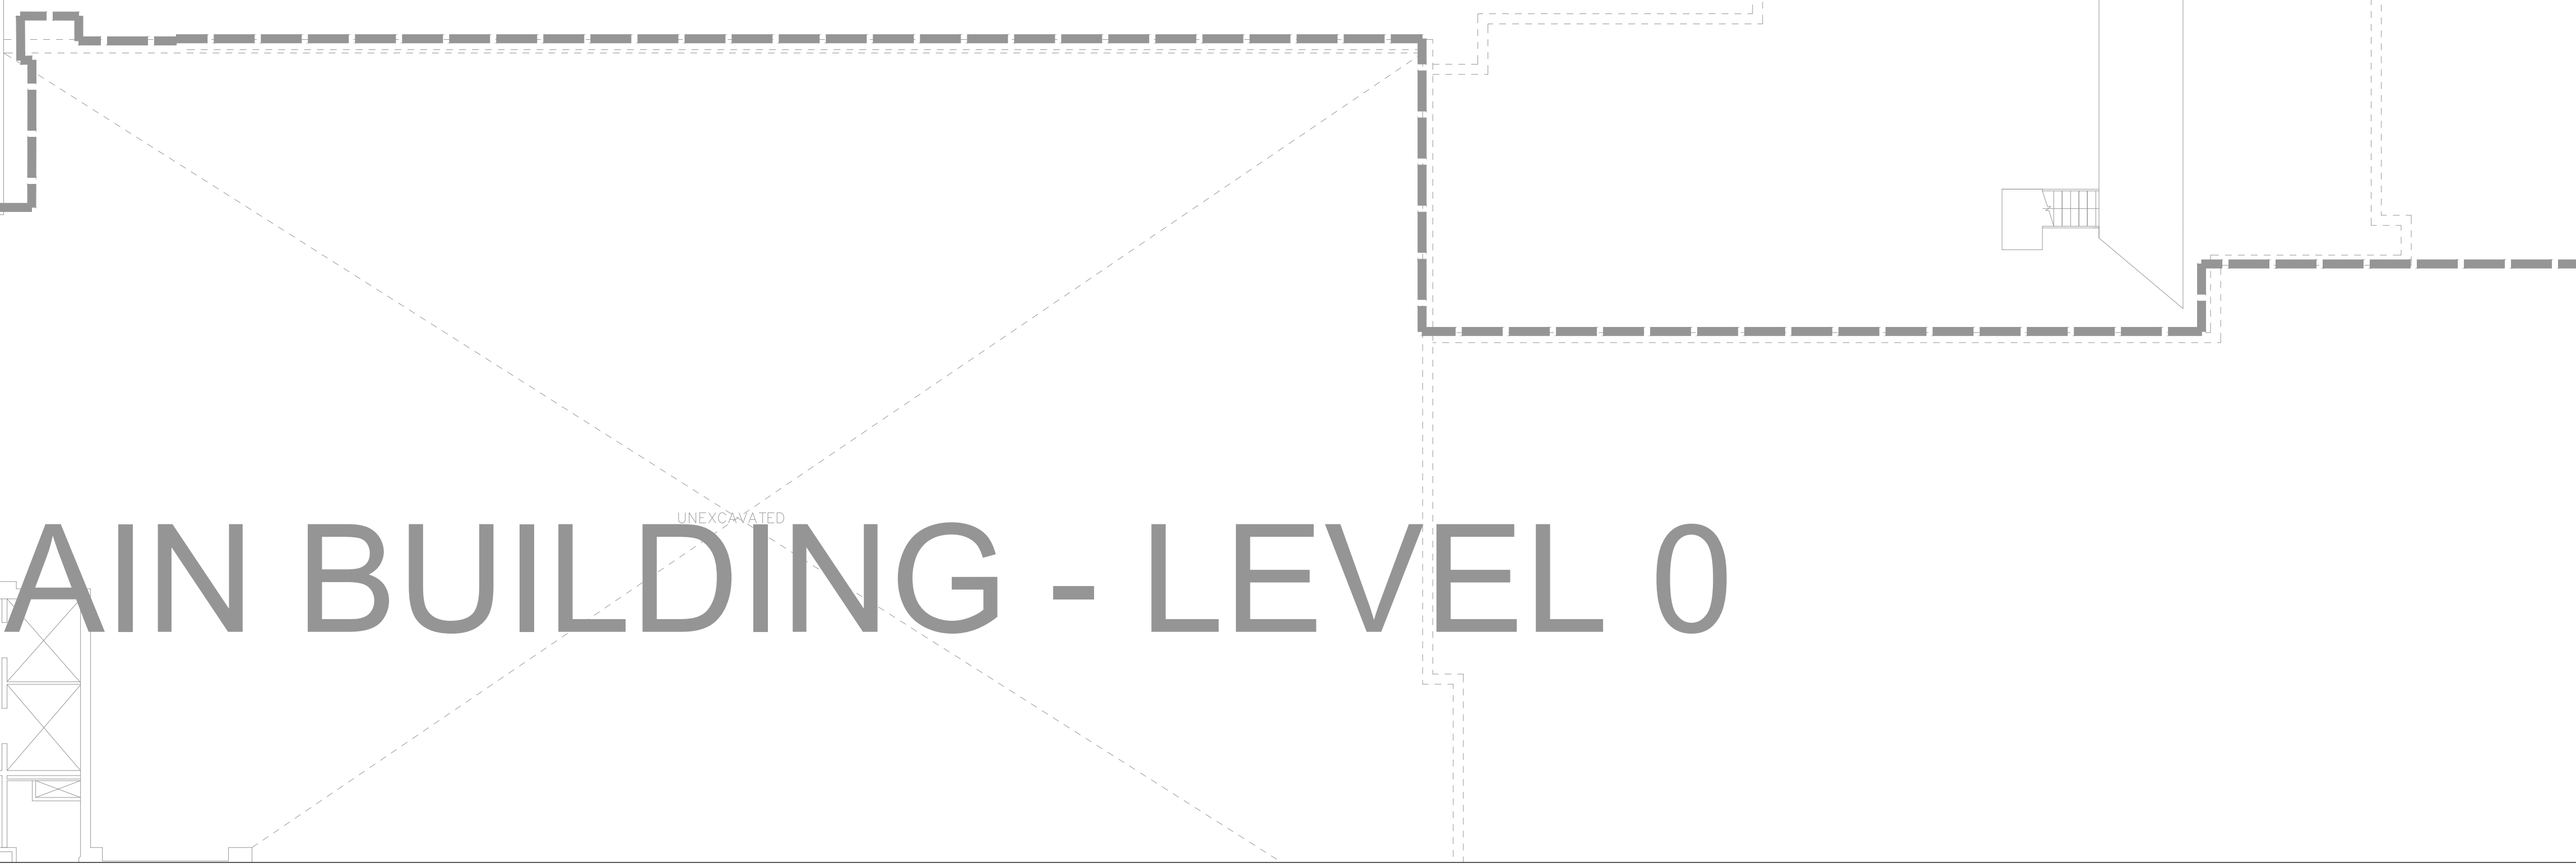
RA-01A

DRAWING:
EAST WING AND NORTH WING LEVEL 0
ACM ON FLOORS

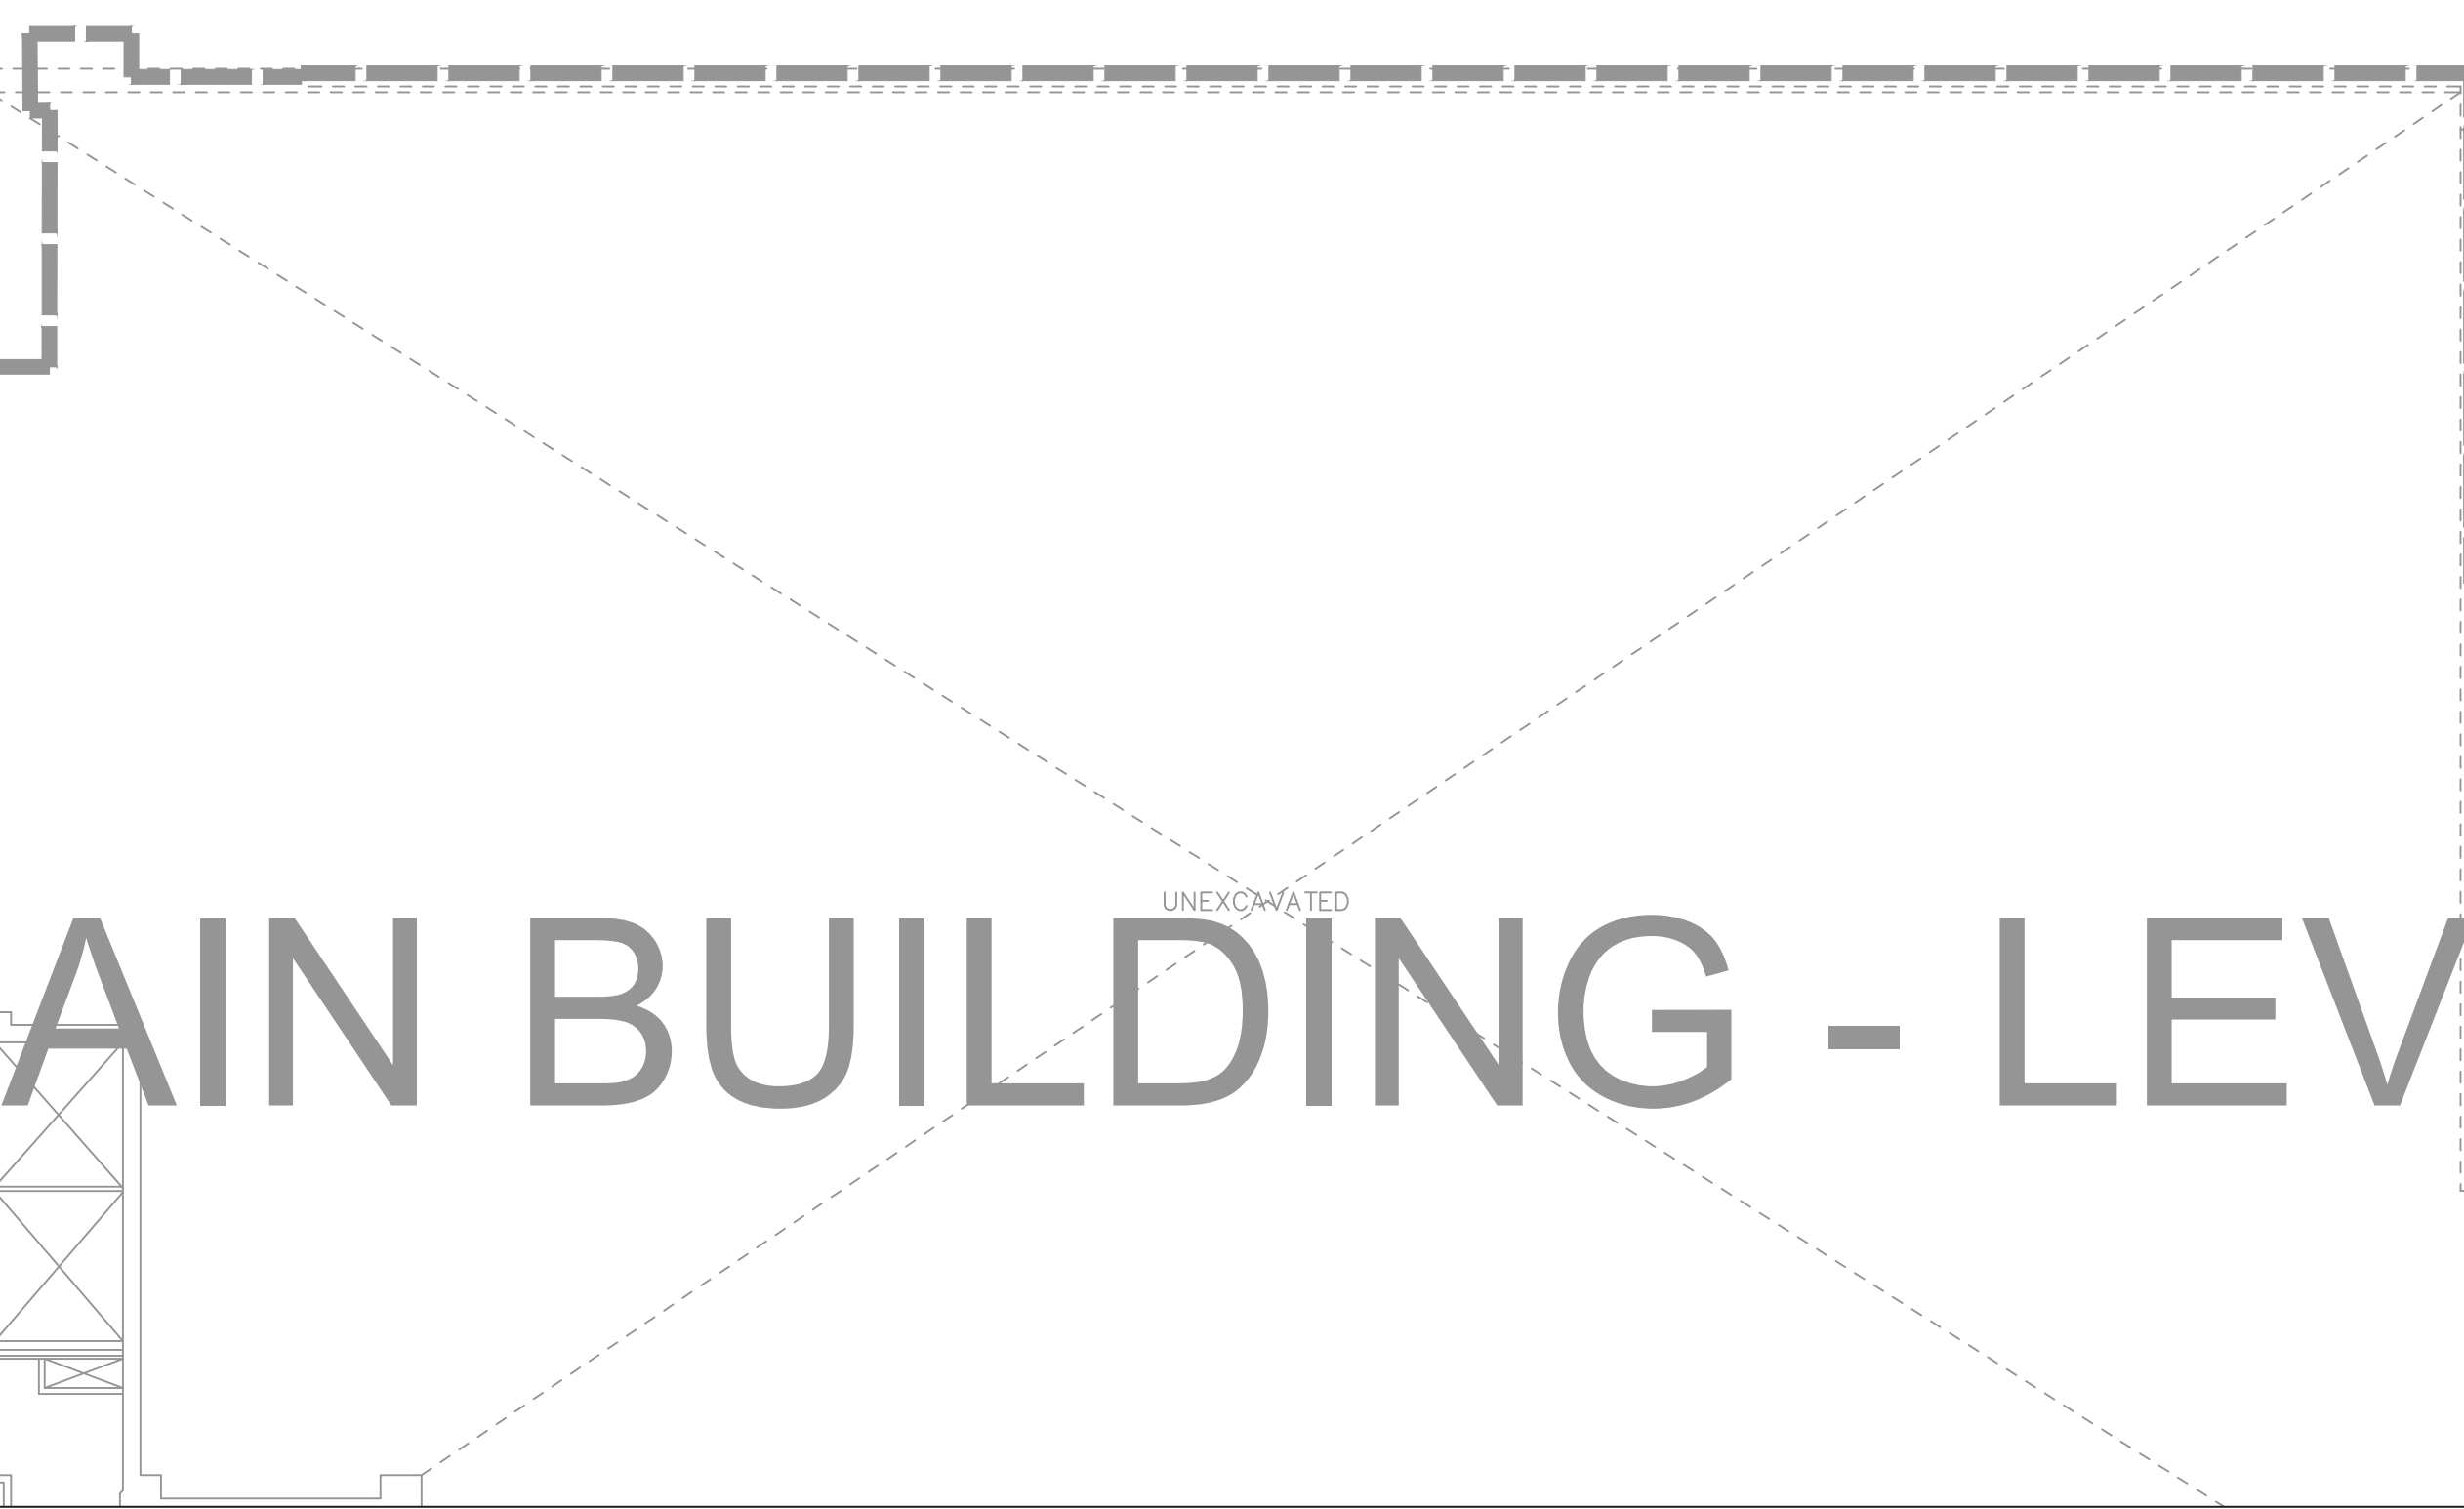
T TRANSITE DUCT BANK
LEVEL 0 BURIED UNDER ROAD

DRAWING:
EAST WING AND NORTH WING LEVEL 0 OTHER ACM

HHS reports that Transite duct bank, buried outside of the north side of the Wing under Copeland Avenue, was abated but residual pockets may remain. These pockets remain buried under Copeland Avenue. Transite is a non-friable material and is presumed to be in good condition.

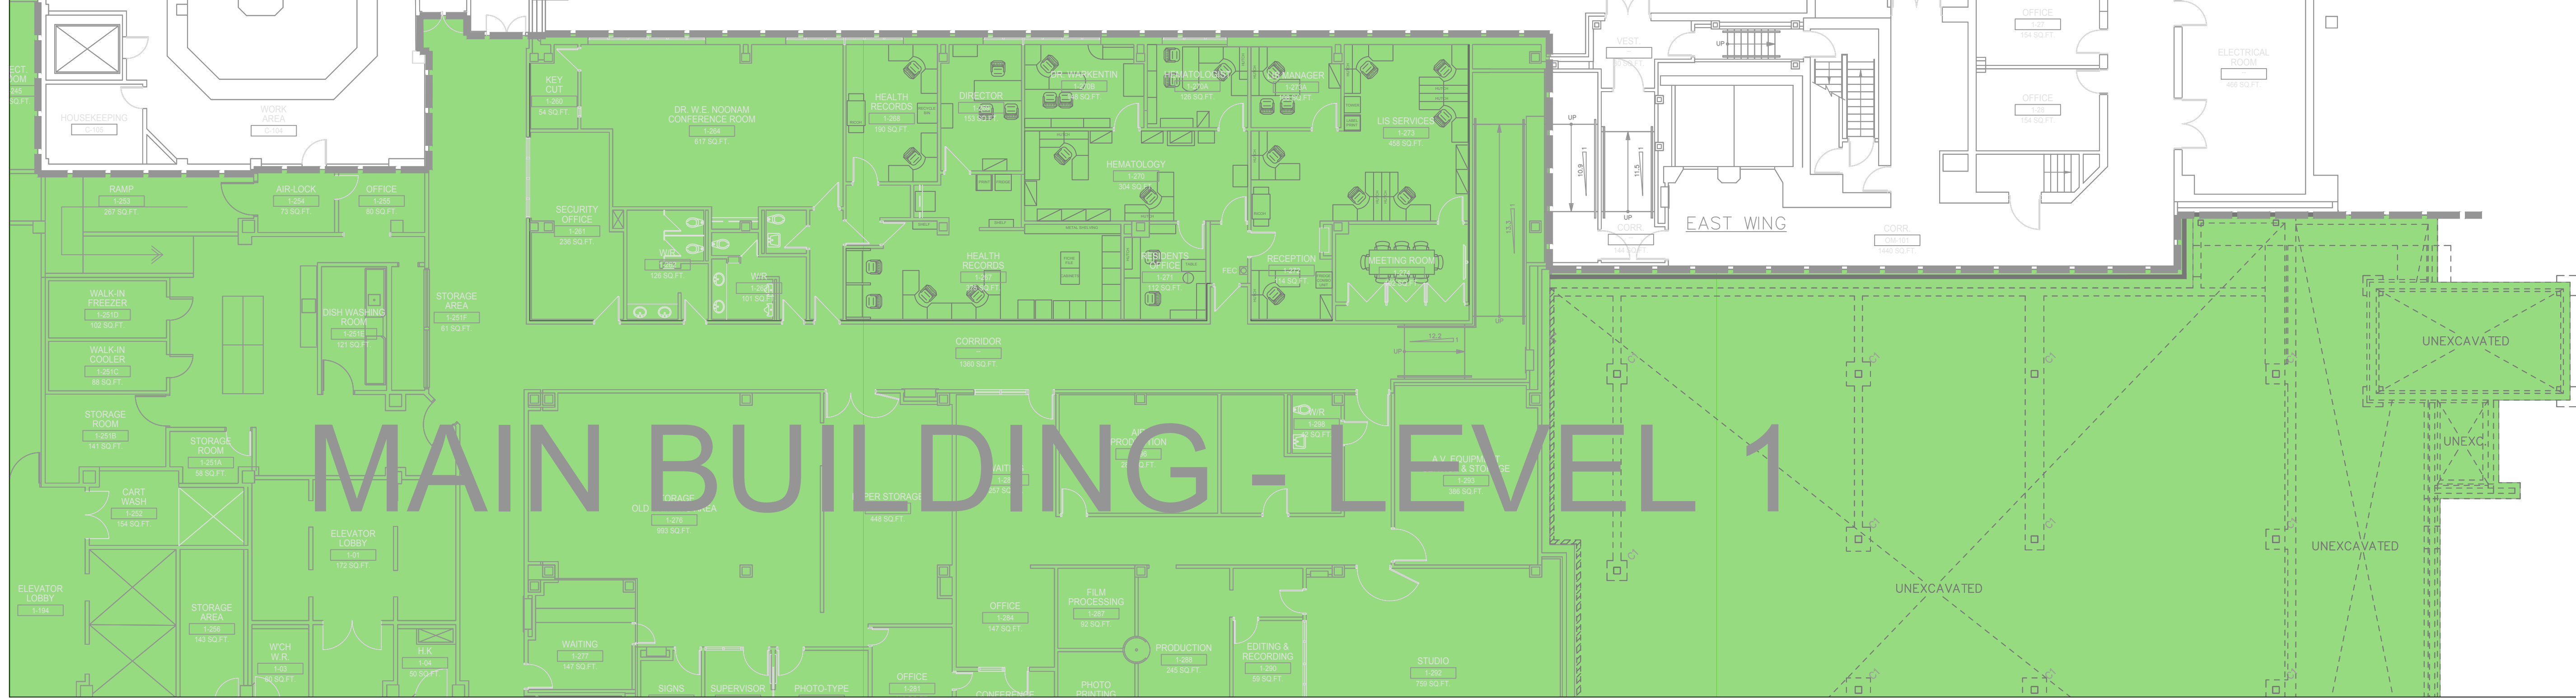
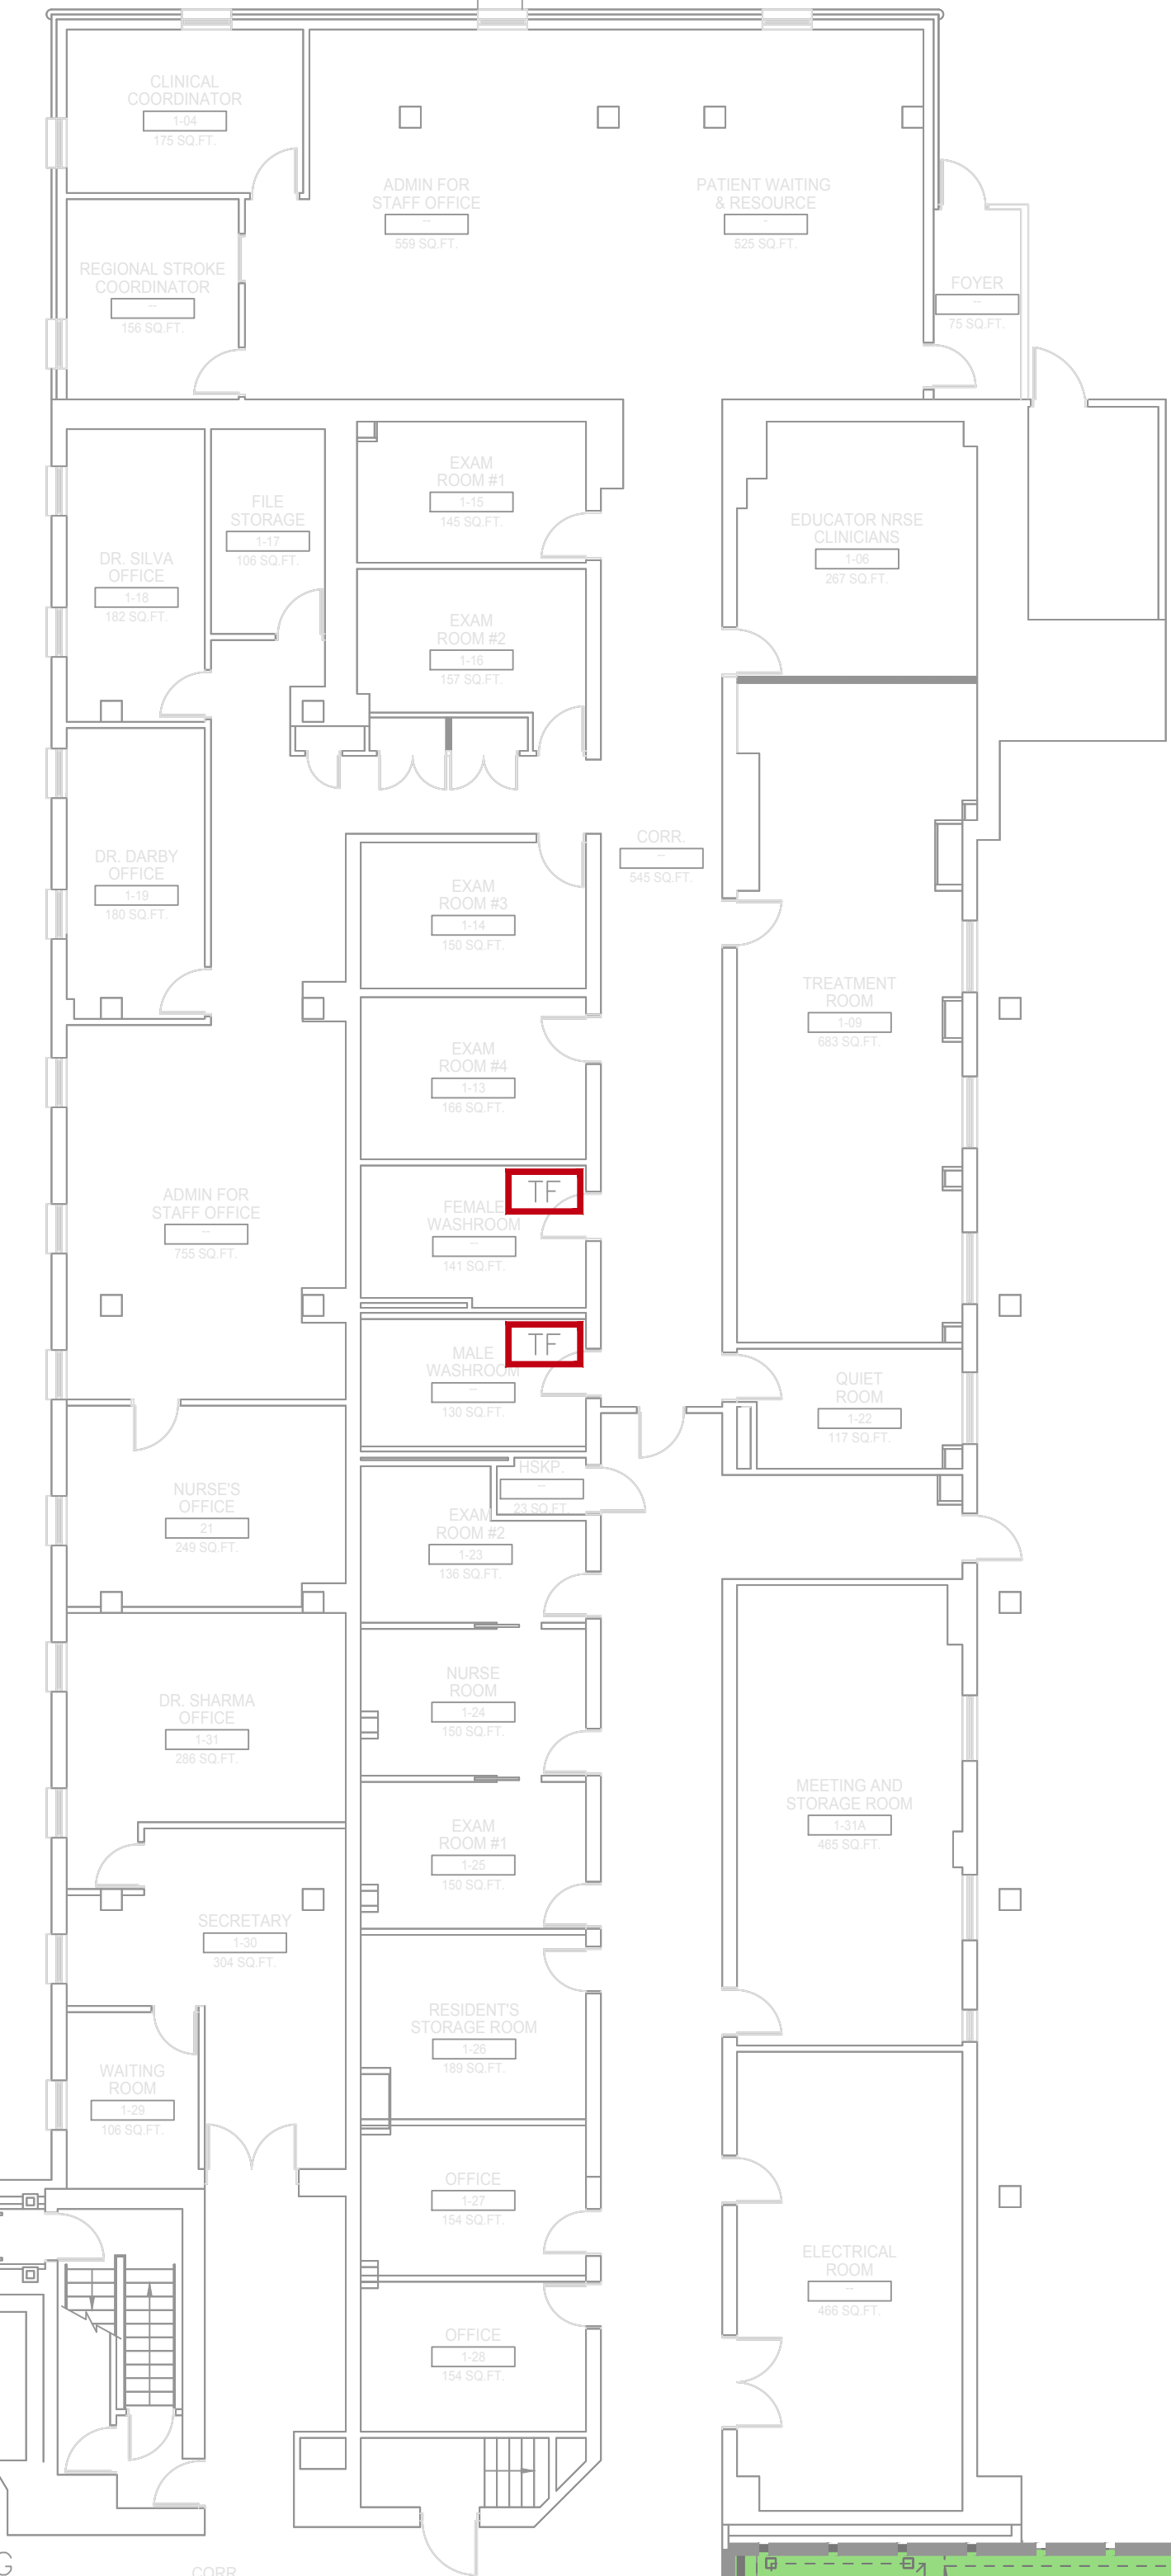
RA-02D

NORTH WING LEVEL 1

EAST WING LEVEL 1

DRAWING:
EAST WING AND NORTH WING
LEVEL 1
OTHER ACM

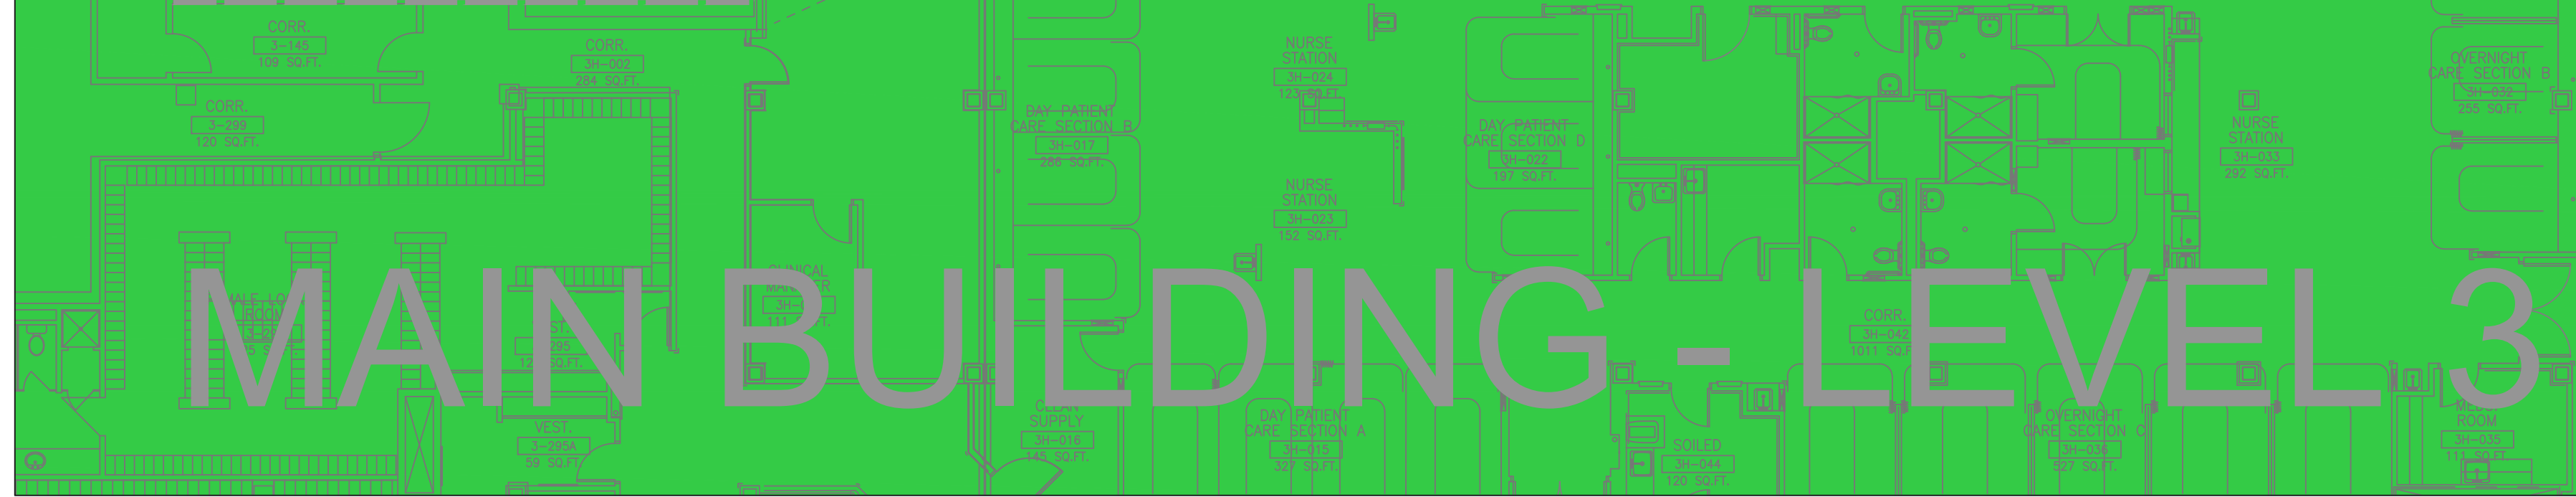
PLOT DATE: NOVEMBER 2018
DEPARTMENT: HAZARDOUS MATERIALS
SUPERVISOR: MICHAEL MAIORANA
N.T.S.
DRAWN BY: JORDAN BOULOS
DRAWING NO.: RA-04A

NORTH WING LEVEL 3

NORTH WING LEVEL 3 UPPER

EAST WING LEVEL 3

LEGEND - FLOORS

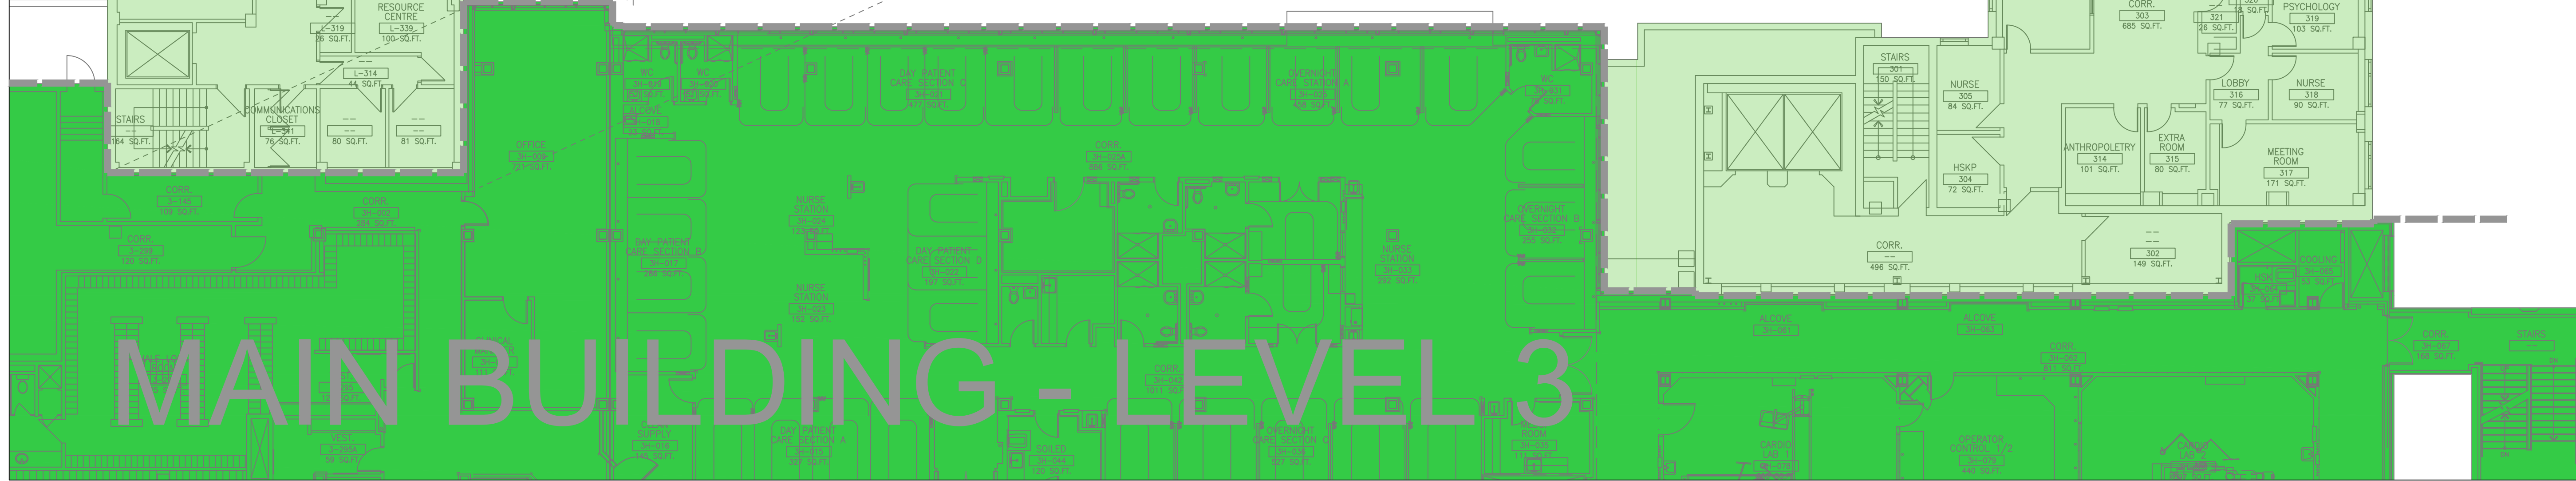
PLOT DATE: NOVEMBER 2018 DEPARTMENT: HAZARDOUS MATERIALS
 SCALE: N.T.S. SUPERVISOR: MICHAEL MAIORANA
 DRAWN BY: JORDAN BOULOS FILE NAME: 030 RA-04 Floor Level 3 EW and NW HIGH
 DRAWING NO. RA-04B

NORTH WING LEVEL 3

NORTH WING LEVEL 3 UPPER

EAST WING LEVEL 3

MAIN BUILDING - LEVEL 3

LEGEND - WALLS

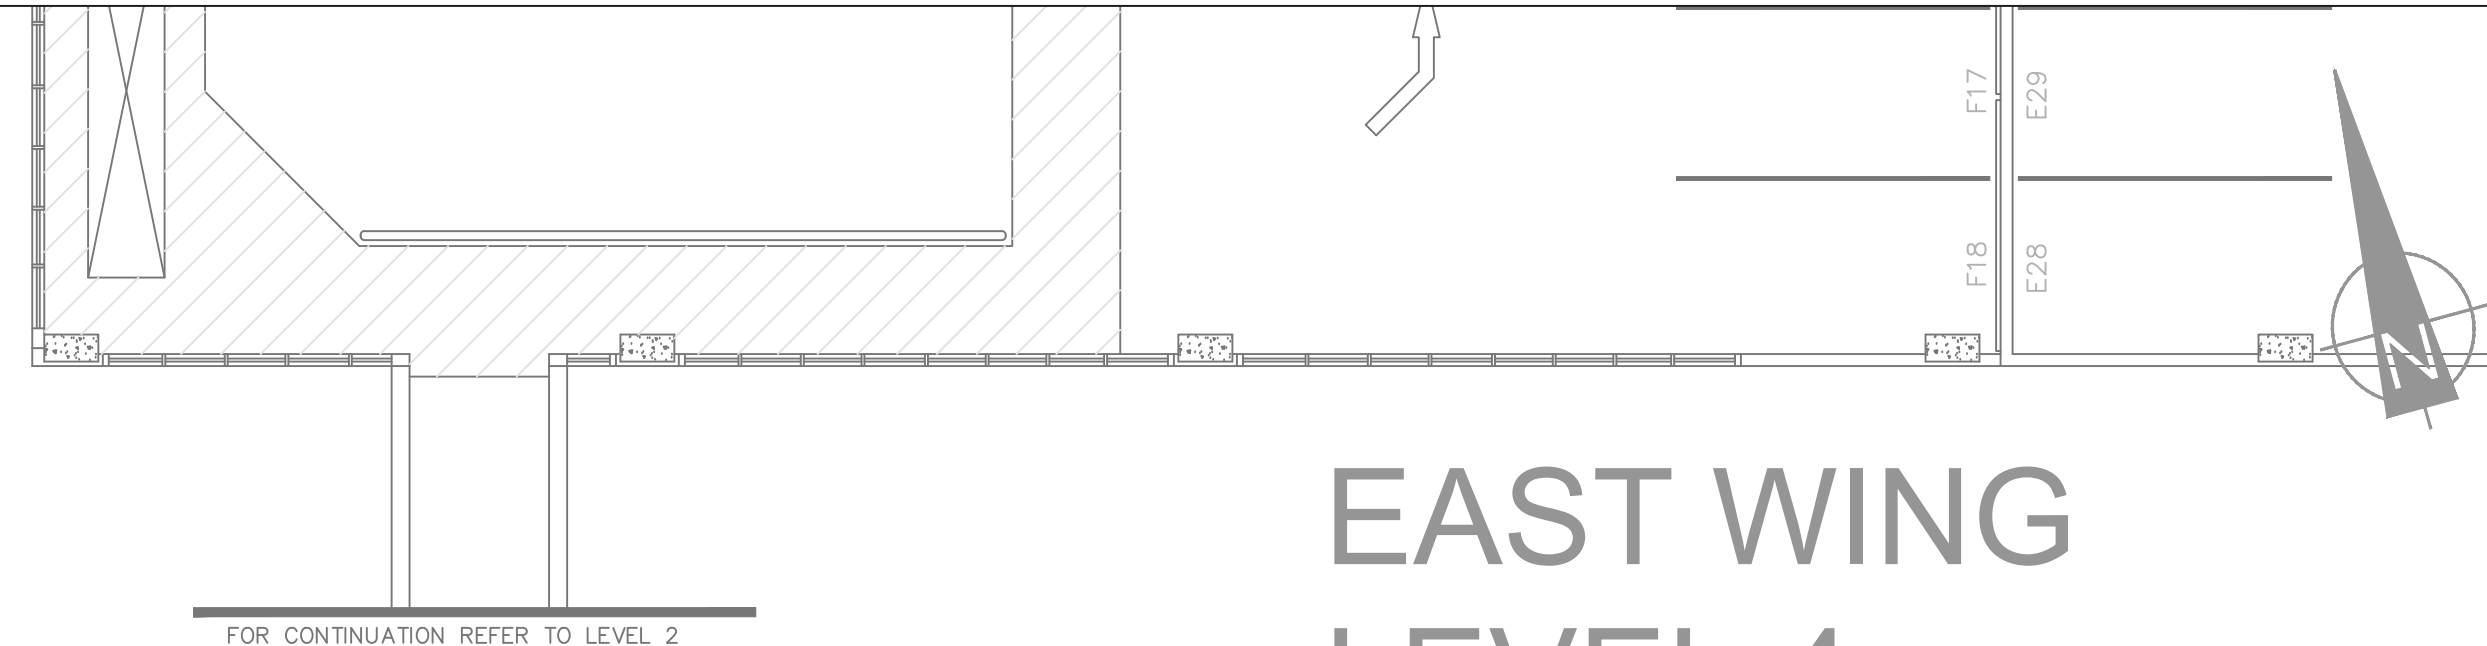
PLOT DATE: NOVEMBER 2018 DEPARTMENT: HAZARDOUS MATERIALS
SCALE: N.T.S. SUPERVISOR: MICHAEL MAIORANA
DRAWN BY: JORDAN BOULOS FILE NAME: 030 RA-05 Floor Level 4 FW and NW HIGH
DRAWING NO. RA-05A

NORTH WING LEVEL 4

MAIN BUILDING - LEVEL 4

EAST WING LEVEL 4

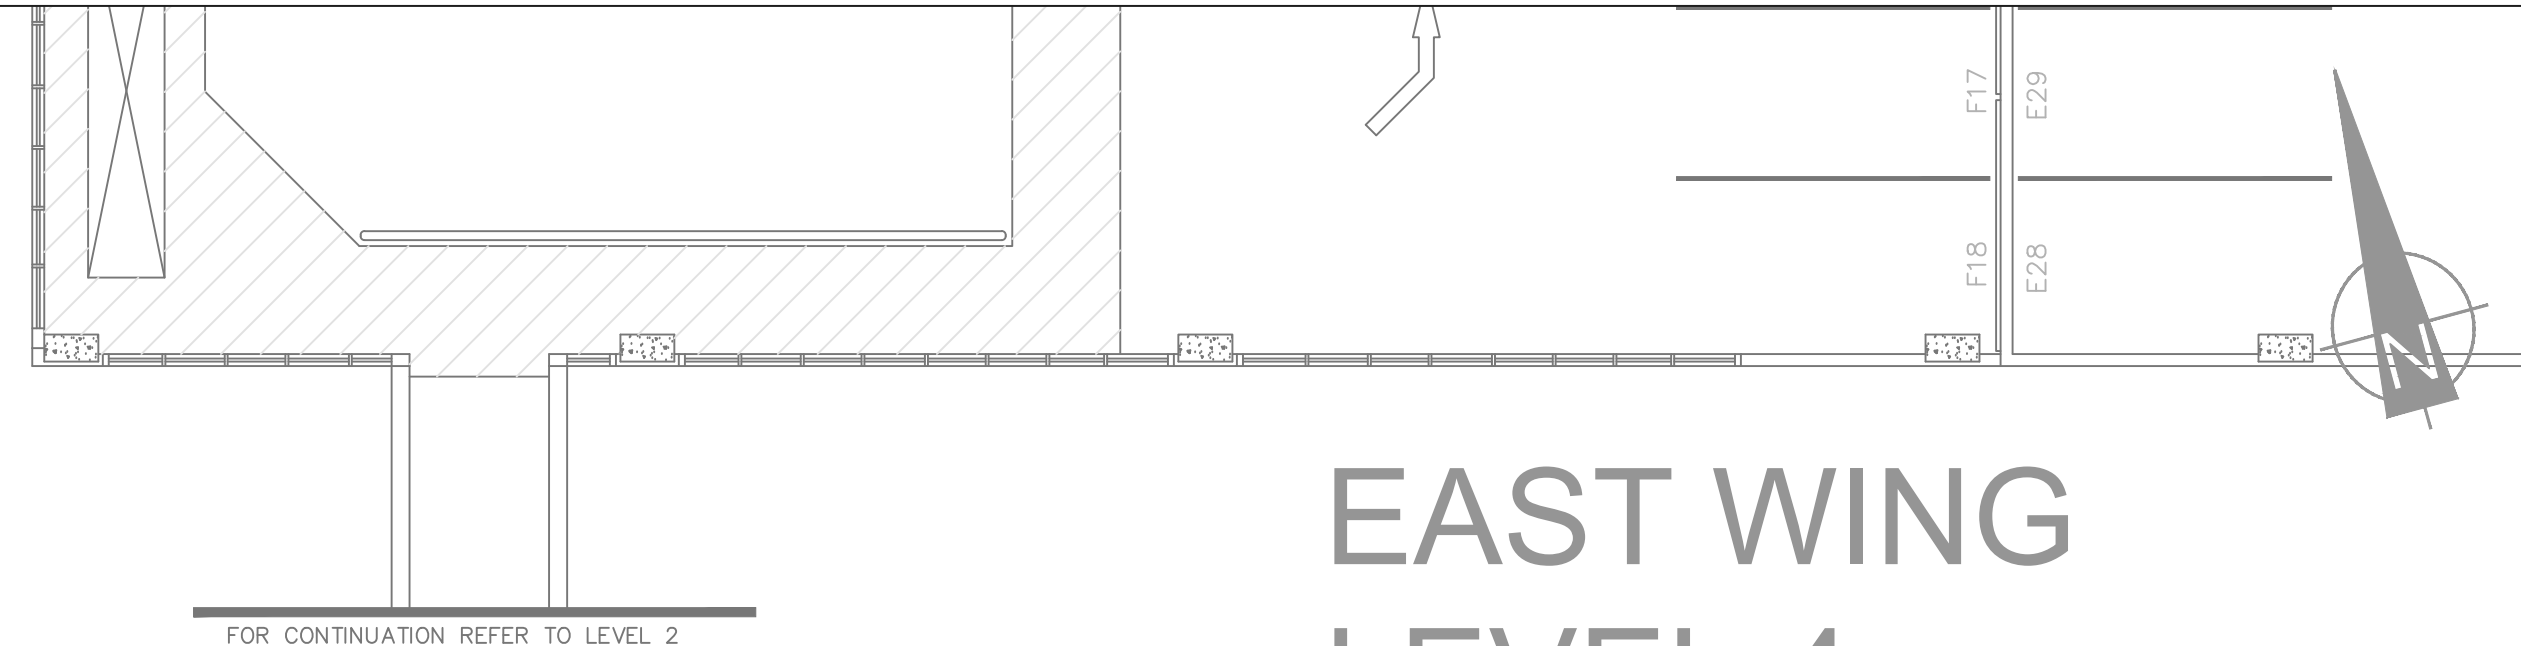
PLOT DATE: NOVEMBER 2018 DEPARTMENT: HAZARDOUS MATERIALS
SCALE: N.T.S. SUPERVISOR: MICHAEL MAIORANA
DRAWN BY: JORDAN BOULOS FILE NAME: 2018030 RA-05 Floor Level 4 FW and NW HIGH
DRAWING No. RA-05B

NORTH WING LEVEL 4

MAIN BUILDING - LEVEL 4

EAST WING LEVEL 4

LEGEND - WALLS
