FINAL
Asbestos
Reassessment

Hamilton General Hospital
237 Barton Street East, Hamilton,
Ontario

Hamilton General Hospital, 237 Barton Street East, Hamilton, Ontario
Hamilton Health Sciences

January 16, 2019
Pinchin File: 217420.030
FINAL

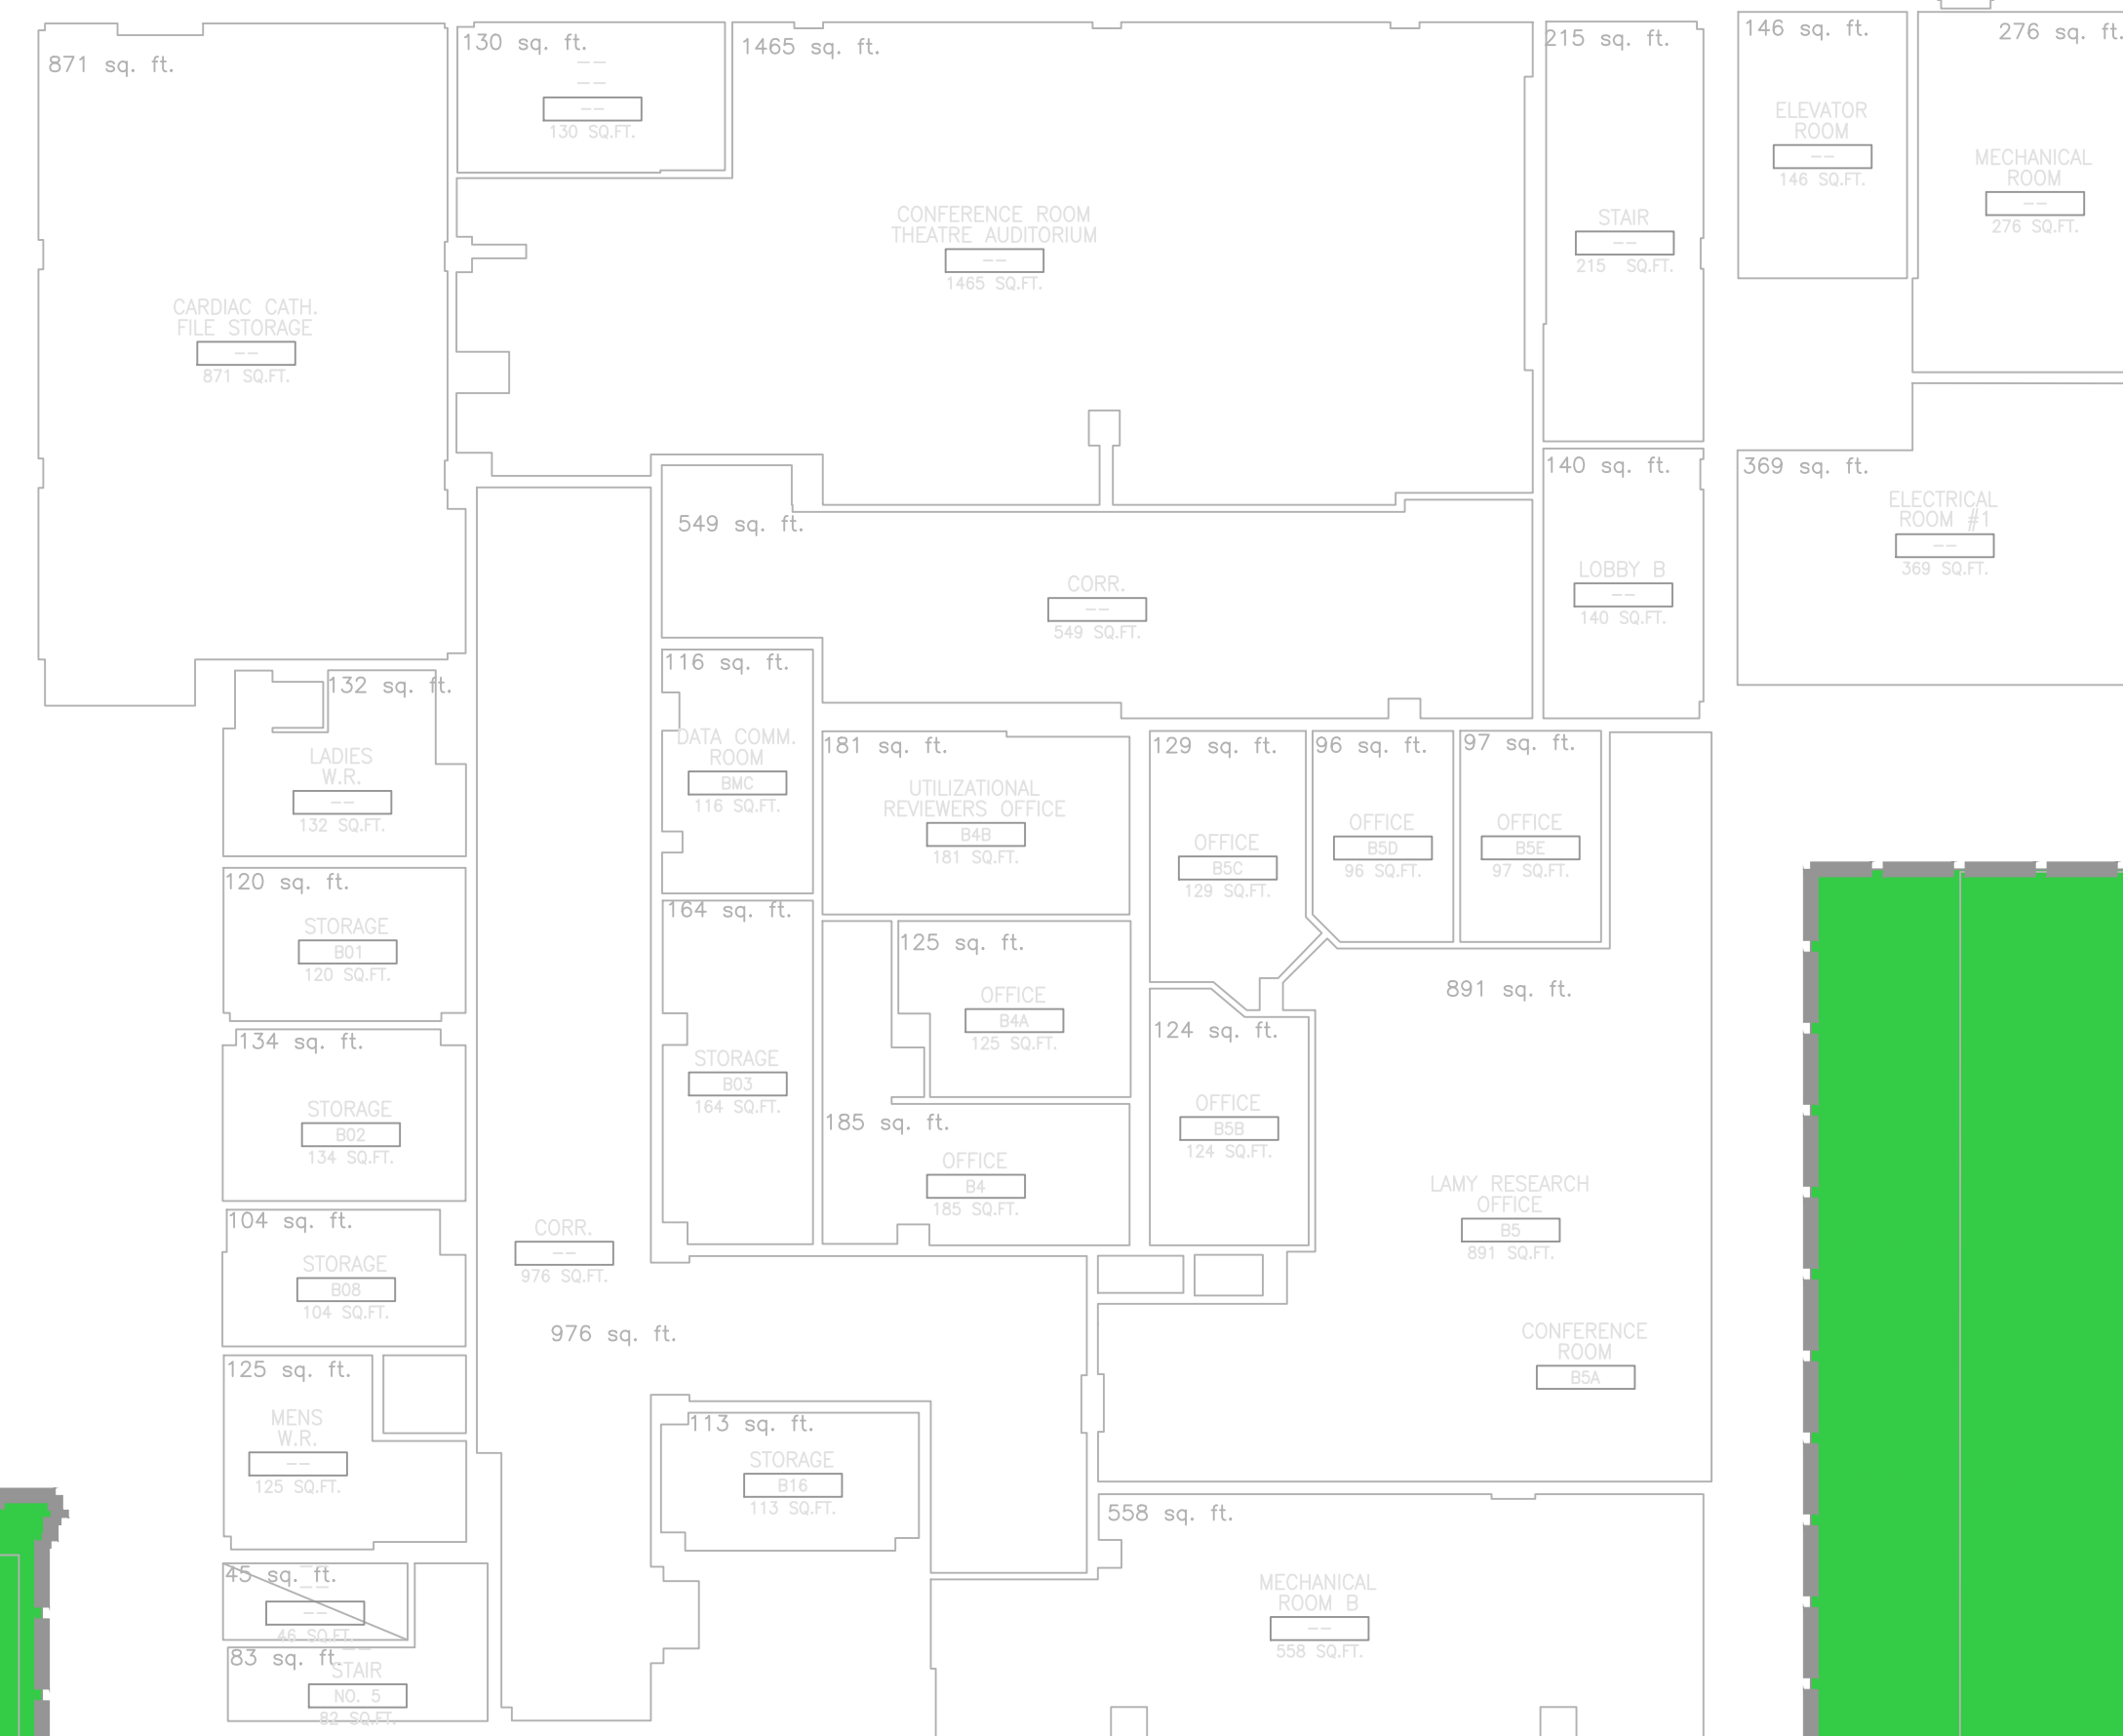
INTERN'S RESIDENCE LEVEL 0

McMASTER WING LEVEL 0

MAIN BUILDING - LEVEL 0

- LEGEND - FLOORS
- ACM VINYL FLOOR TILES
 - ACM VINYL SHEET FLOORING
 - ACM ABATED AREA AS PER HHS RECORDS

DRAWING: McMASTER AND INTERN'S RES LEVEL 0 ACM ON FLOORS

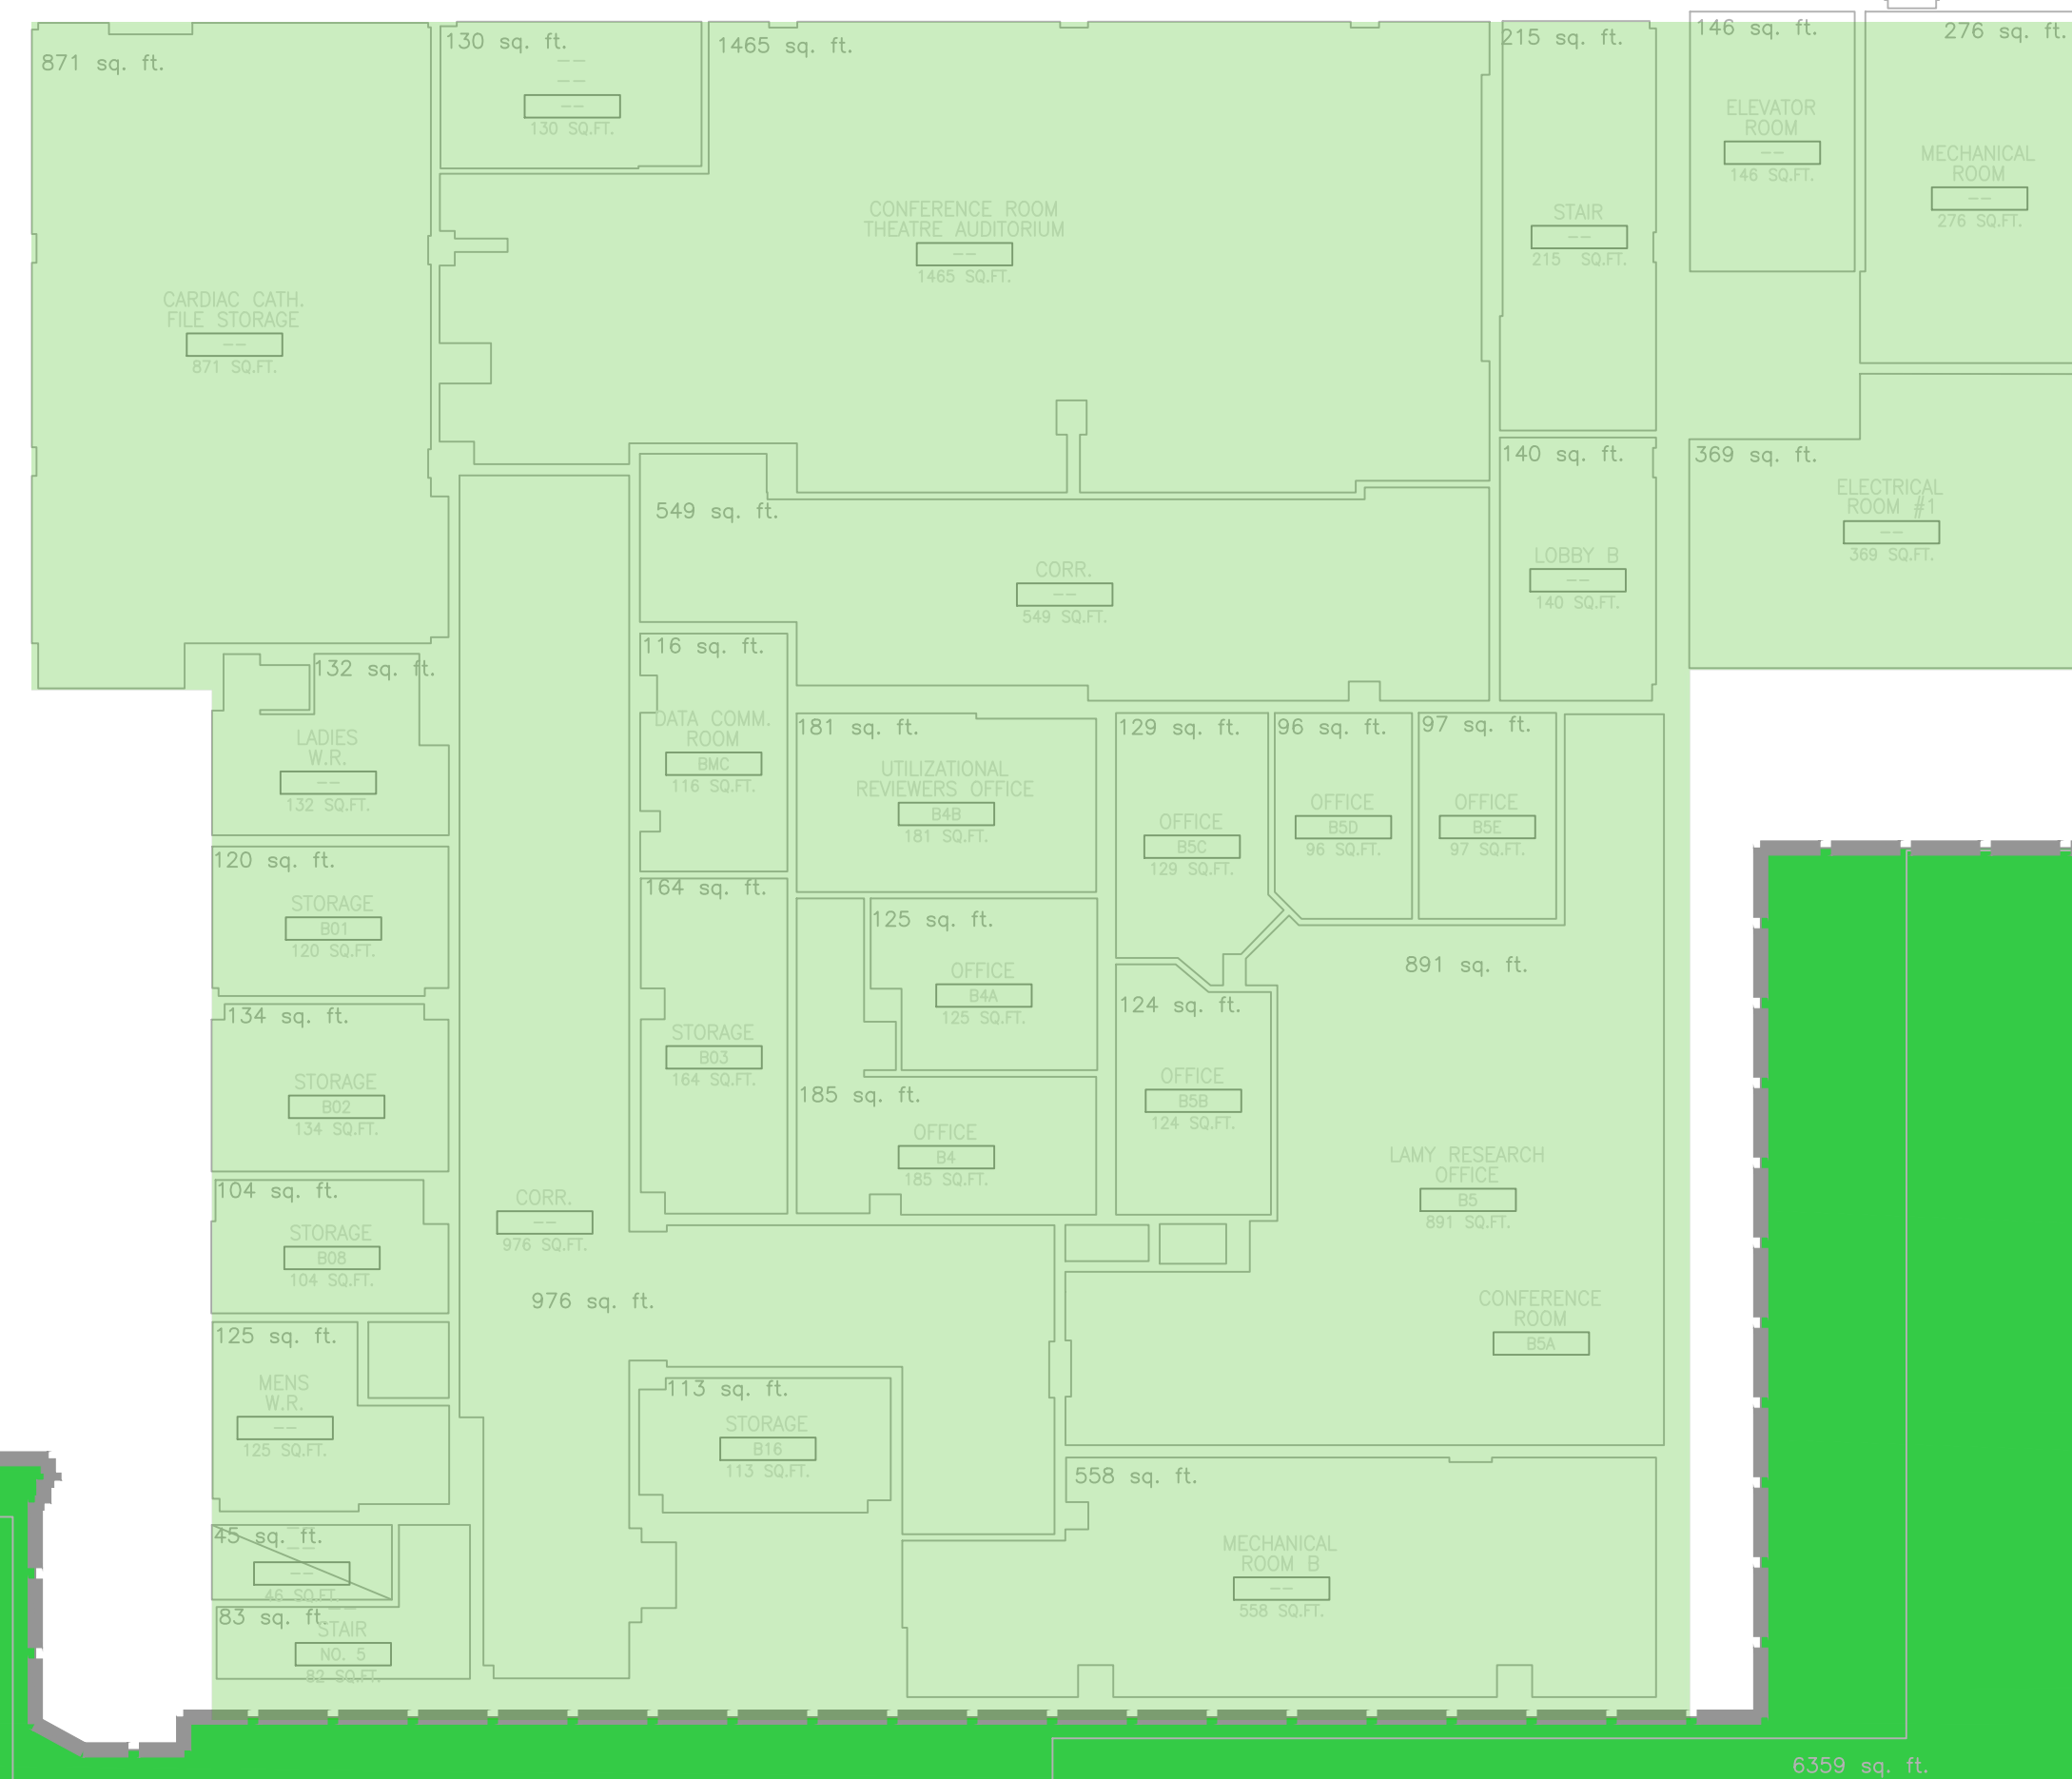
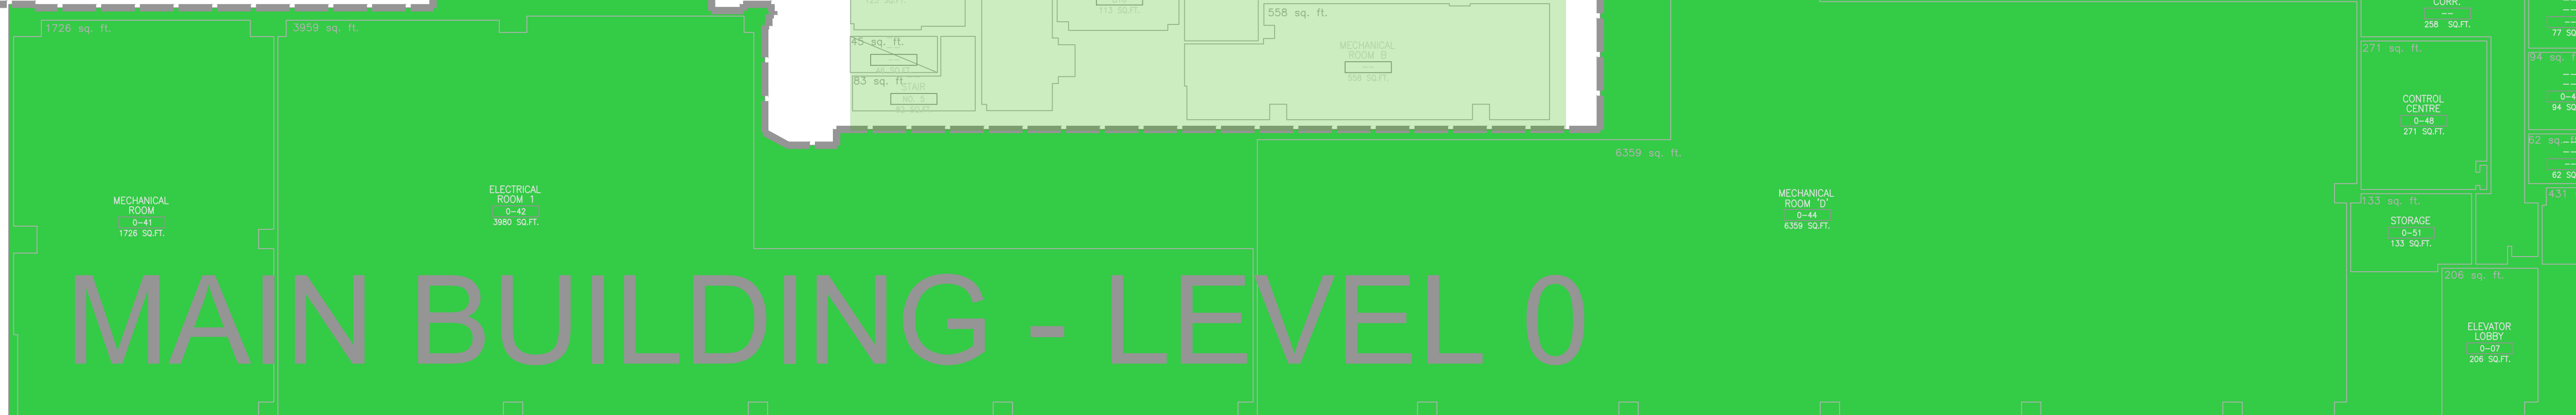
DRAWING: MCMMASTER AND INTERN'S RES LEVEL 0 ACM ON WALLS

- LEGEND - WALLS**
- ACM DRYWALL JOINT COMPOUND ON WALLS
 - ACM PLASTER ON WALLS
 - NO ACM PRESENT
 - ACM ABATED AREA AS PER HHS RECORDS

INTERN'S RESIDENCE LEVEL 0

McMASTER WING LEVEL 0

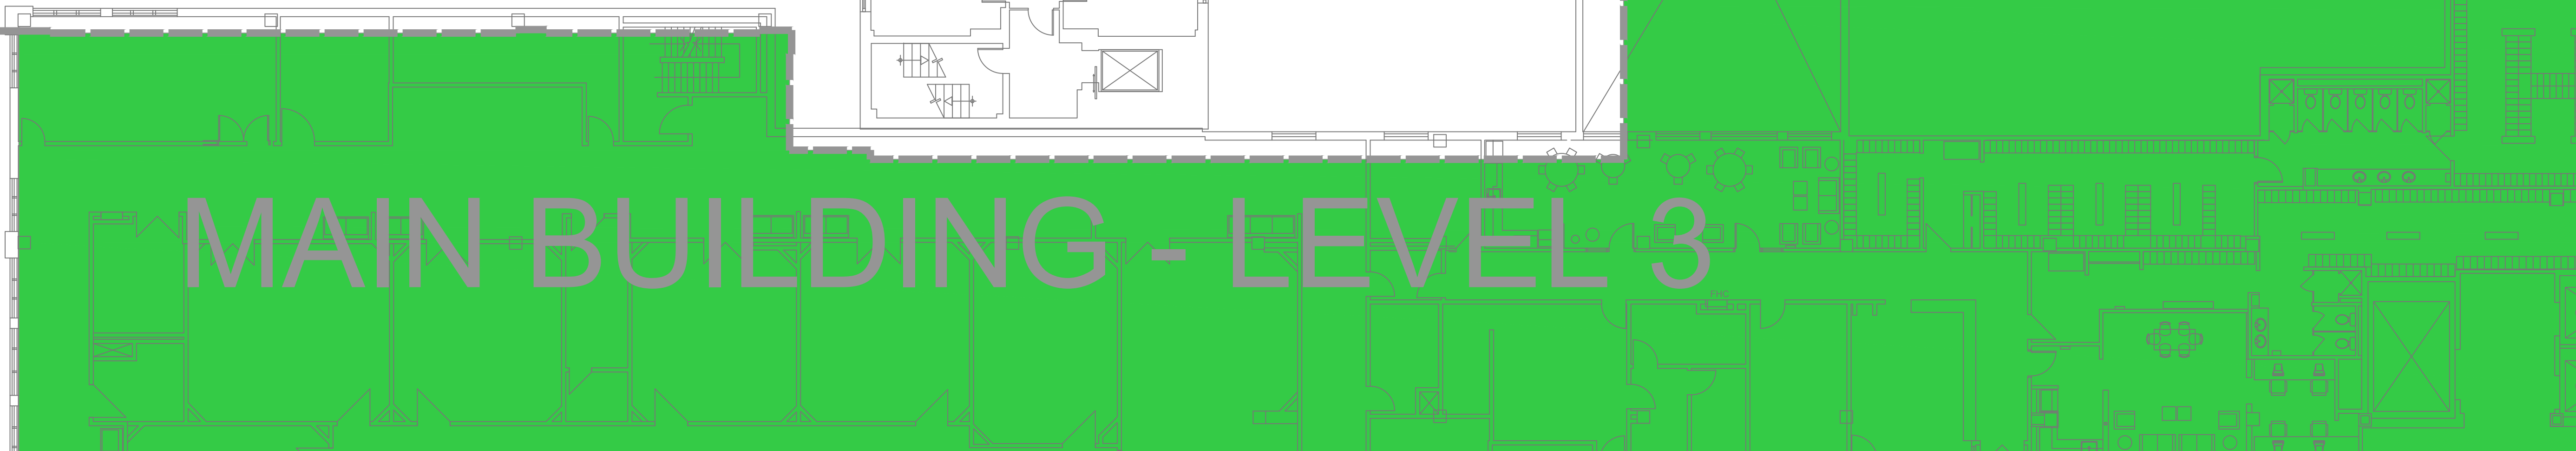
DRAWING:
McMASTER AND INTERNS RES LEVEL 3
ACM ON FLOORS

INTERNS' RESIDENCE LEVEL 3

McMASTER WING LEVEL 3

MAIN BUILDING - LEVEL 3

- LEGEND - FLOORS
- ACM VINYL FLOOR TILES
 - ACM VINYL SHEET FLOORING
 - ACM ABATED AREA AS PER HHS RECORDS

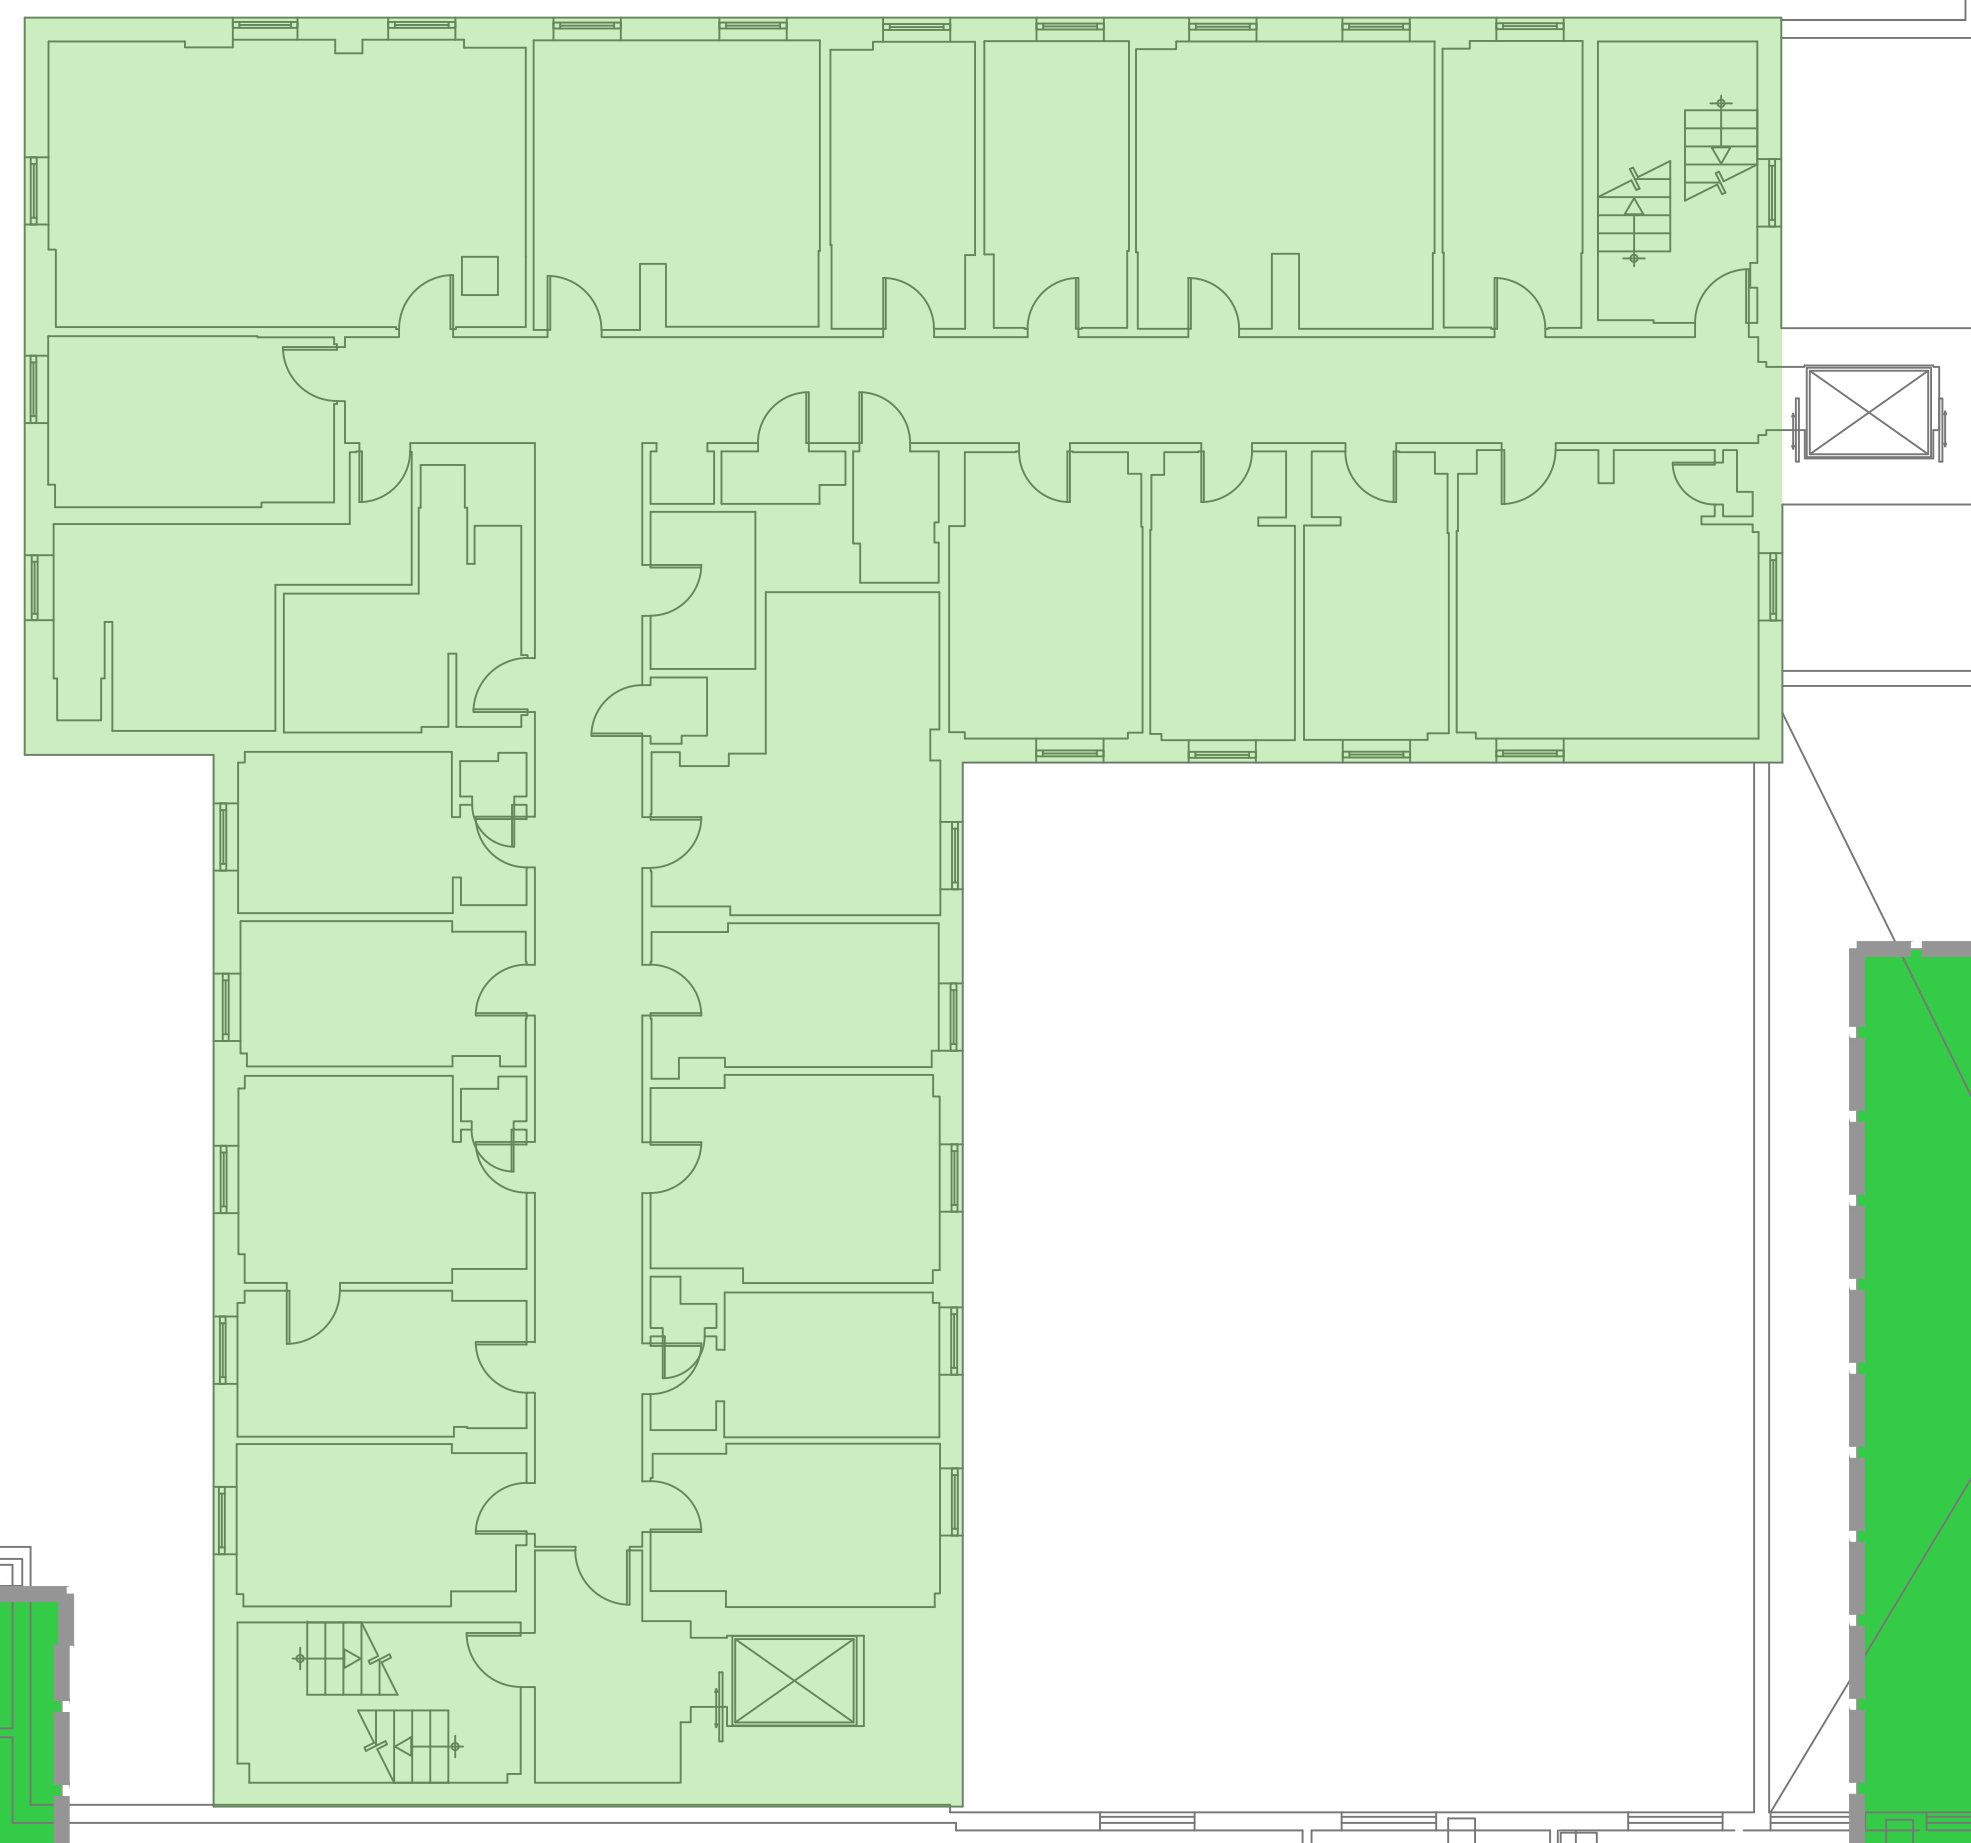
DRAWING:
McMASTER AND INTERNS RES LEVEL 3
ACM ON WALLS

- ACM DRYWALL JOINT COMPOUND ON WALLS
- ACM PLASTER ON WALLS
- NO ACM PRESENT
- ACM ABATED AREA AS PER HHS RECORDS

INTERNS' RESIDENCE LEVEL 3

McMASTER WING LEVEL 3

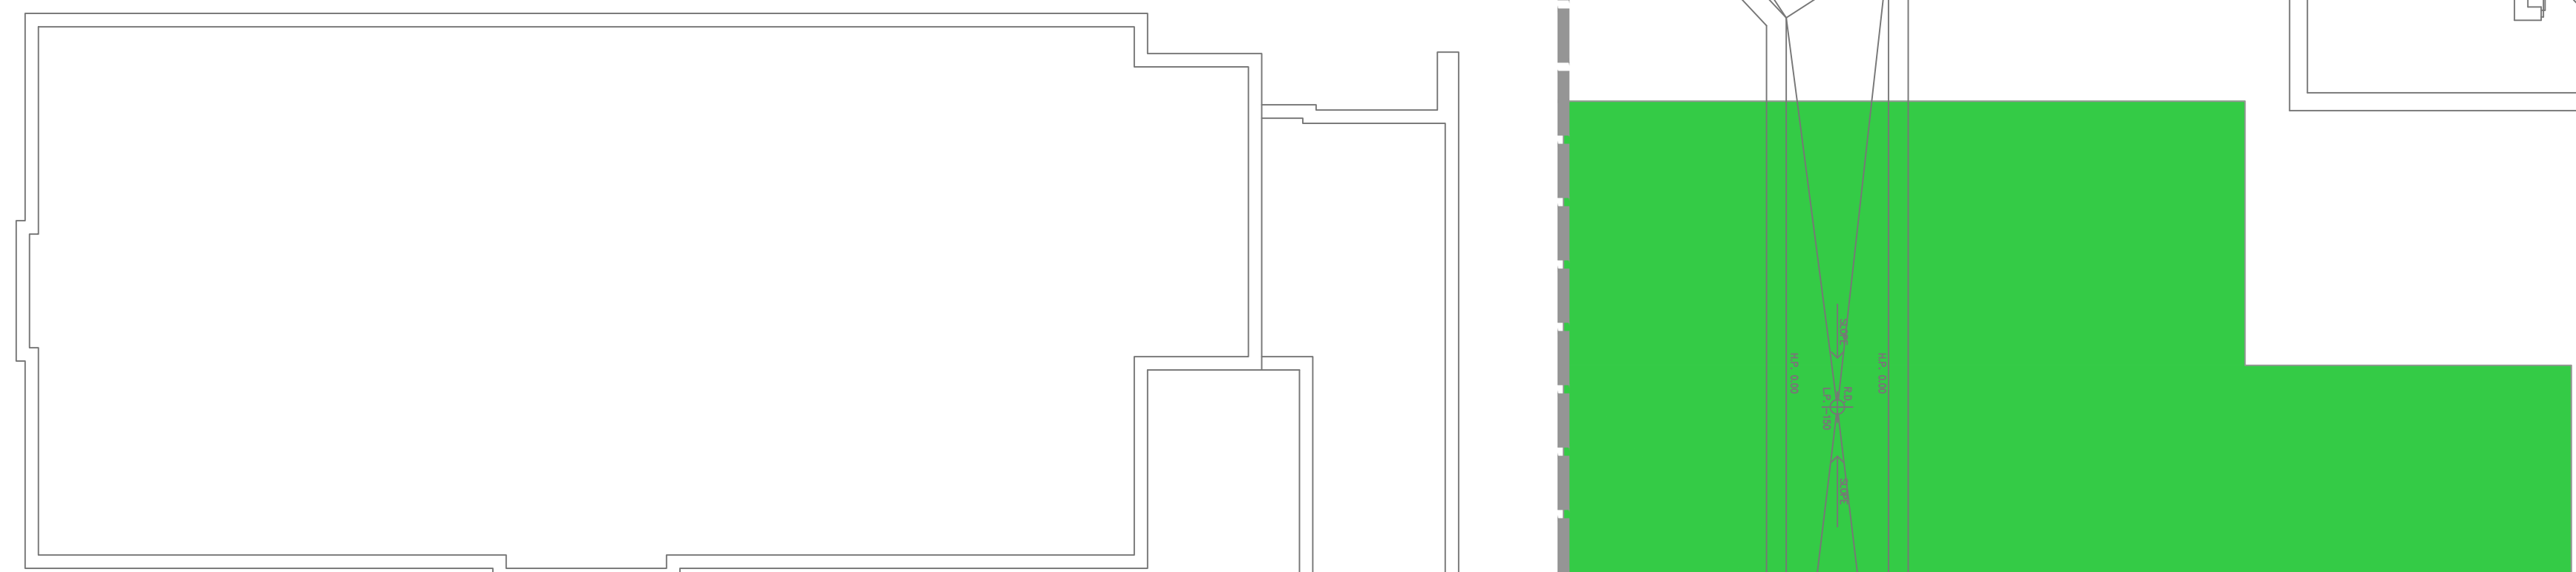
DRAWING:
McMASTER AND INTERNS RES
LEVEL 3
OTHER ACM

INTERNS' RESIDENCE LEVEL 3

McMASTER WING LEVEL 3

MAIN BUILDING - LEVEL 3

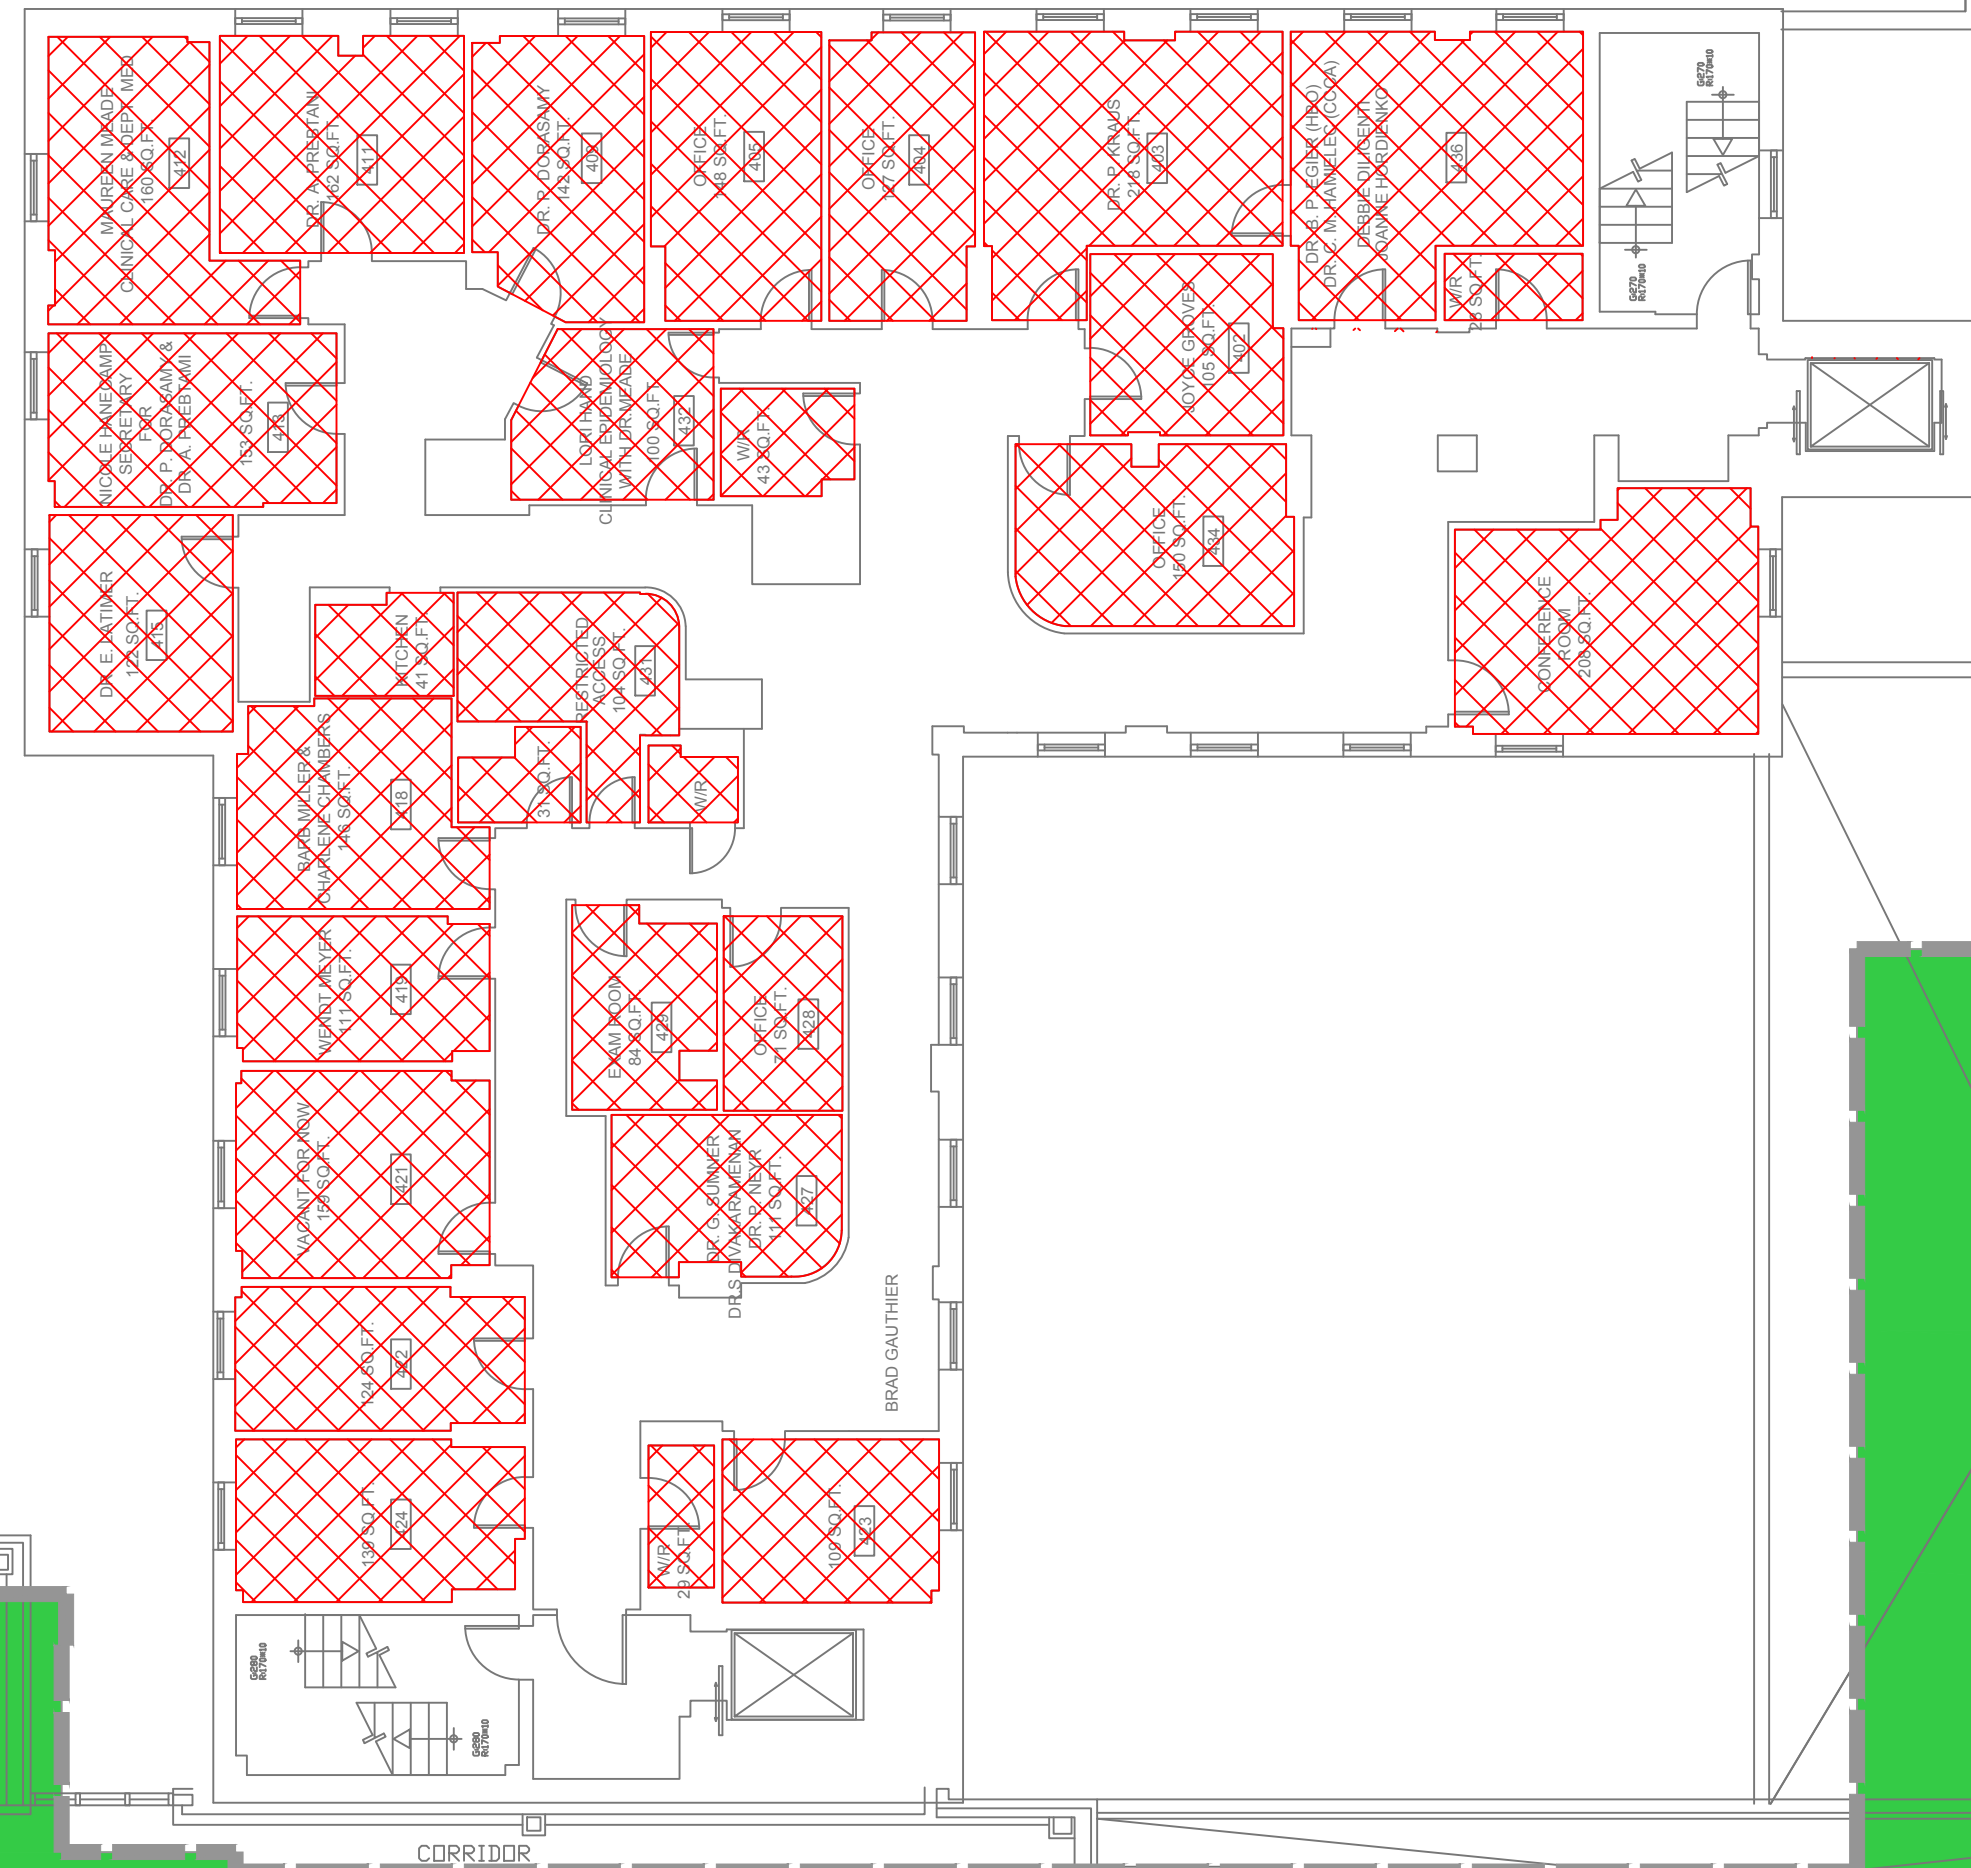
PLOT DATE: NOVEMBER 2018 DEPARTMENT: HAZARDOUS MATERIALS
 SCALE: N.T.S. SUPERVISOR: MICHAEL MAIORANA
 DRAWN BY: JORDAN BOULOS FILE # 030 RA-14 Floor Level
 DRAWING No. 4 MM and NR HIGH

INTERNS' RESIDENCE LEVEL 4

McMASTER WING LEVEL 4

DRAWING NOTES:
1. 9"x9" VINYL FLOOR TILE MAY EXIST BELOW VINYL SHEET FLOORING IN AREAS SHOWN HATCHED

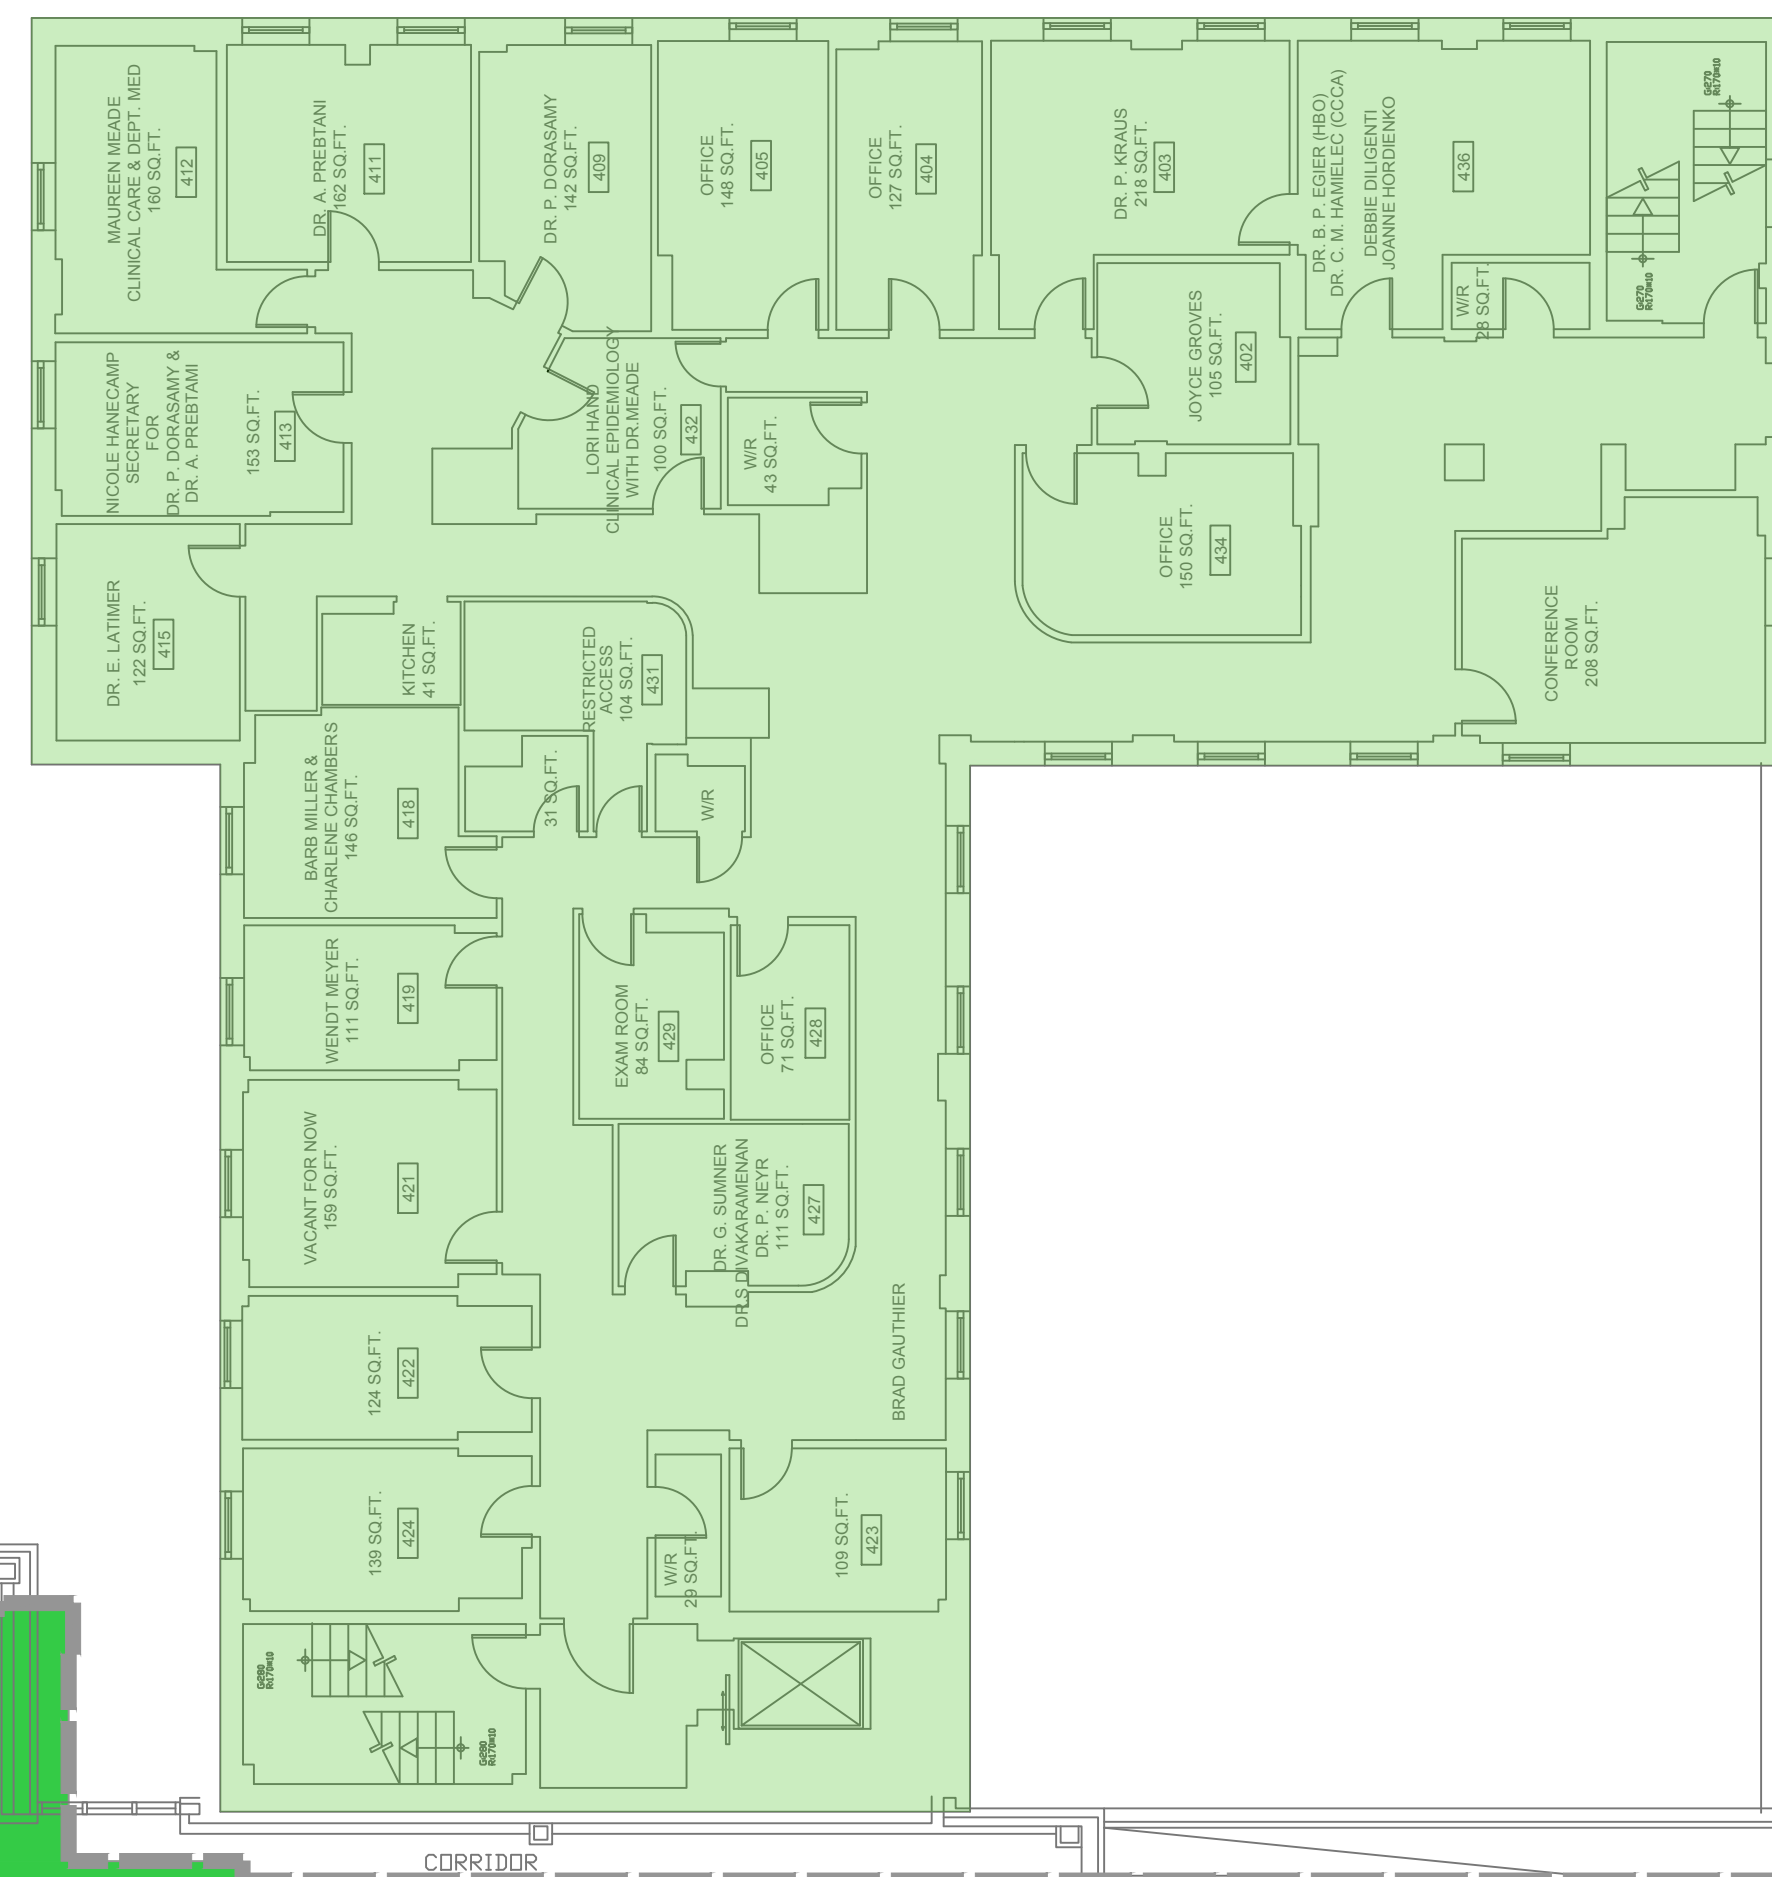
DRAWING:
McMASTER AND INTERNS RES
LEVEL 4
ACM ON WALLS

- LEGEND - WALLS**
- ACM DRYWALL JOINT COMPOUND ON WALLS
 - ACM PLASTER ON WALLS
 - NO ACM PRESENT
 - ACM ABATED AREA AS PER HHS RECORDS

INTERNS' RESIDENCE LEVEL 4

McMASTER WING LEVEL 4
