FINAL
Asbestos
Reassessment

Hamilton General Hospital
237 Barton Street East, Hamilton,
Ontario

Hamilton General Hospital, 237 Barton Street East, Hamilton, Ontario
Hamilton Health Sciences

January 16, 2019
Pinchin File: 217420.030
FINAL

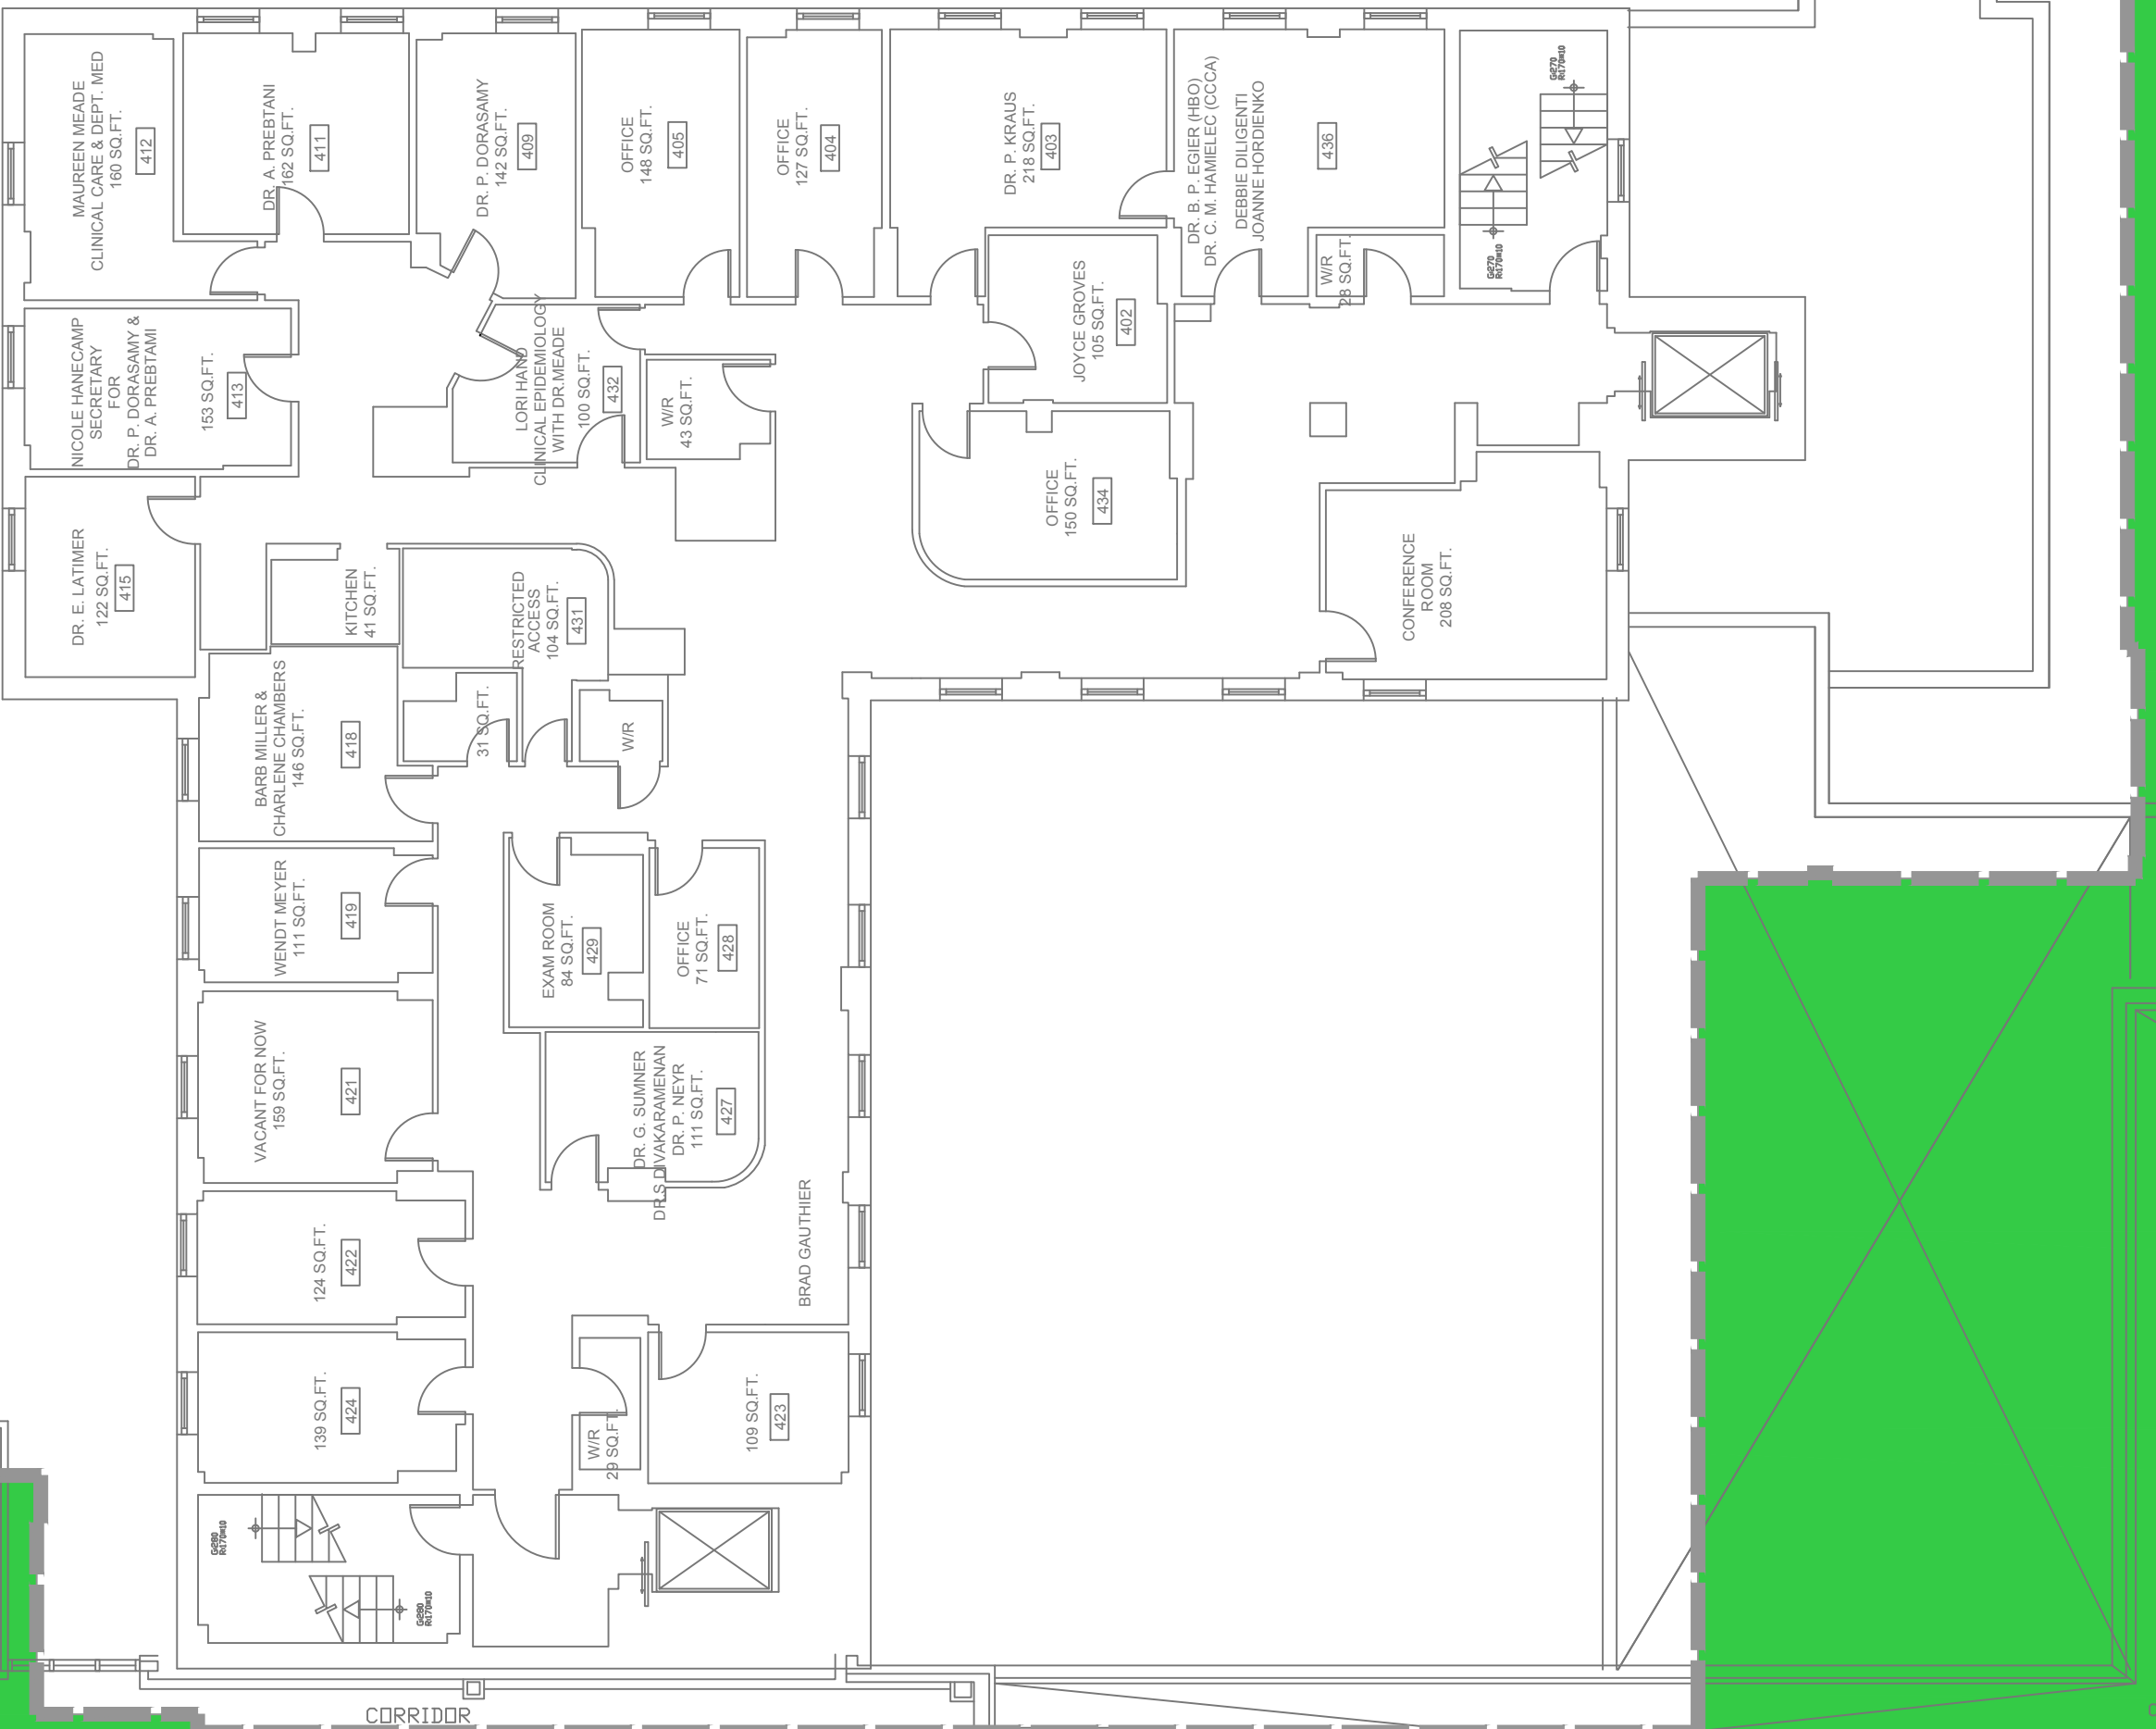
DRAWING:
McMASTER AND INTERNS RES LEVEL 4 ACM ON CEILINGS

ACM CEILING TILES
	ACM DRYWALL JOINT COMPOUND ON CEILING
	ACM PLASTER ON CEILINGS
	NO ACM PRESENT
	ACM ABATED AREA AS PER HHS RECORDS

INTERNS' RESIDENCE LEVEL 4

McMASTER WING LEVEL 4

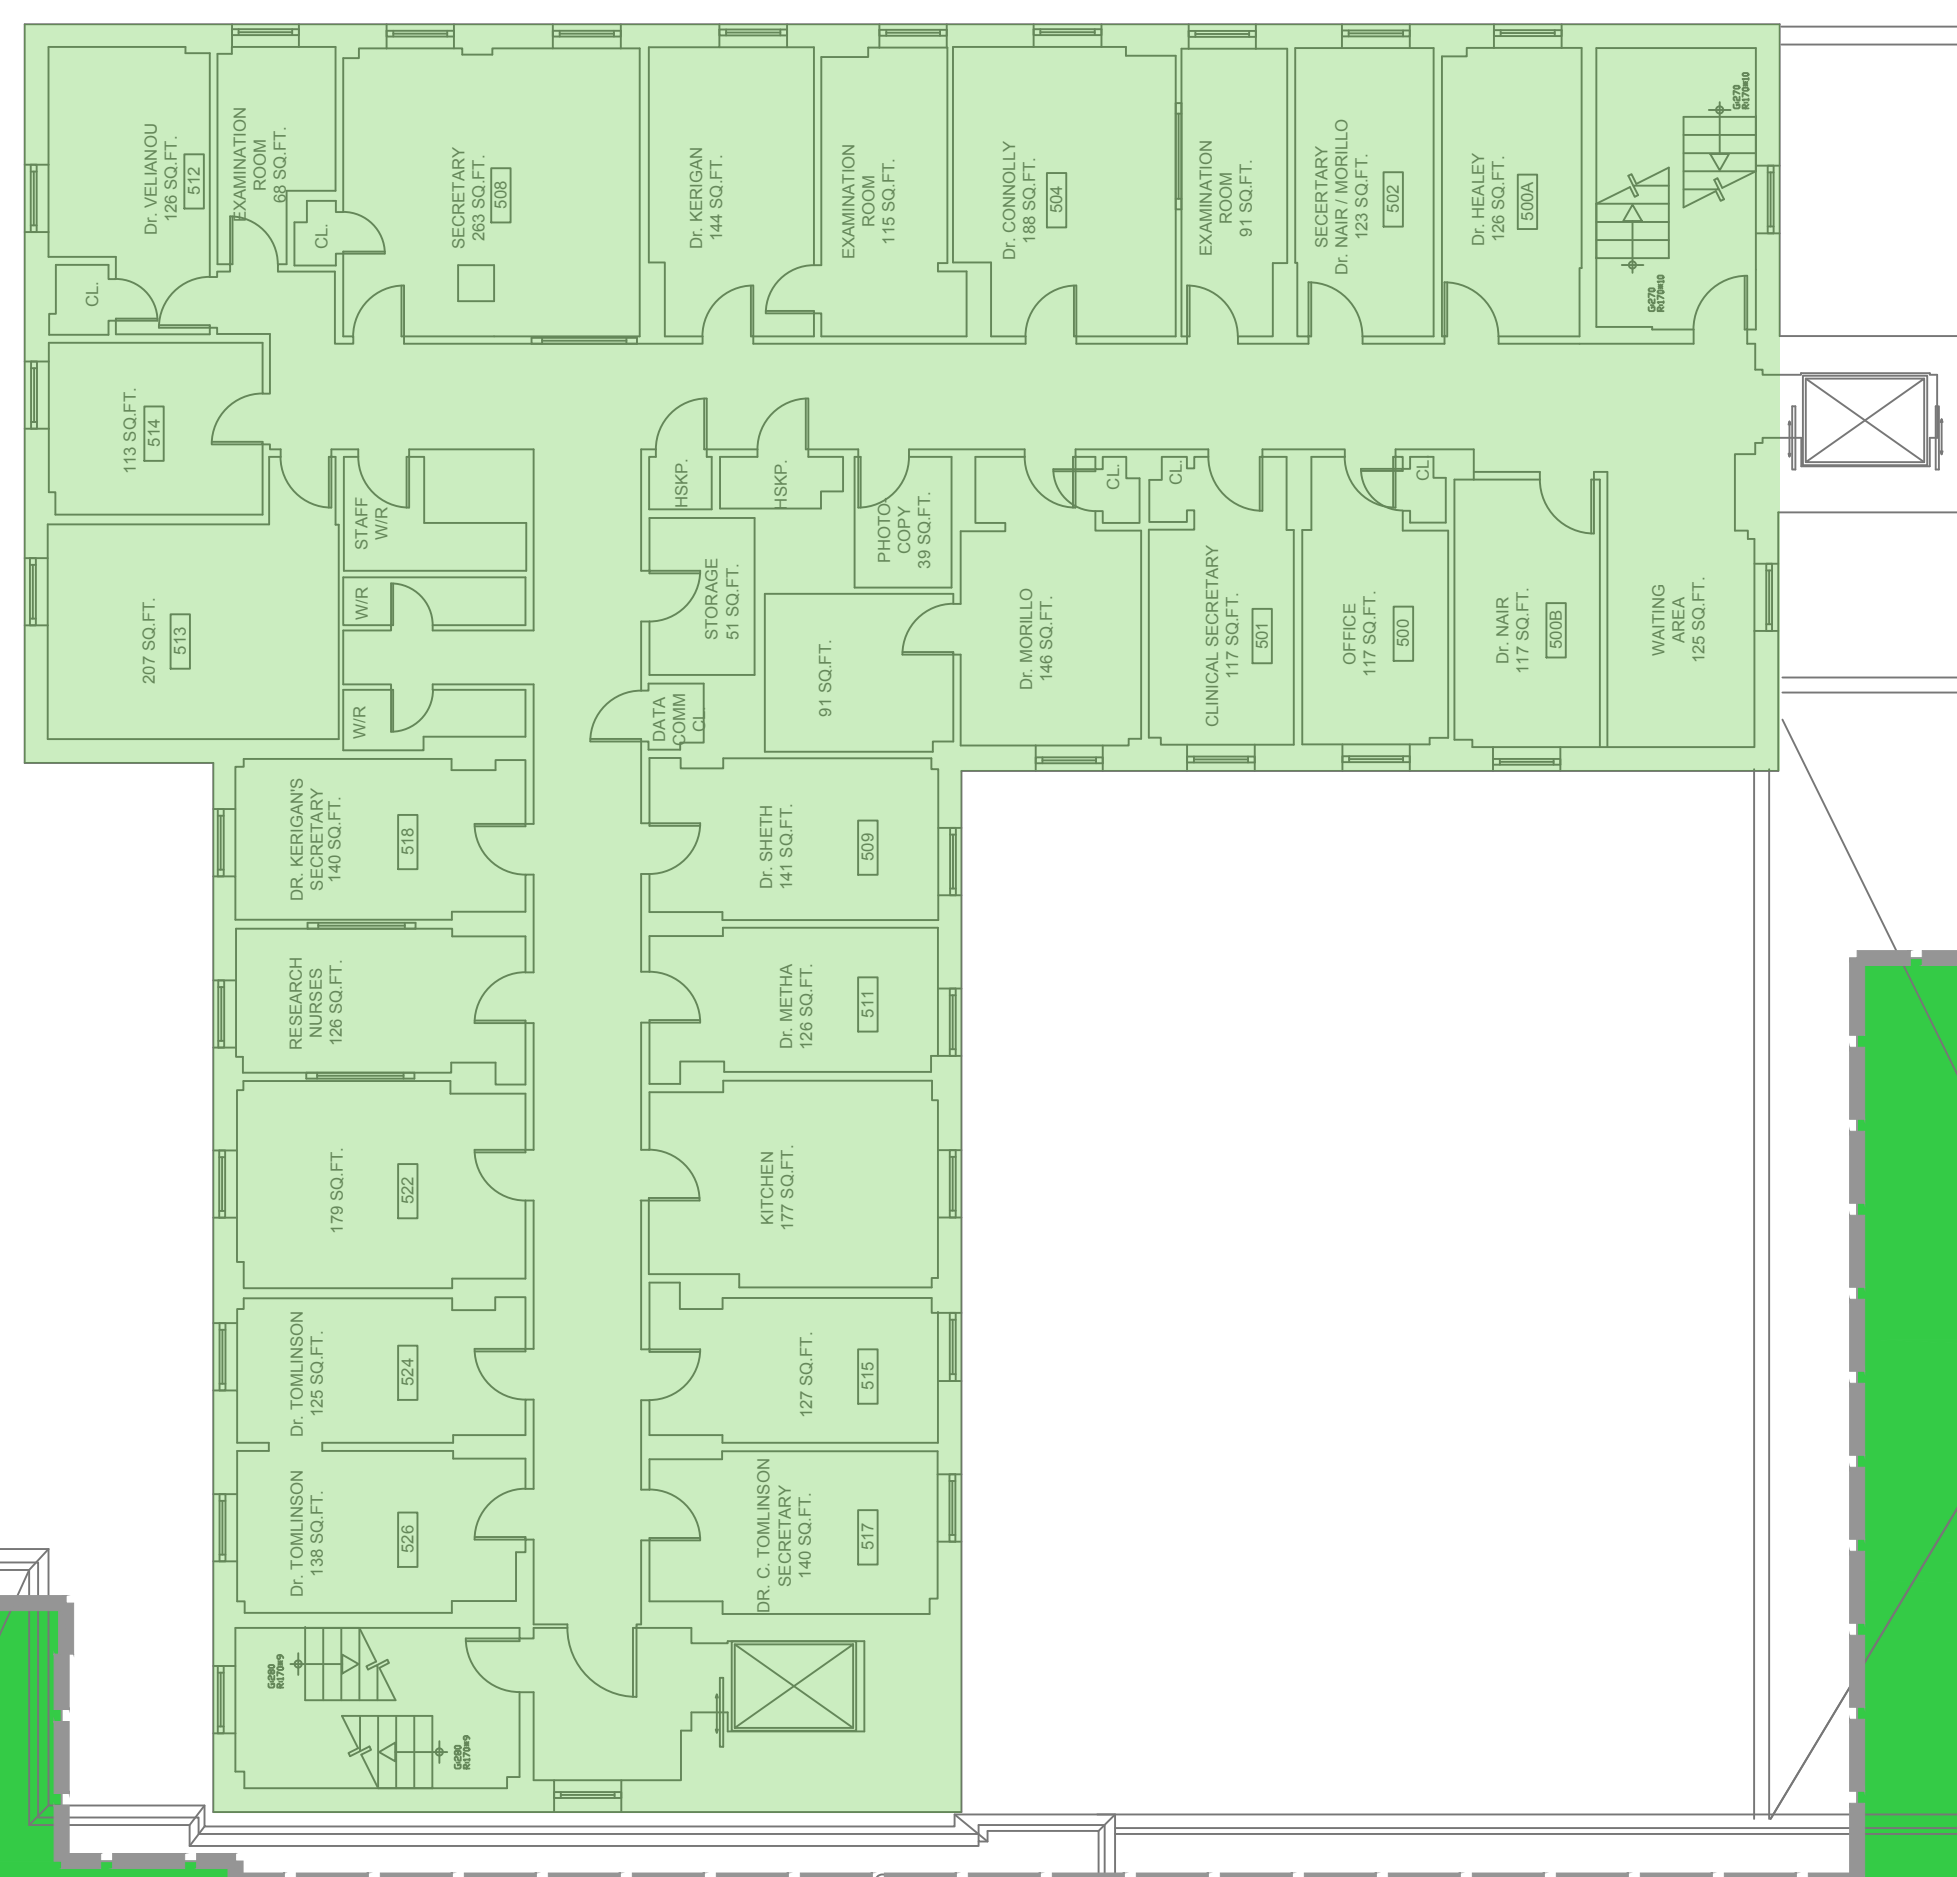
DRAWING:
McMASTER AND INTERNS RES LEVEL 5
ACM ON WALLS

1. MAJORITY OF WALLS ON THIS LEVEL ARE PLASTER WHICH IS NOT ASBESTOS CONTAINING. ONLY DRYWALL JOINT COMPOUND CONTAINS ASBESTOS.

INTERNS' RESIDENCE LEVEL 5

McMASTER WING LEVEL 5

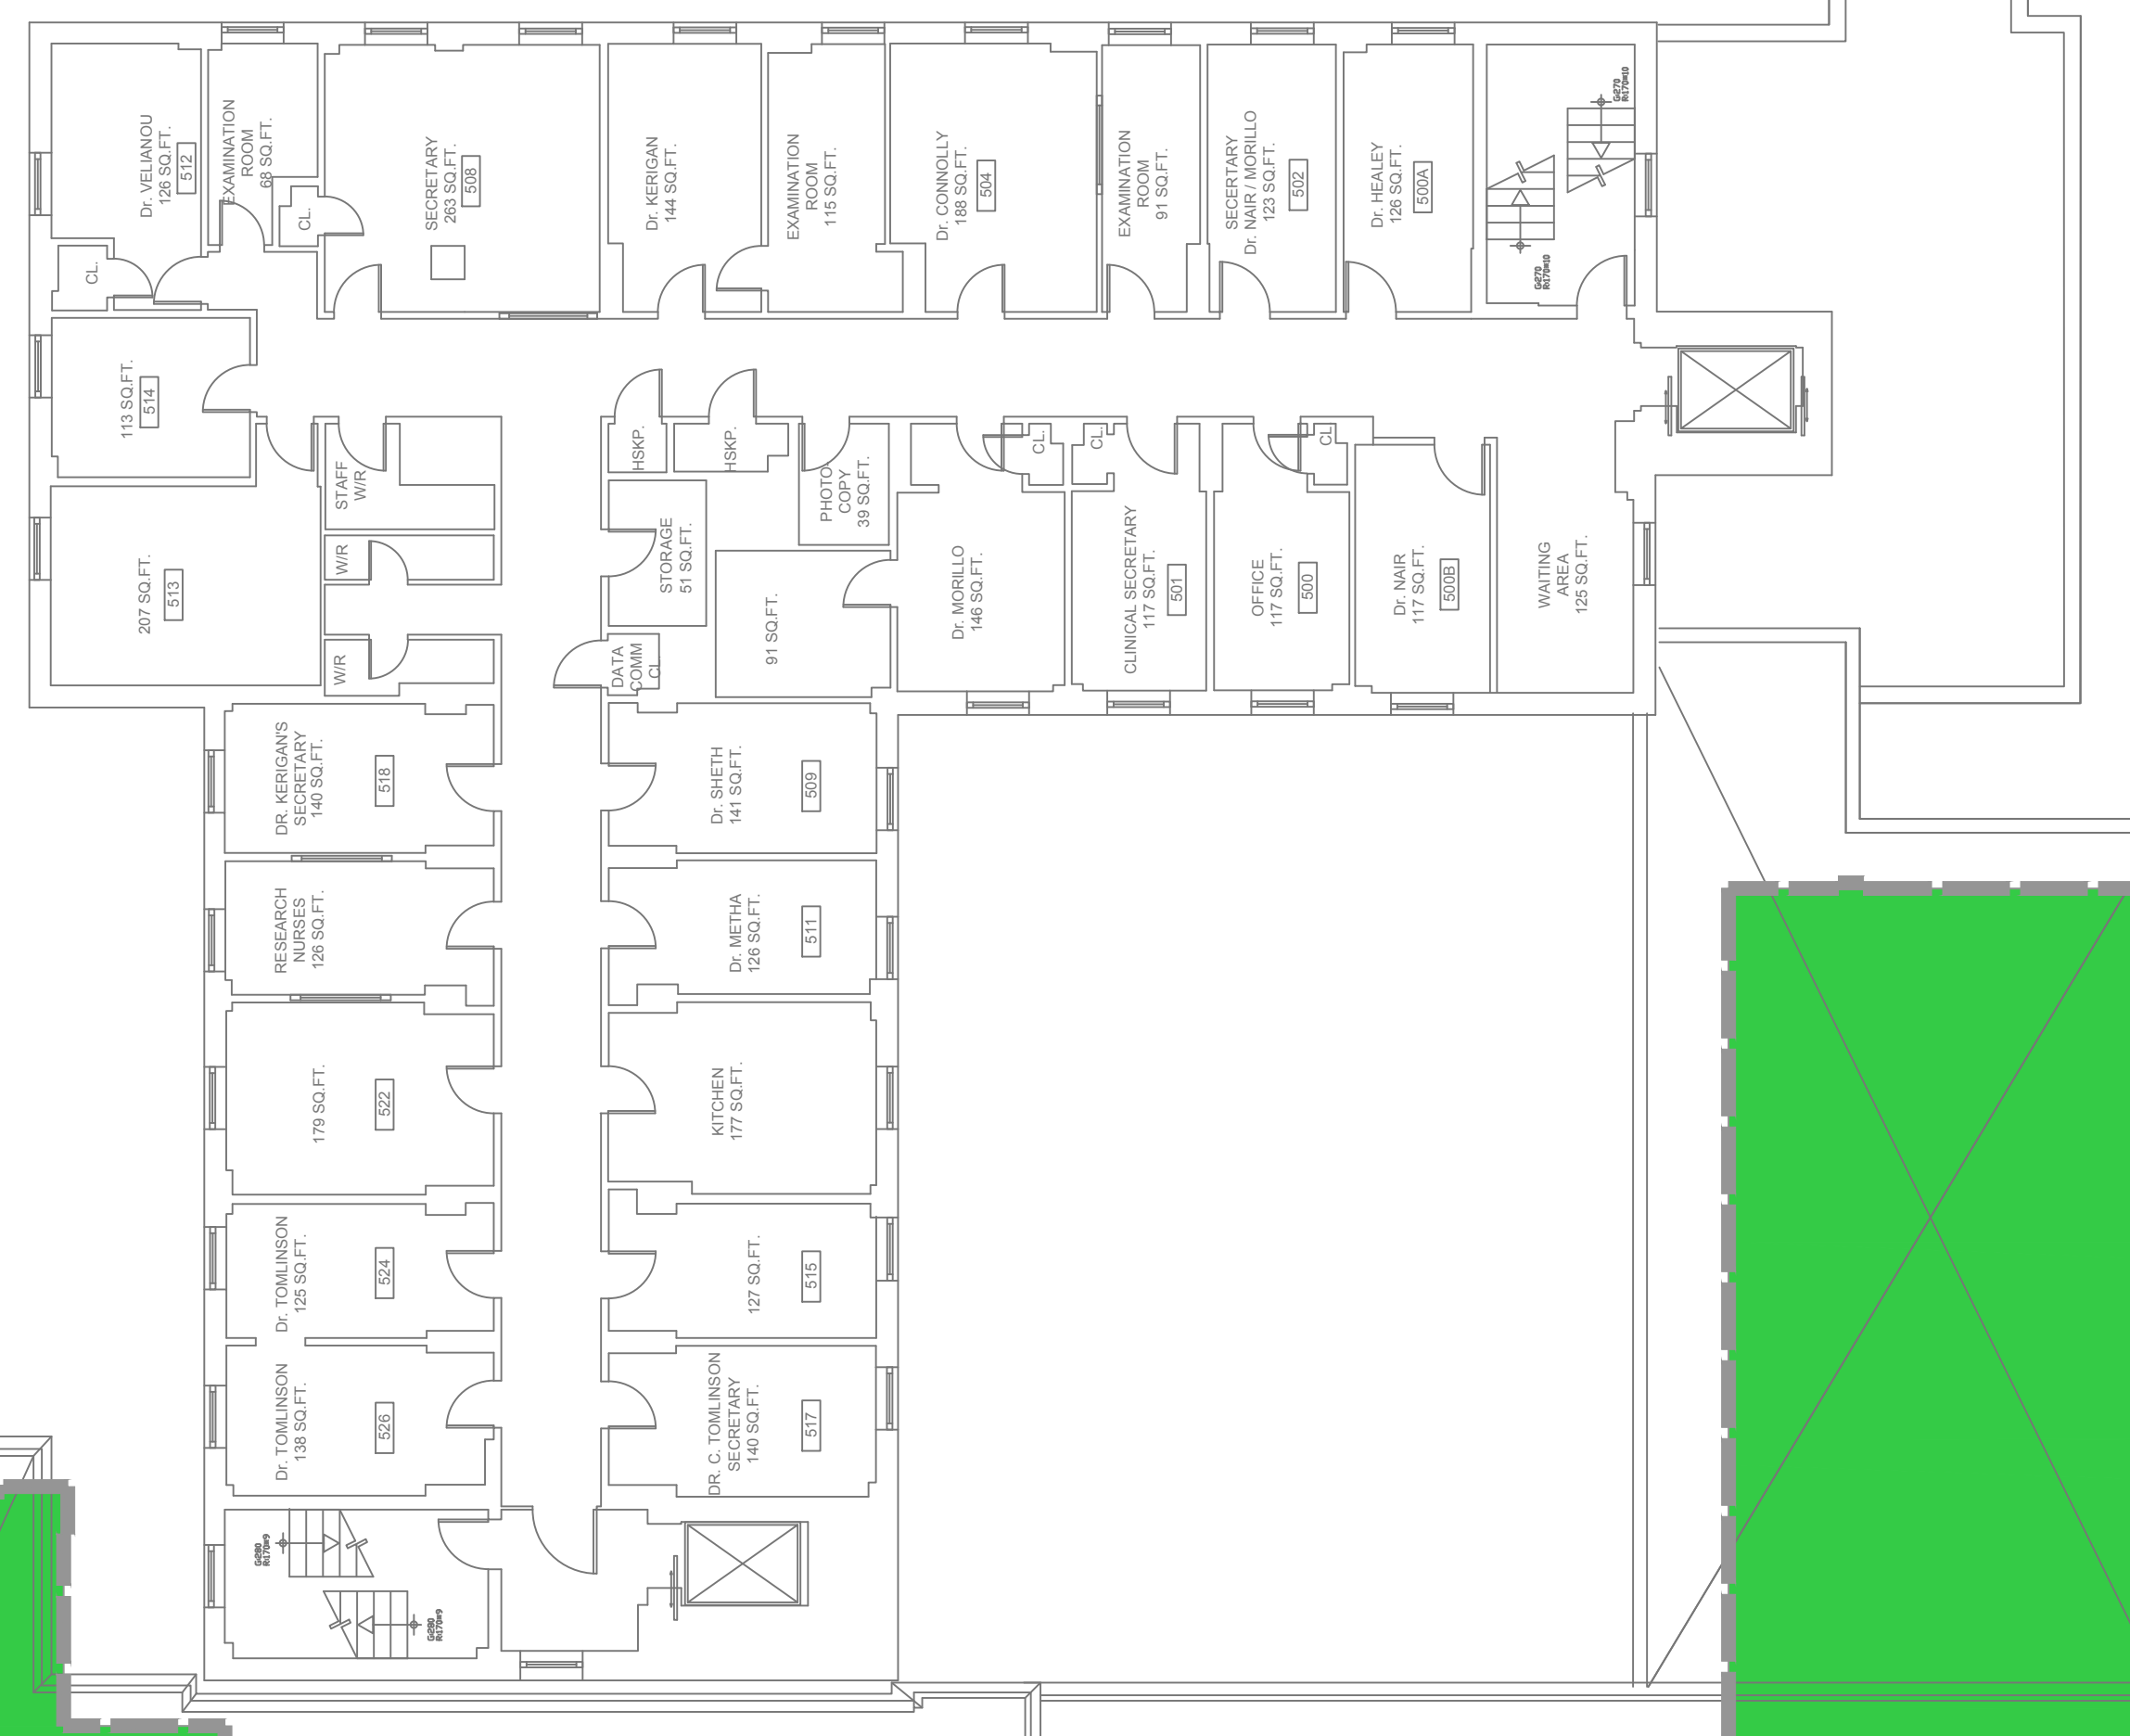
DRAWING:
McMASTER AND INTERNS RES LEVEL 5 ACM ON CEILINGS

- LEGEND - CEILING
- ACM CEILING TILES
 - ACM DRYWALL JOINT COMPOUND ON CEILING
 - ACM PLASTER ON CEILINGS
 - NO ACM PRESENT
 - ACM ABATED AREA AS PER HHS RECORDS

McMASTER WING LEVEL 5

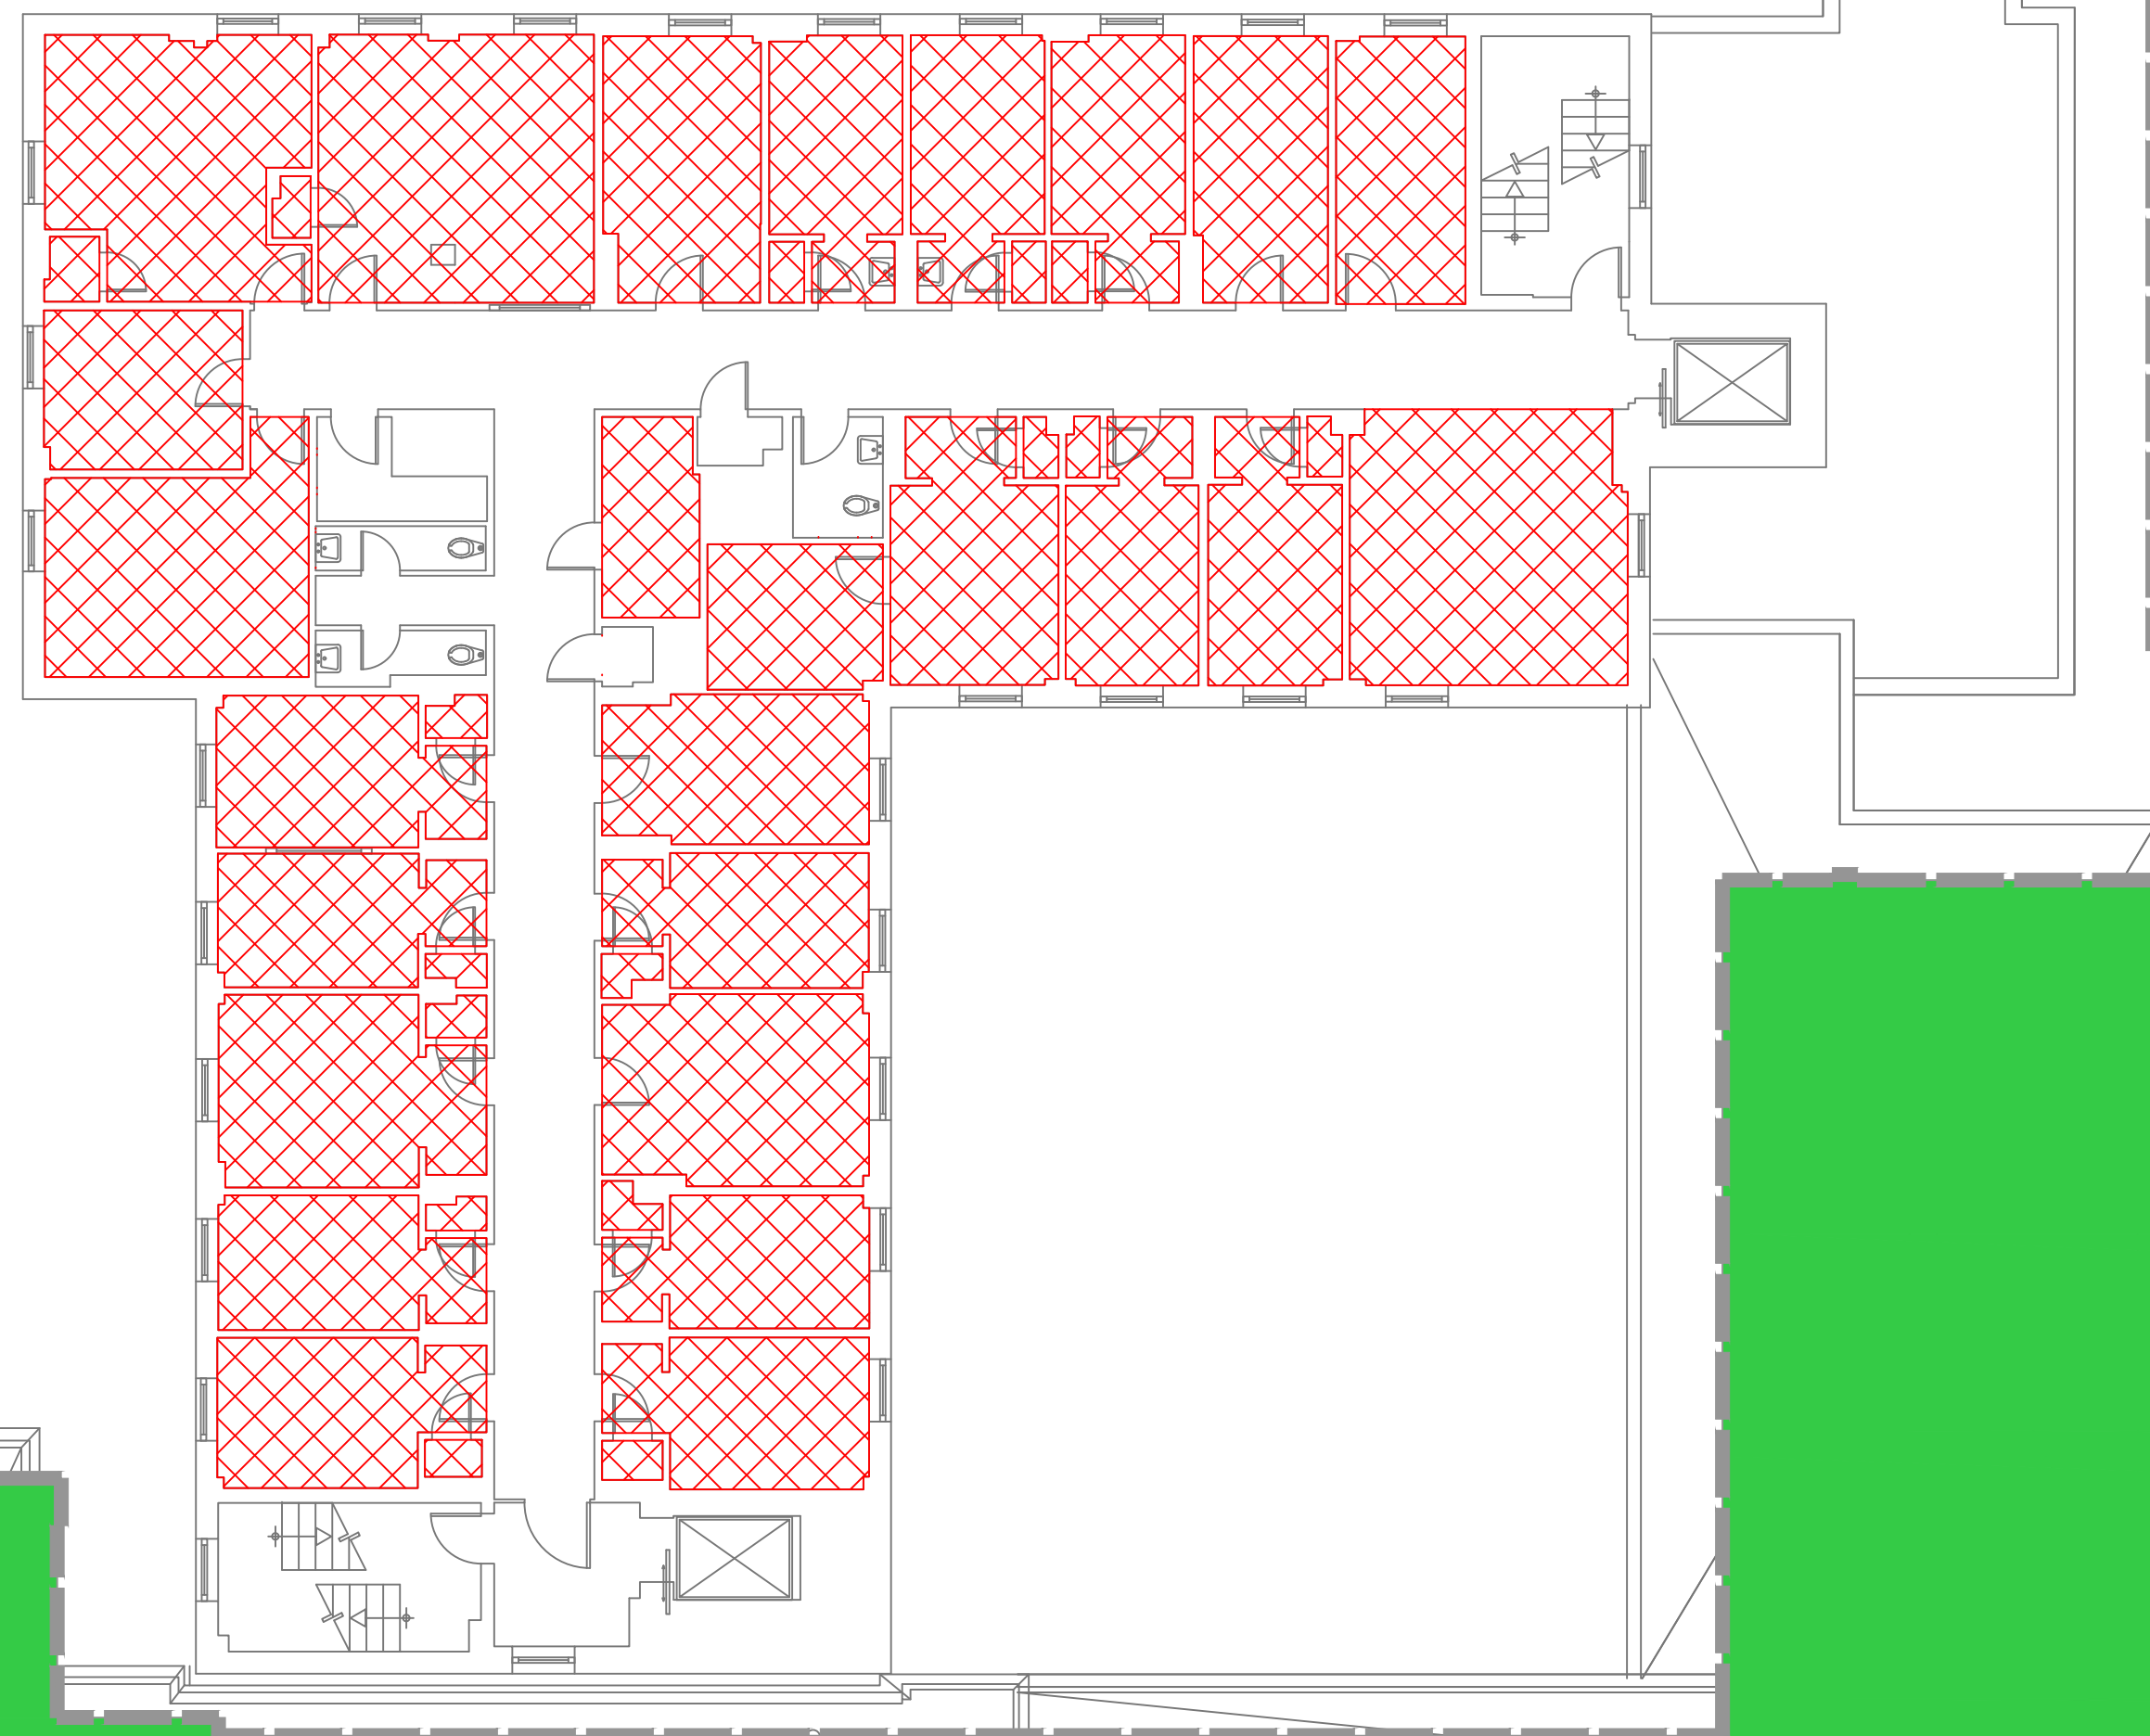
DRAWING:
McMASTER AND INTERNS RES
LEVEL 6
ACM ON FLOORS

1. 9"x9" VINYL FLOOR TILE MAY EXIST BELOW VINYL SHEET FLOORING IN AREAS SHOWN HATCHED

- ACM VINYL FLOOR TILES
- ACM VINYL SHEET FLOORING
- ACM ABATED AREA AS PER HHS RECORDS

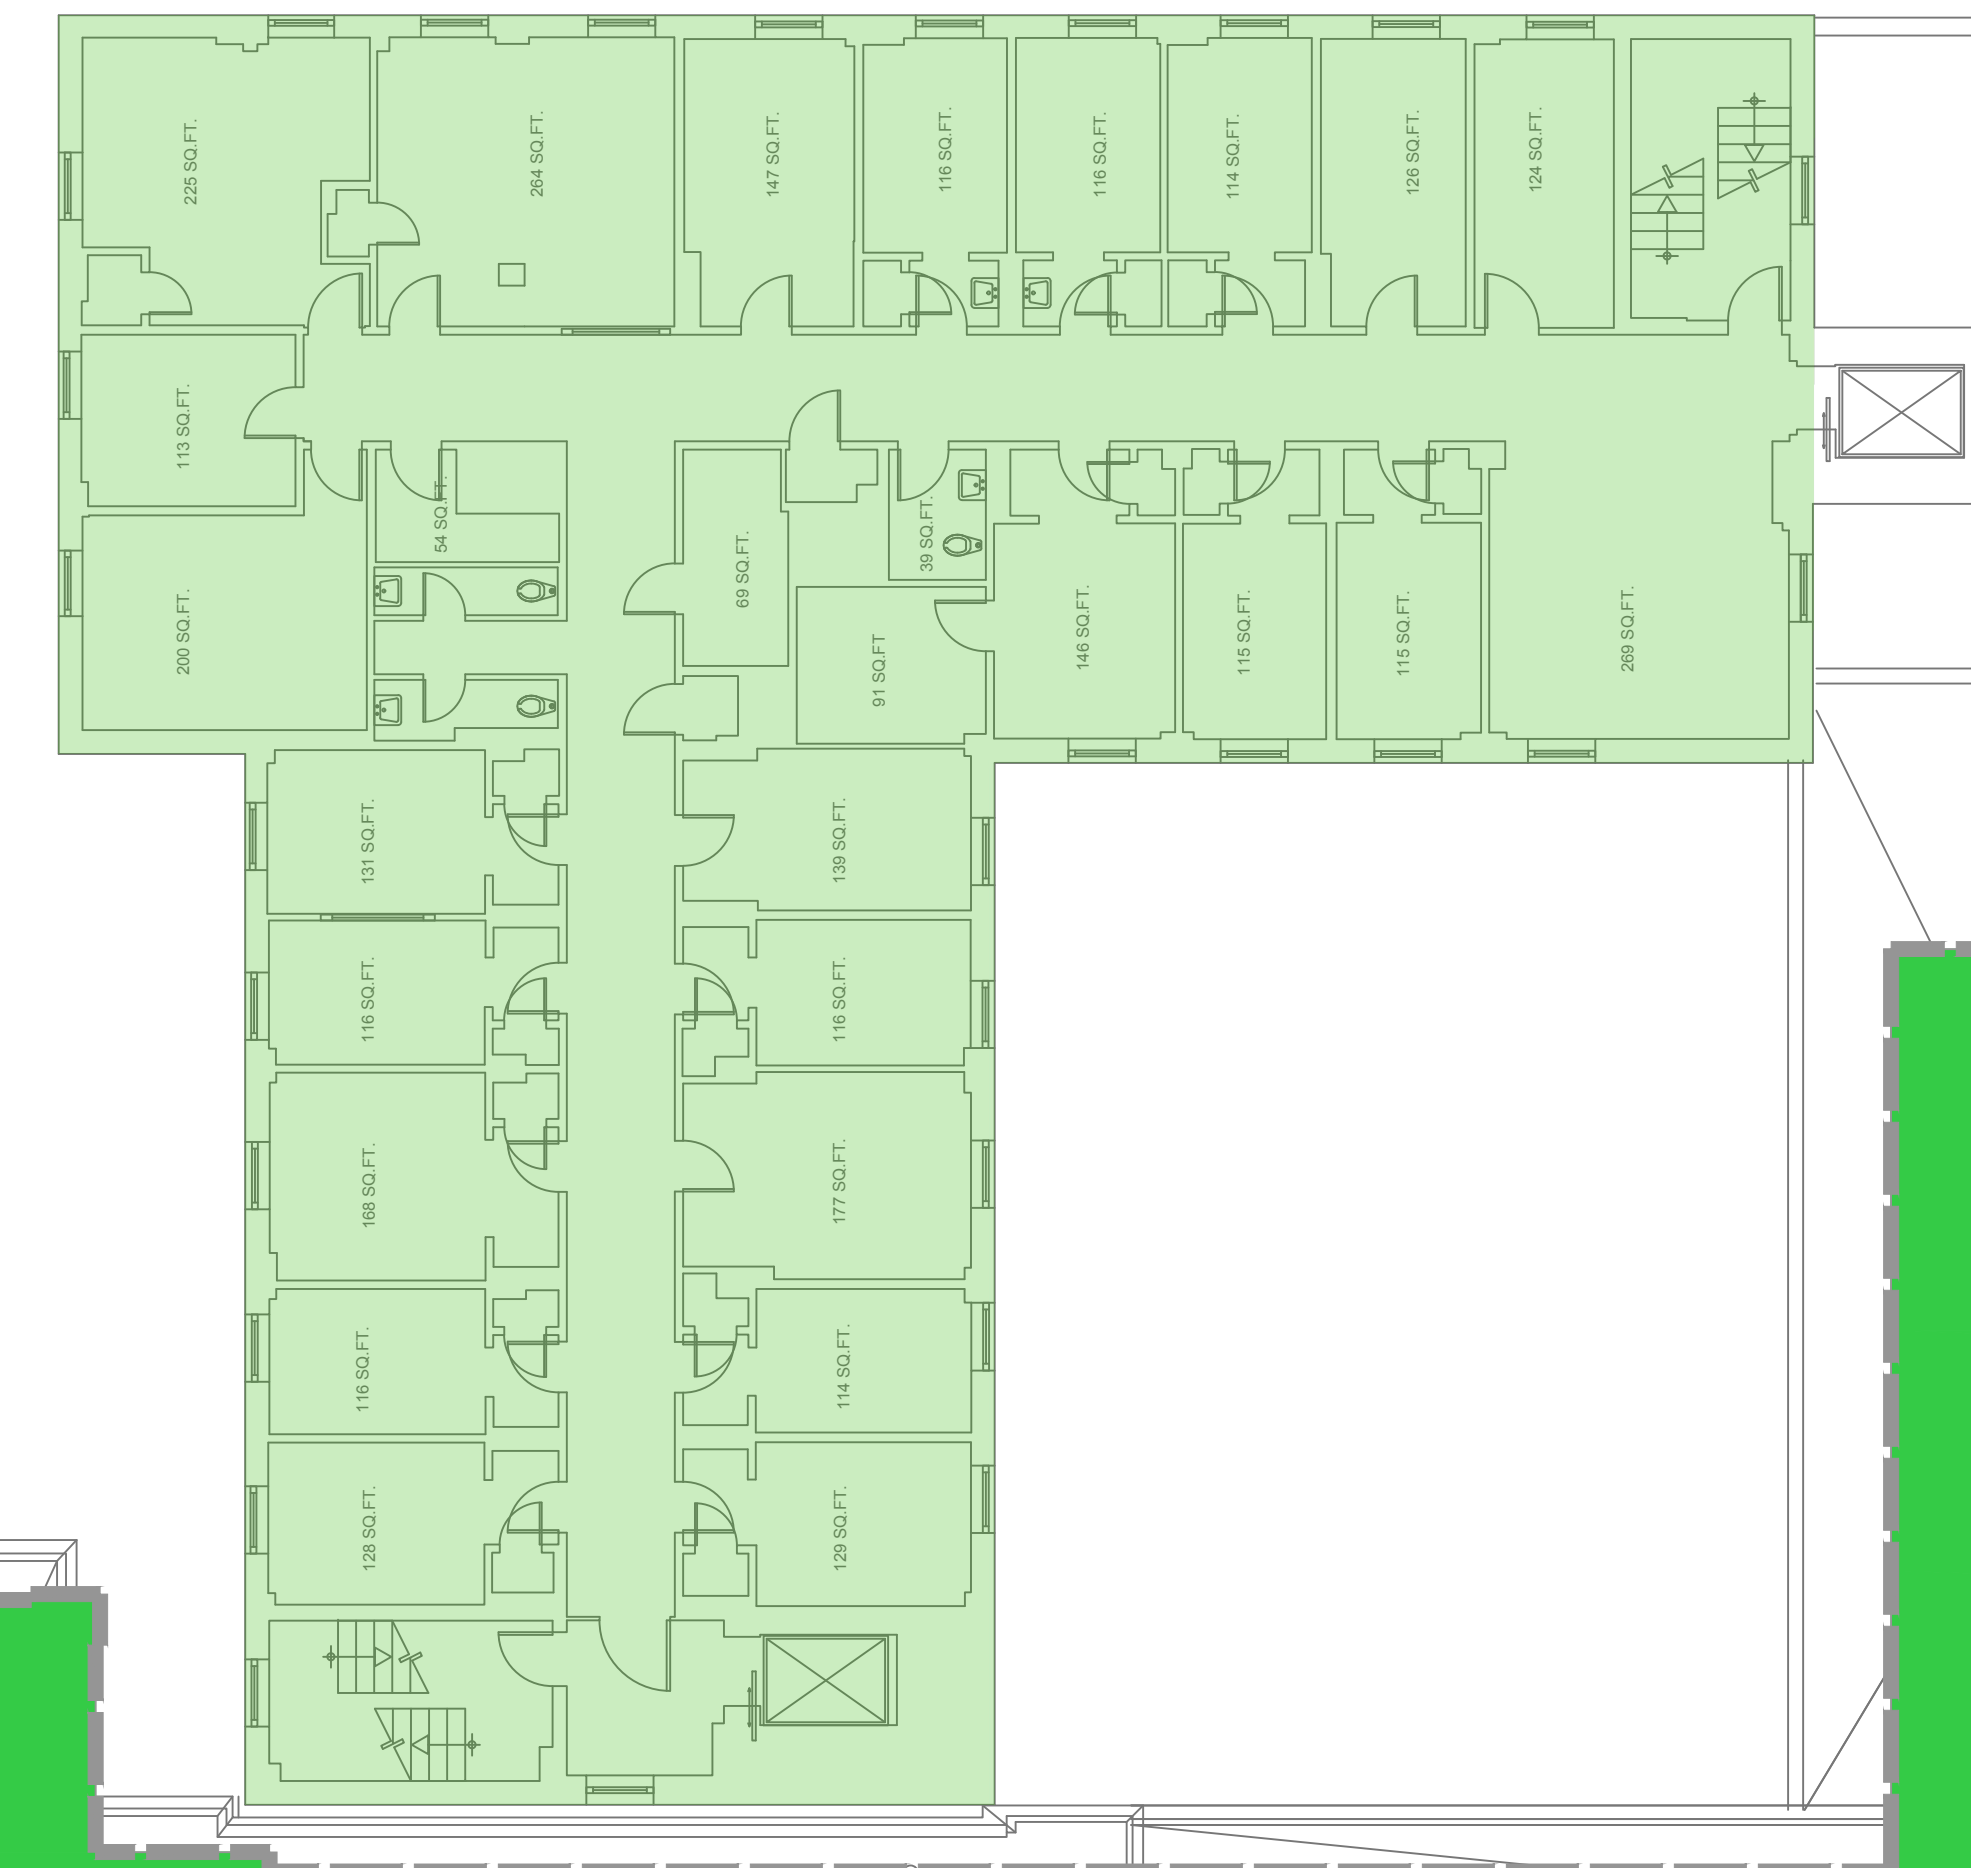
DRAWING:
McMASTER AND INTERNS RES LEVEL 6 ACM ON CEILINGS

INTERNS' RESIDENCE LEVEL 6

McMASTER WING LEVEL 6

- LEGEND - CEILING
- ACM CEILING TILES
 - ACM DRYWALL JOINT COMPOUND ON CEILING
 - ACM PLASTER ON CEILINGS
 - NO ACM PRESENT
 - ACM ABATED AREA AS PER HHS RECORDS

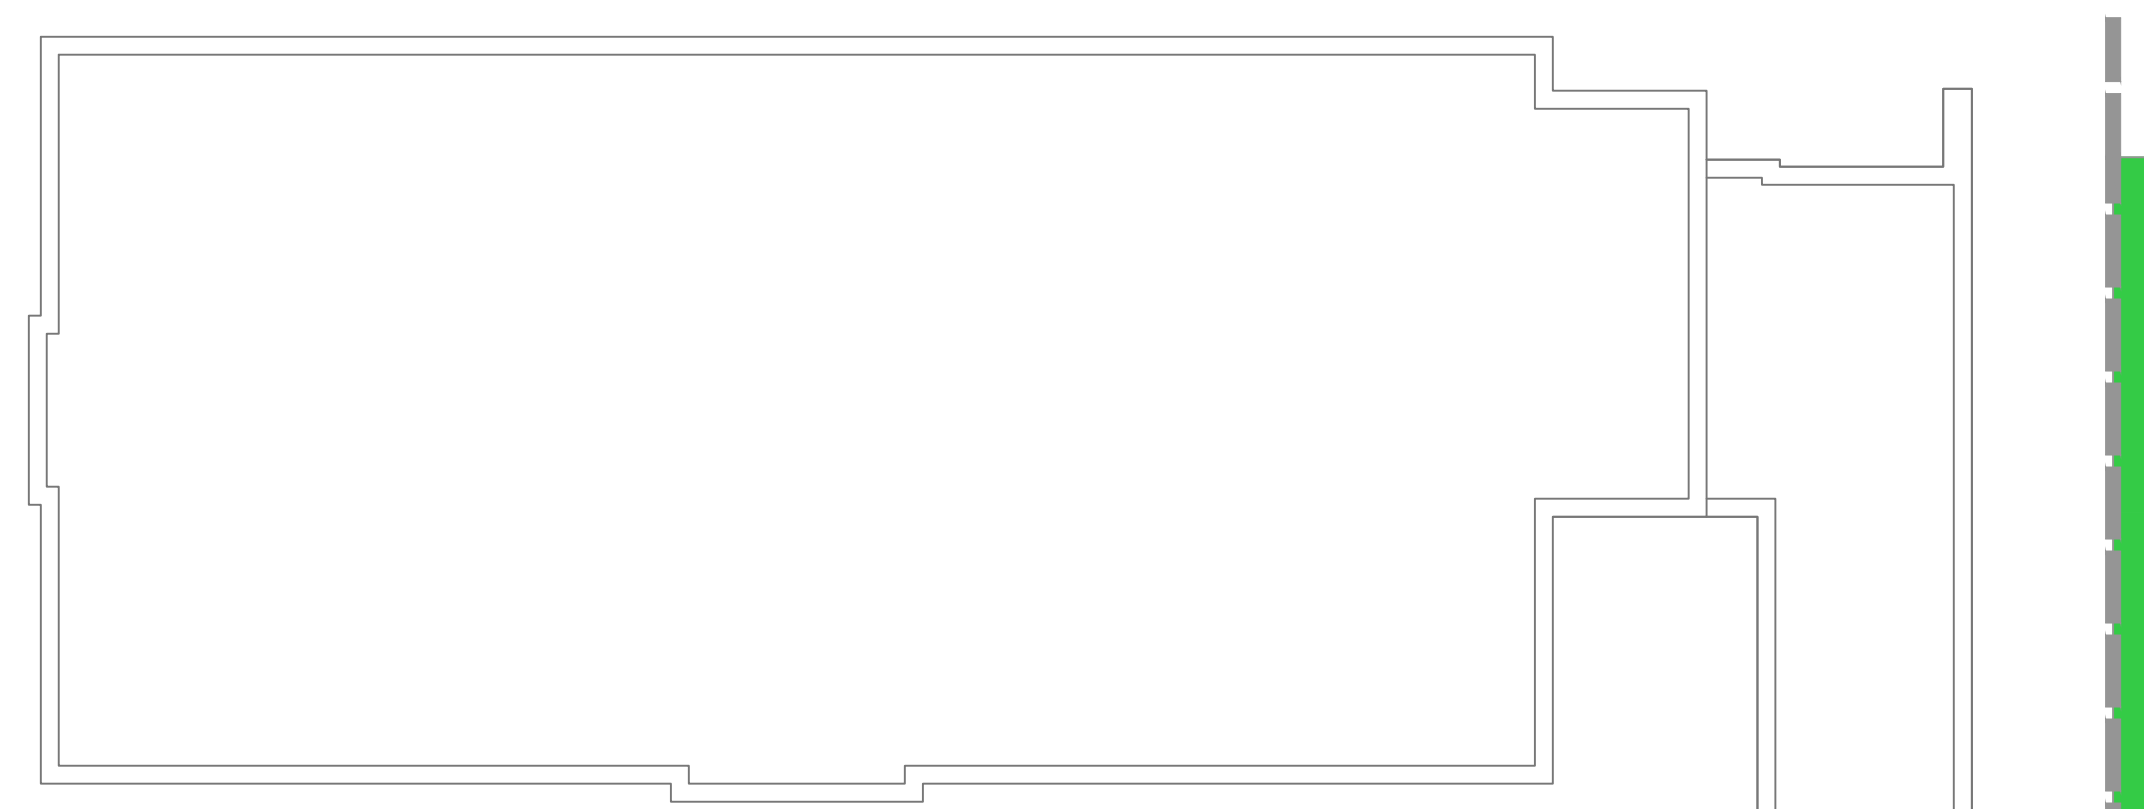
DRAWING:
McMASTER AND INTERNS RES LEVEL 6 OTHER ACM

INTERNS' RESIDENCE LEVEL 6

McMASTER WING LEVEL 6

PI	ACM PIPE INSULATION
DI	ACM DUCT INSULATION
MI	ACM MECHANICAL INSULATION
T1	TYPE 1 ENTRY
T2	TYPE 2 ENTRY
T3	TYPE 3 ENTRY
TF	ACM TEXTURE FINISH
FS	ACM FIRESTOPPING
T	TRANSITE
NAR	NO ACCESS TO ROOM/AREA
