FINAL
Asbestos
Reassessment

Hamilton General Hospital
237 Barton Street East, Hamilton,
Ontario

Hamilton General Hospital, 237 Barton Street East, Hamilton, Ontario
Hamilton Health Sciences

January 16, 2019
Pinchin File: 217420.030
FINAL

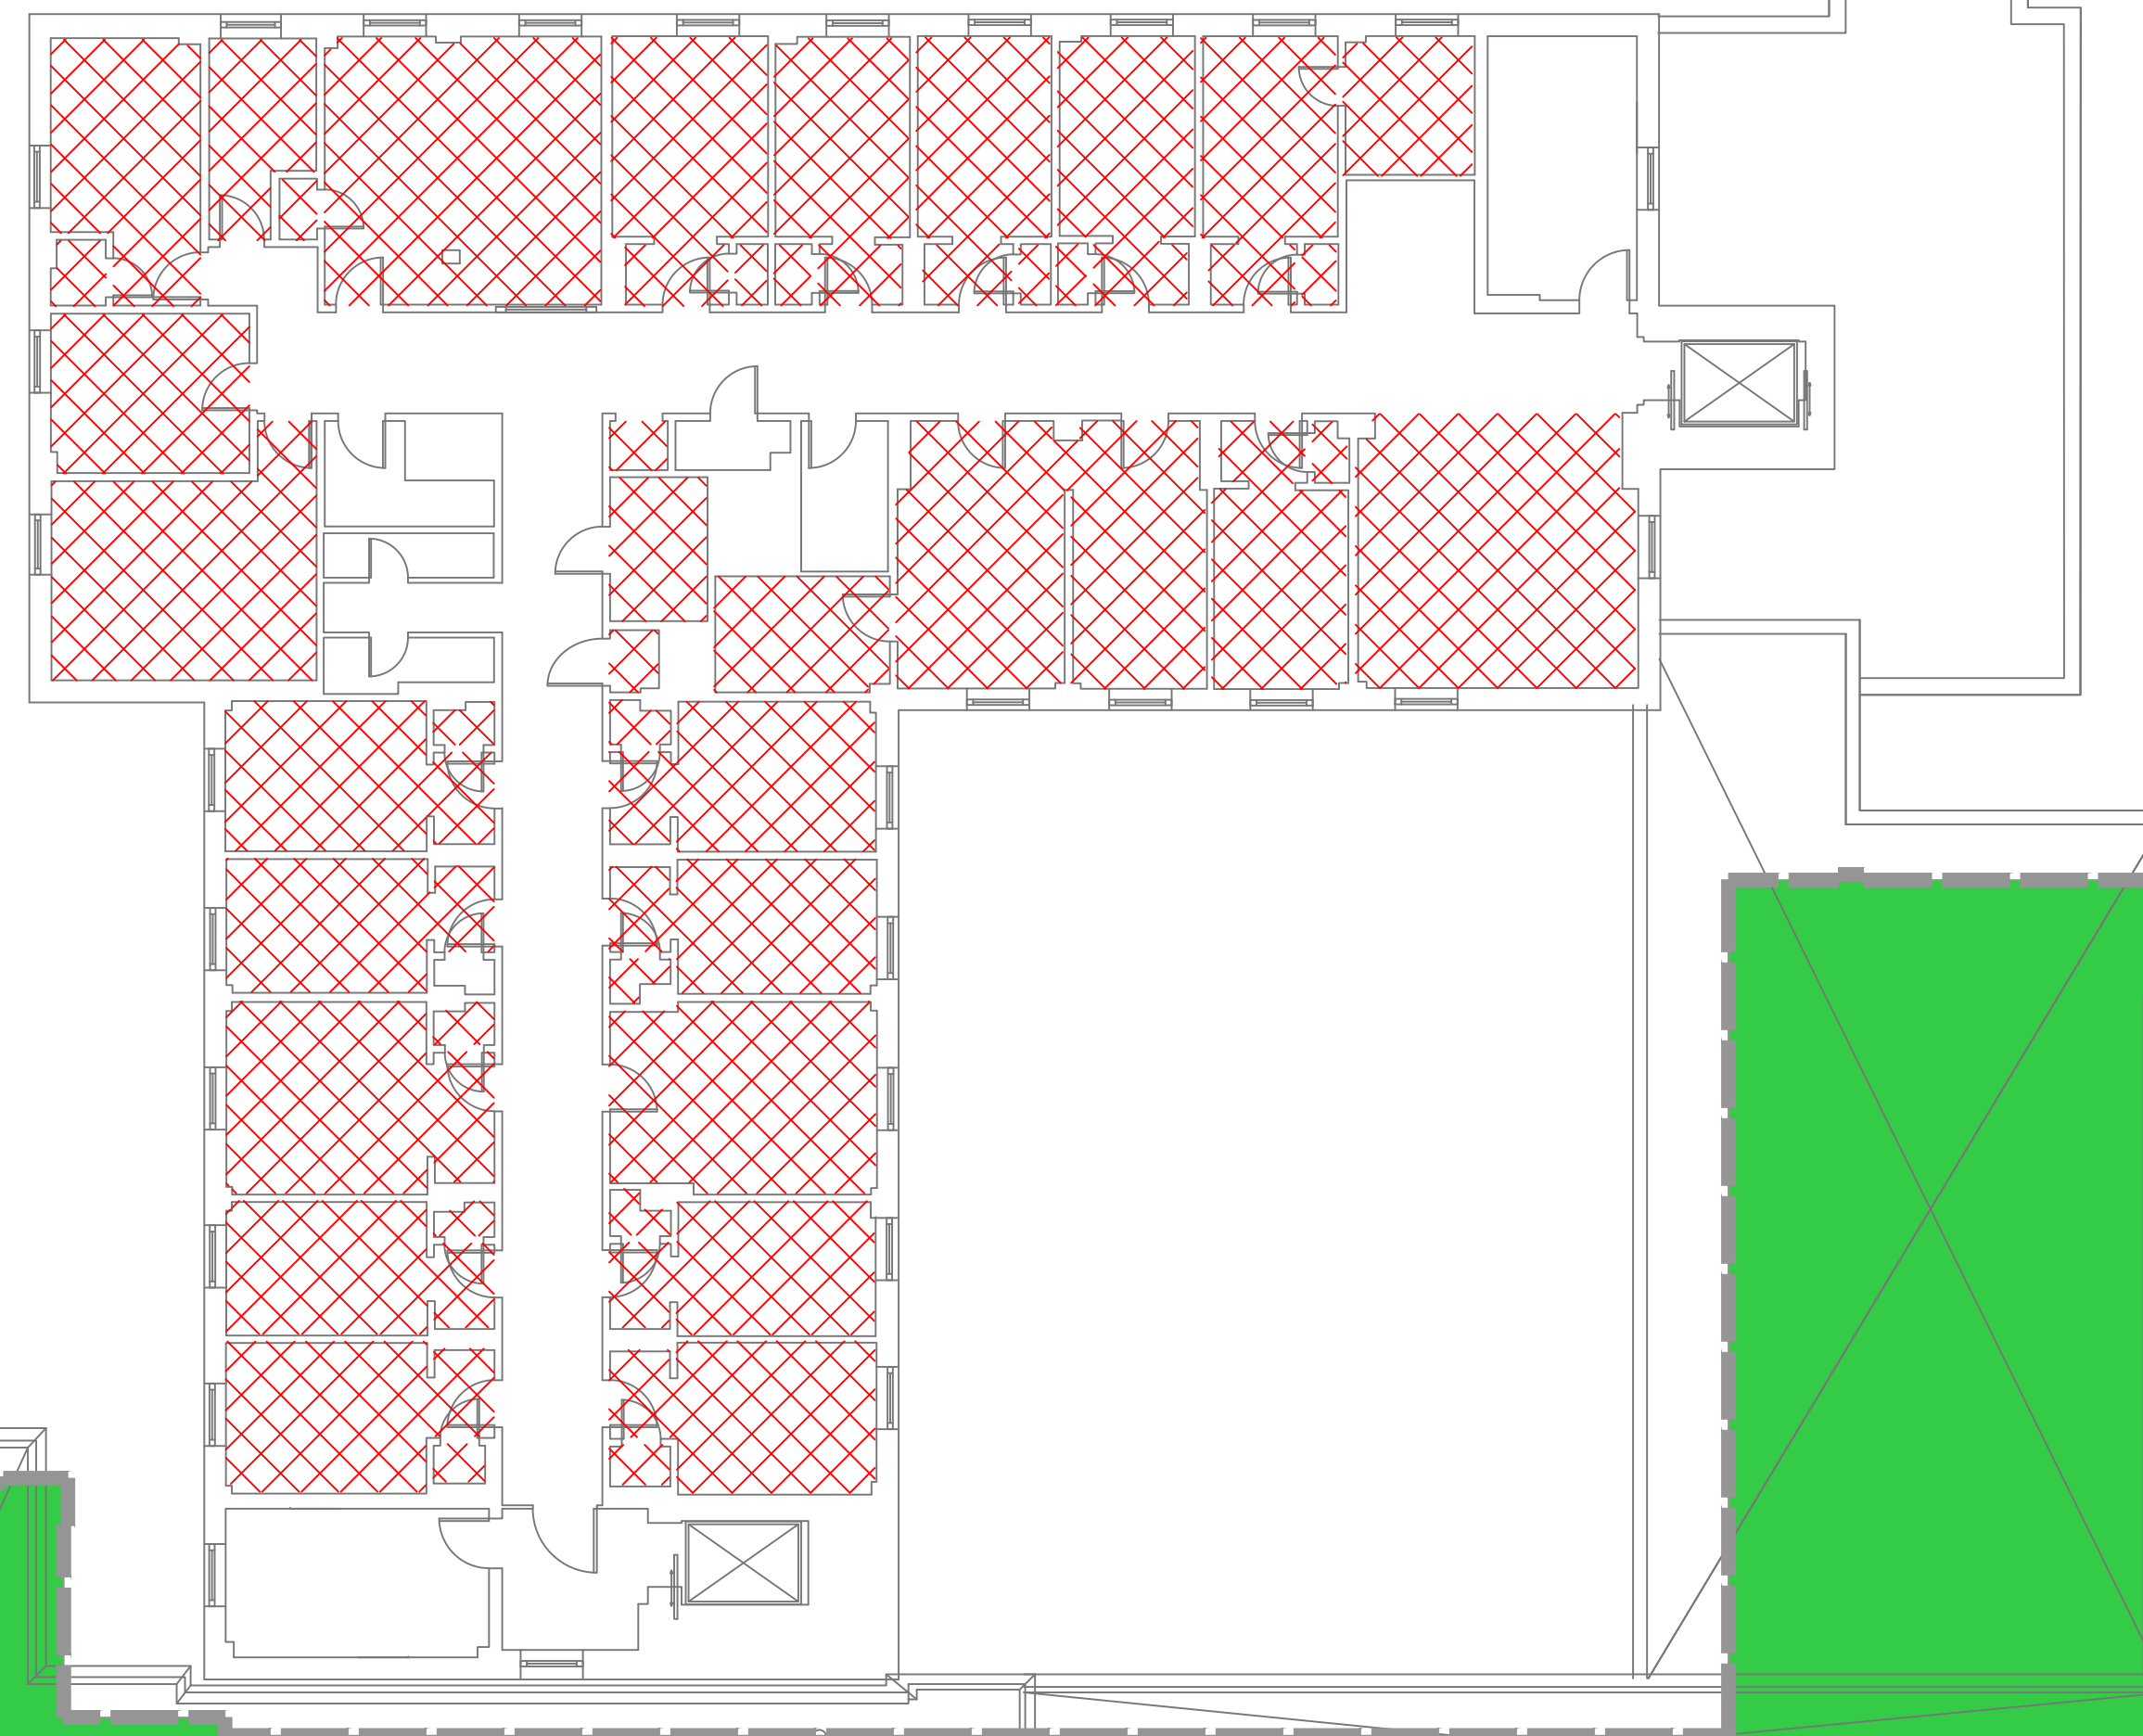
DRAWING:
McMASTER AND INTERNS RES
LEVEL 7
ACM ON FLOORS

1. 9"x9" VINYL FLOOR TILE MAY EXIST BELOW VINYL SHEET FLOORING IN AREAS SHOWN HATCHED

MAIN BUILDING-LEVEL 7

- LEGEND - FLOORS
- ACM VINYL FLOOR TILES
 - ACM VINYL SHEET FLOORING
 - ACM ABATED AREA AS PER HHS RECORDS

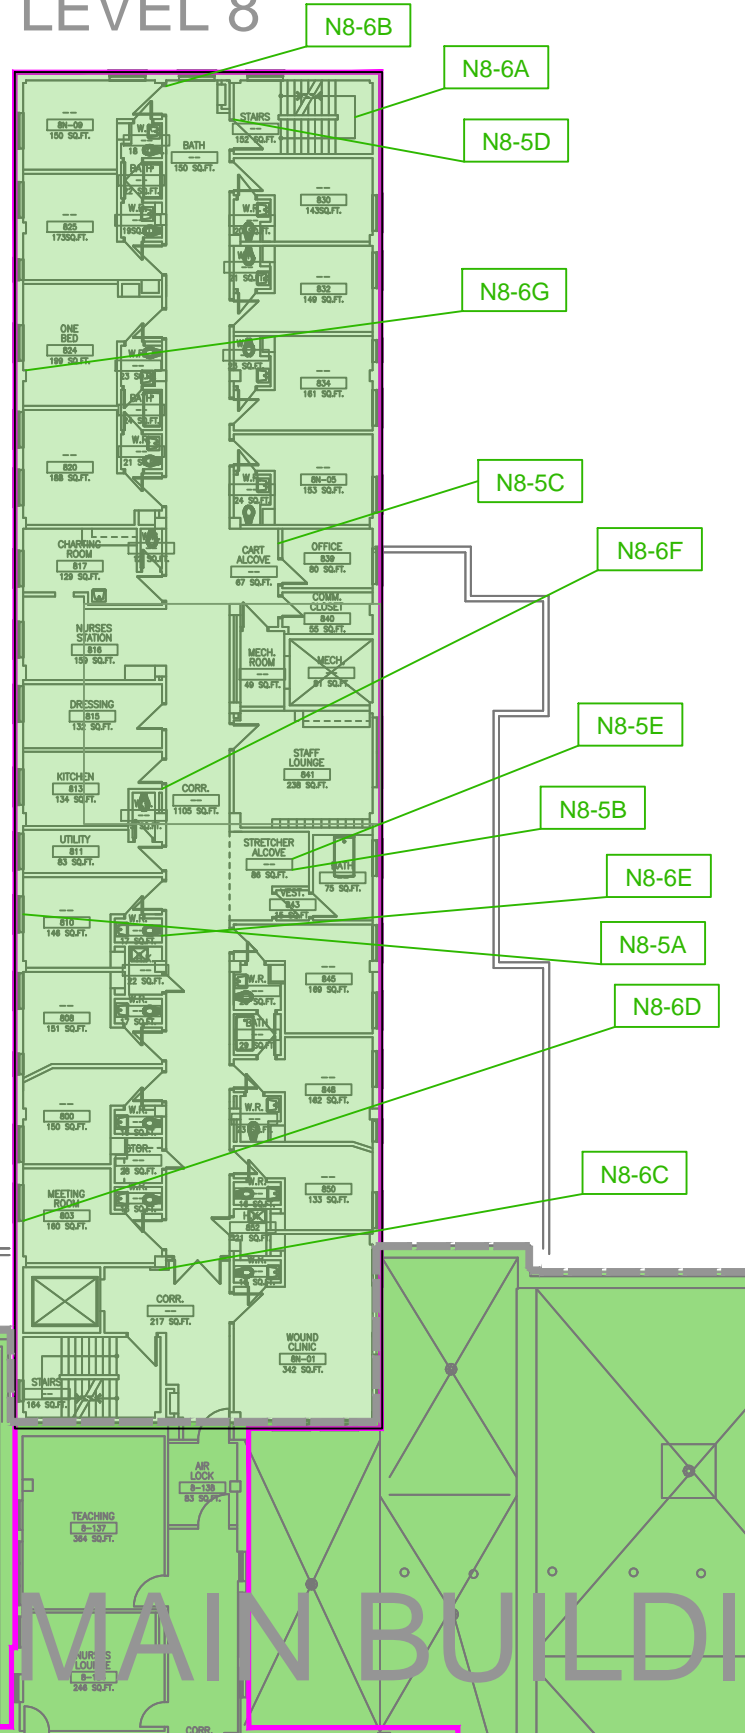
NORTH WING LEVEL 8 UPPER

- ACM PRESENT IN DRYWALL JOINT COMPOUND AND/OR PLASTER
- SUSPECT ACM
- NO ACM PRESENT
- ACM ABATED AREA AS PER HHS RECORDS

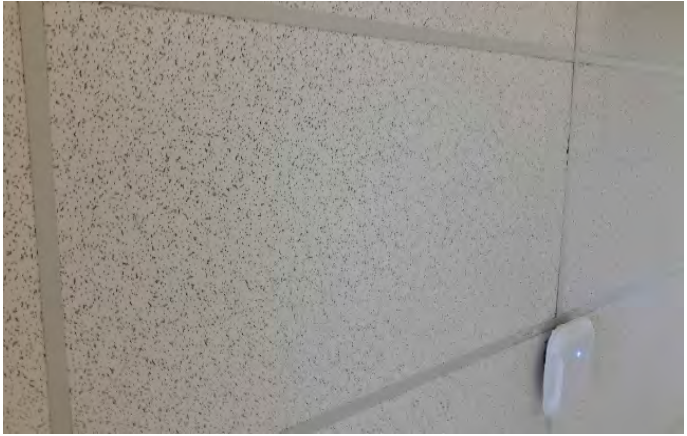
TABLE V Summary of Ceiling Tiles (CT)				
MIN	Description	Sample Number	Results	Photograph
CT1	2' x 4' Pinholes w/ Small Fissures	17429- HG-E1- 03A to 03C	None Detected

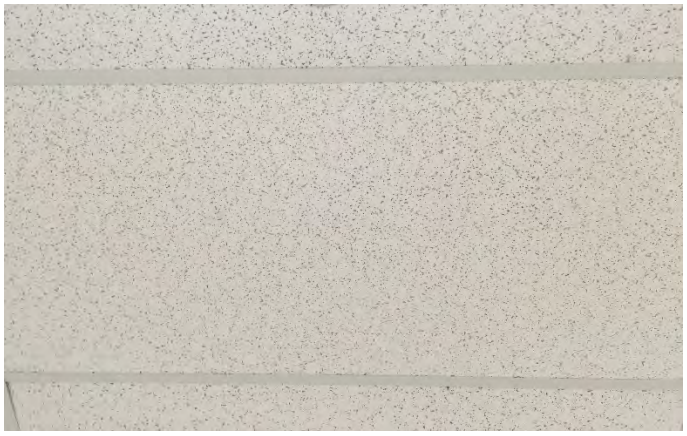
CT2	2' x 4' Pinholes w/ Medium Fissures	17429- HG-E4 - 04A to 04C	None Detected

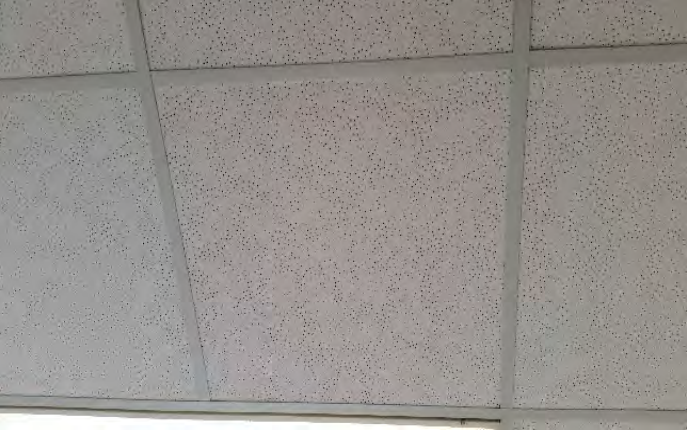
CT3	2' x 2' Small and Large Pinholes	17429- HG-E3- 04A to 04C	None Detected

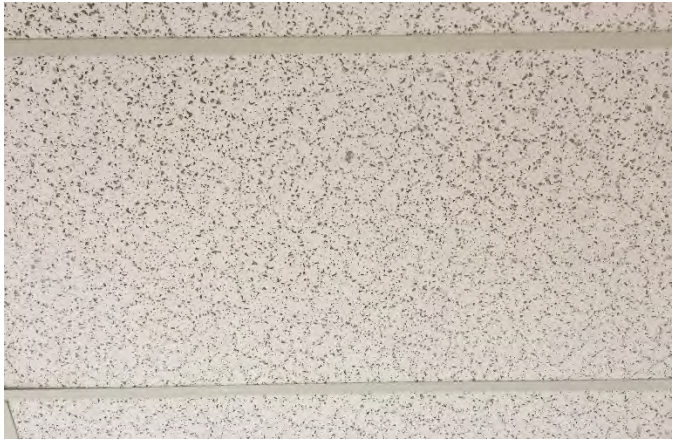
TABLE V Summary of Ceiling Tiles (CT)				
MIN	Description	Sample Number	Results	Photograph
CT4	2' x 4' Pinholes and Clustered Flecks	17429- HG-N2- 03A to 03B	None Detected

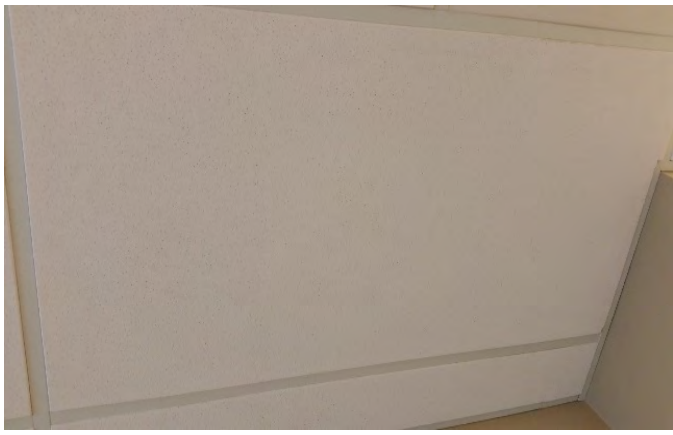
CT5	2' x 4' Textured w/ Tiny Pinholes	17429- HG-N3L- 04A to 04C	None Detected

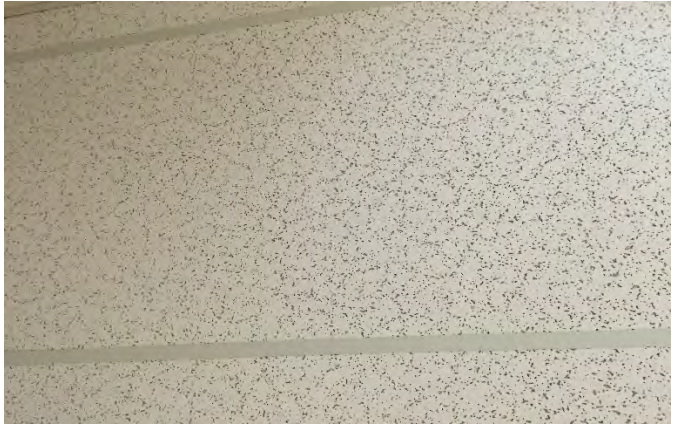
CT6	2' x 4' Pinholes and Flecks	17429- HG-N6- 04A to 04C	None Detected

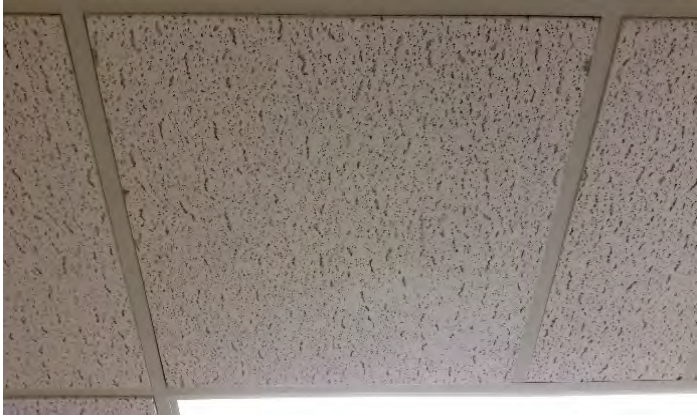
TABLE V Summary of Ceiling Tiles (CT)				
MIN	Description	Sample Number	Results	Photograph
CT7	2' x 2' Pinhole w/ Medium Fissures	17429- HG-N7- 04A to 04C	None Detected

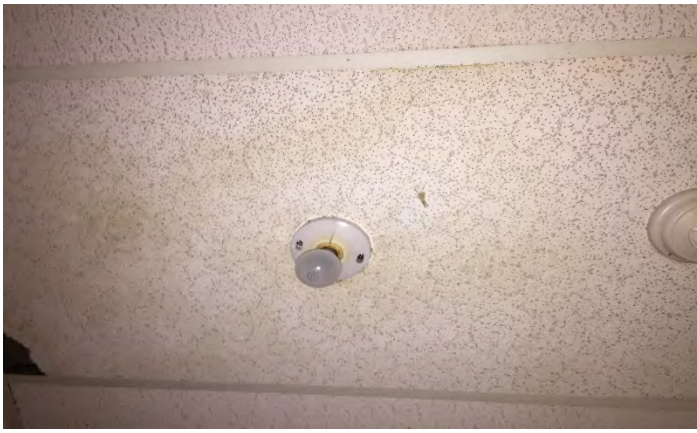
CT8	2' x 2' Ceiling Tile	17429- HG-JR1- 03A to 03C	None Detected

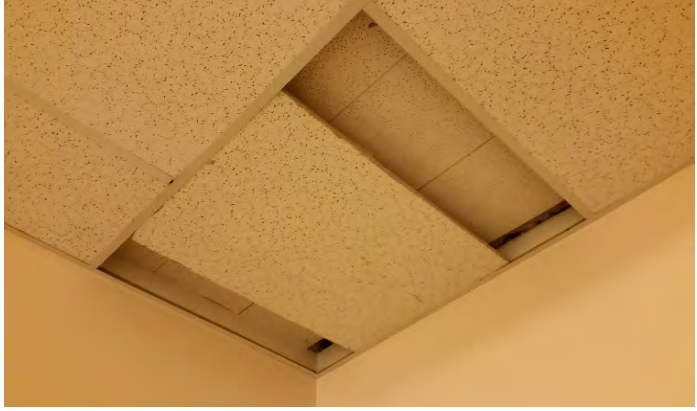
CT9	1' x 1' Small and Medium Pinholes	17429- HG-MC0- 04A to 04C	None Detected

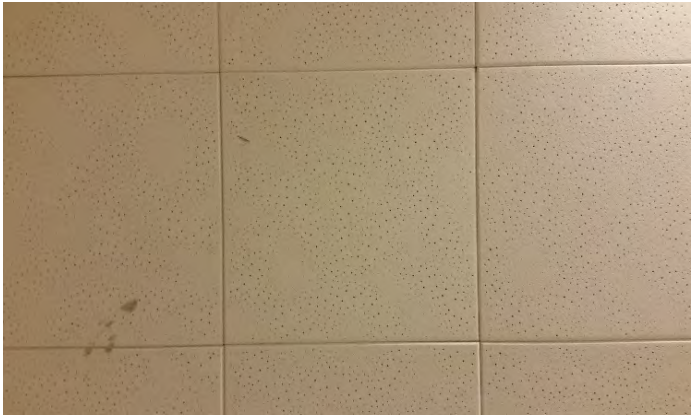
TABLE V Summary of Ceiling Tiles (CT)				
MIN	Description	Sample Number	Results	Photograph
CT10	1' x 1' Glue-on Medium and Small Pinholes	17429- HG-MC2- 04A to 04C	5-6% Amosite

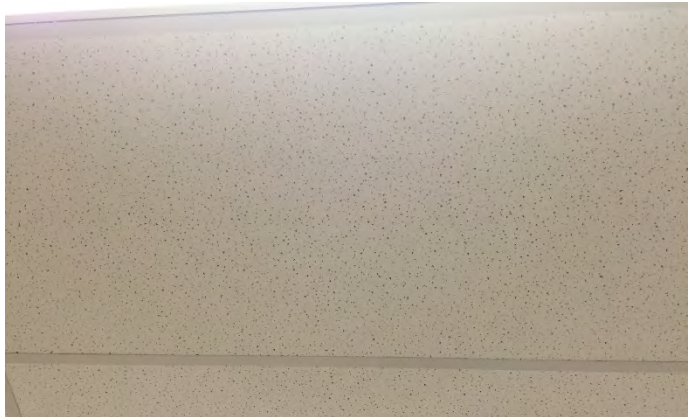
CT11	2' x 4' Small Flecks and Small Pinholes	17429- HG-PGO- 03A to 03C	None Detected

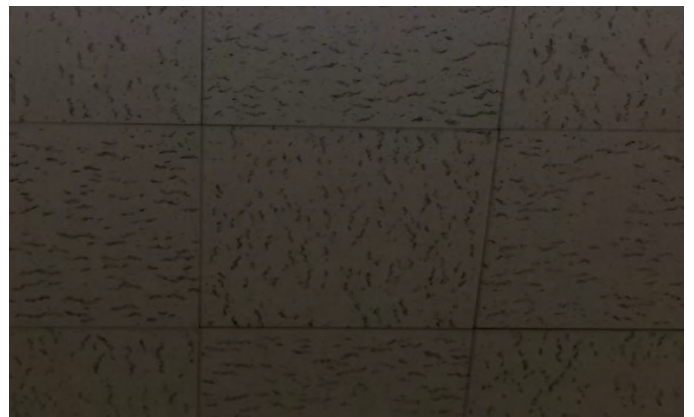
CT12	1' x 1' Glue-on Scattered Dot and Fissure Pattern	Previously Sampled in 2008	0.5-5% Chrysotile 5-10% Amosite
