FINAL
Asbestos
Reassessment

West Lincoln Memorial Hospital
169 Main Street East, Grimsby,
Ontario

January 17, 2019

Pinchin File: 217420.030

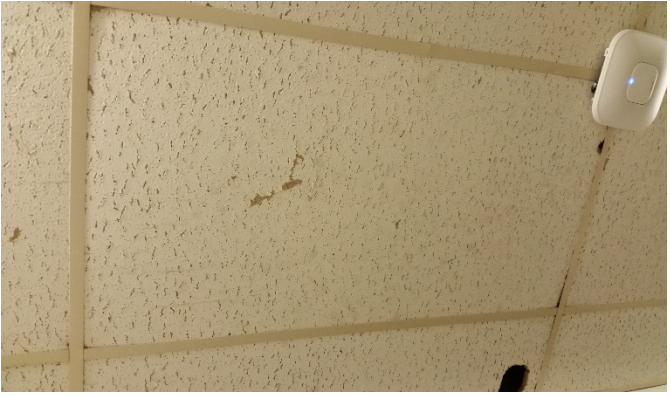
TABLE V Summary of Ceiling Tiles (CT)				
MIN	Description	Sample Number	Results	Photograph
CT1	2'x4' Fissures and Pinholes	17429- WL- ERB- 05A to 05C	None Detected

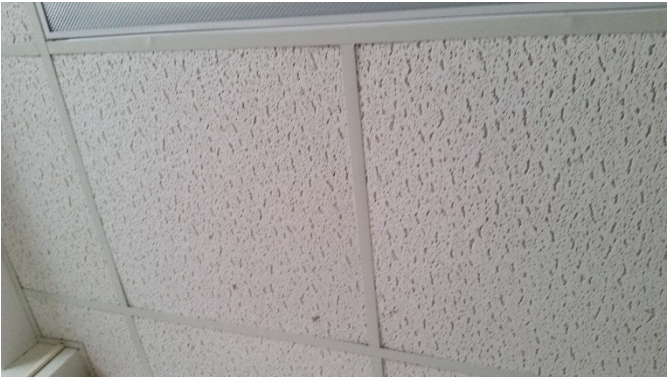
CT2	2'x2' Long Fissures and Many Pinholes	17429- WL- FWB- 05A to 05C	None Detected

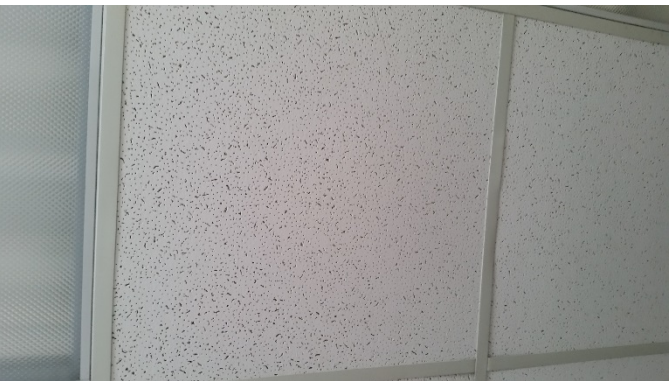
CT3	2'x2' Small Fissures and Many Pinholes	17429- WL- FWB- 09A to 09C	None Detected

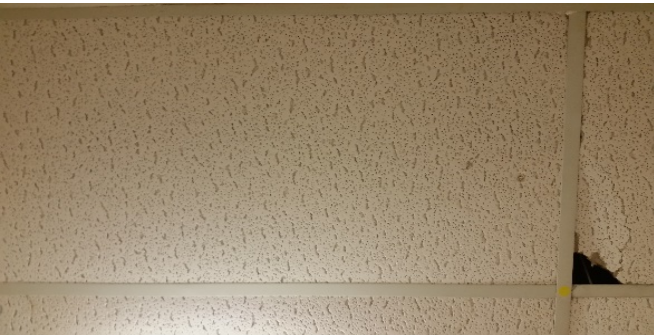
CT5	2'x4' Many Pinholes and Many Fissures	17429-WL-FWG-05A to 05C	None Detected

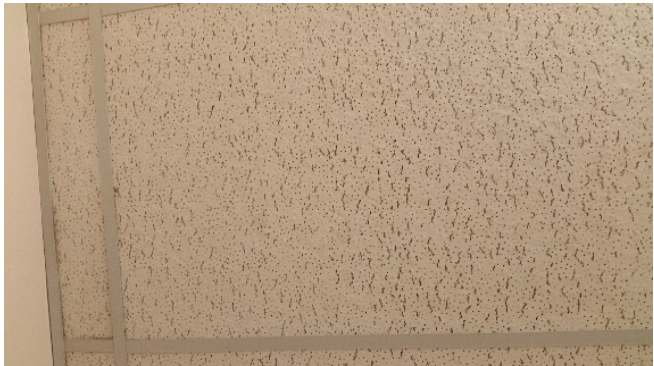
CT6	2'x4' Long Fissures w/ Large Pinholes	17429-WL-FWG-11A to 11C	None Detected

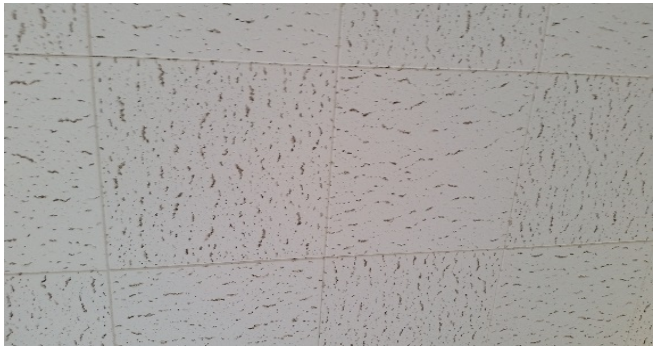
CT7	1'x1' Glue on - Fissures and Pinholes	17429-WL-FW1-12A to 12C	None Detected

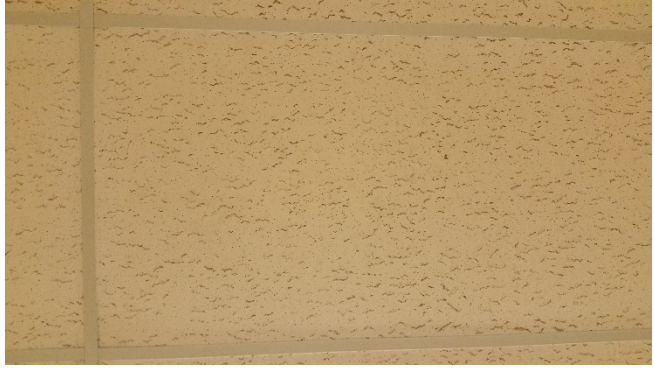
TABLE V Summary of Ceiling Tiles (CT)				
MIN	Description	Sample Number	Results	Photograph
CT8	2'x4' Deep Fissures and Pinholes	17429-WL-MWB-10A to 10C	None Detected

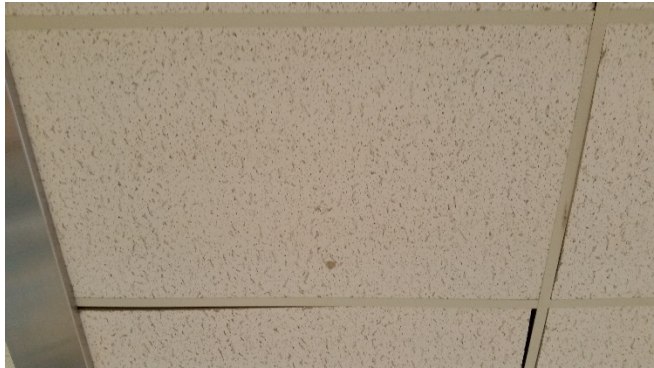
CT9	2'x4' Small and Large Fissures w/ Pinholes	17429-WL-MWG-05A to 05C	None Detected

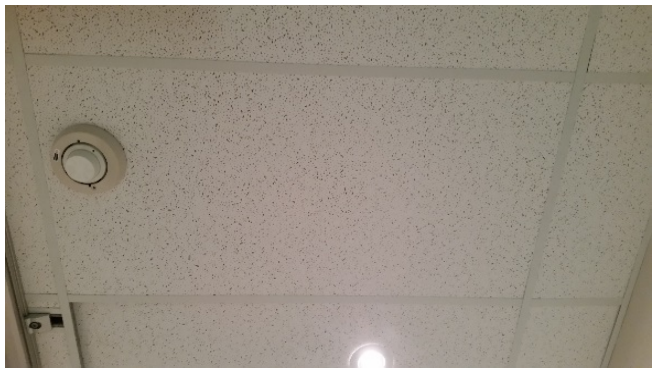
CT10	2'x4' Small Fissures and Pinholes	17429-WL-MWG-11A to 11C	None Detected
